Compliance Assistance Offer

**Florida Department of  
Environmental Protection  
Hazardous Waste Inspection Report**

**Facility Name:** Liquid Environmental Solutions of Florida LLC

**On-Site Inspection Start Date:** 11/30/2016      **On-Site Inspection End Date:** 11/30/2016

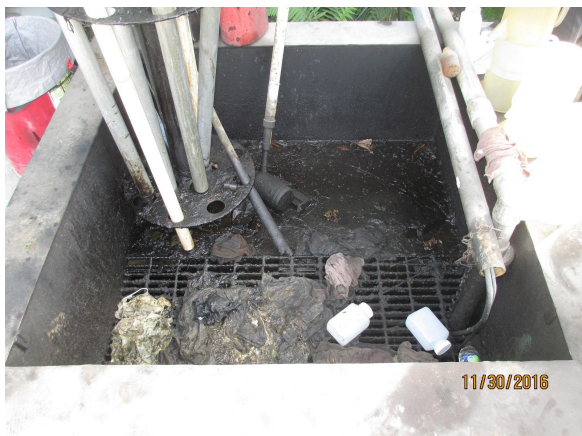
Photo 1

LES personnel collect samples from all incoming liquid waste using a Composite Liquid Waste Sampler (COLIWASA) for fingerprint analysis. After sampling, the COLIWASA is placed in a secondary containment sump for continuous use. There was what appeared to be oil in the sump and on the soil adjacent to the sump (Photo 1). At the time of the inspection, the facility had failed to clean-up the release in this area (Photo 2) [Permit Condition, Part II #8, and 40 CFR 279.54(g)].

Type: Violation  
Rule: **279.54(g)**  
Explanation: The facility failed to clean up the release of used oil in the following areas:  
1. The soil adjacent to the secondary containment sump for the COLIWASA equipment.  
2. The soil directly under the south wall for the SCA areas in the Used Oil Processing Area.  
3. The gravel and soil adjacent to the three off-loading areas for the Oily Water receiving stations.  
Corrective Action: In order to return to compliance, the facility should immediately perform the following steps upon detection of a release of used oil to the environment:  
1. Stop and contain the release of used oil.  
2. Clean up and properly manage the released used oil and remove any contaminated materials or soil for proper disposal.  
3. If necessary to prevent future releases, repair or replace any equipment leaking used oil before returning the equipment to service.

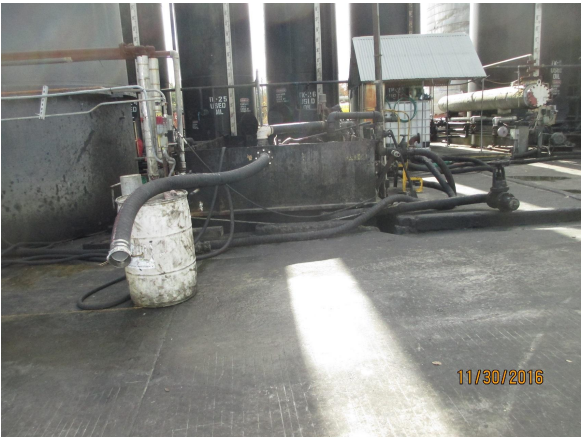
Photo 8

An inspection of the SCA revealed what appeared to be used oil and oily water accumulating around tanks inside the SCA (Photos 8 and 9). Mr. Turovsky told the inspectors that the SCA is cleaned with a pressure washer and scrubbed down at the end of each day. The facility is reminded that liquid and debris accumulation should be removed within 24 hours of detection in accordance with Permit Condition, Part I #40.

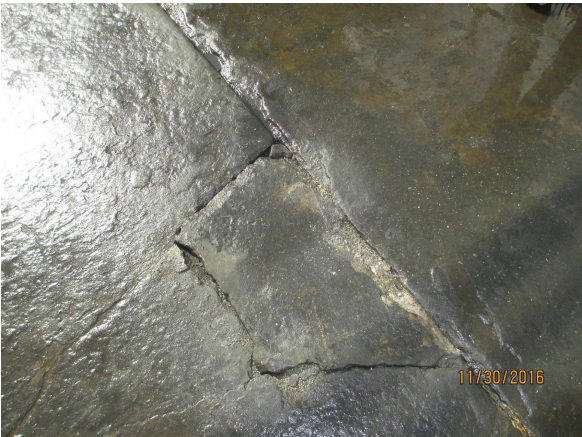
Photo 10

The inspection of the SCA also revealed that there were a few cracks and one large piece of loose concrete in the center of the containment floor (Photo 10). At the time of the inspection, the facility had not repaired these areas [Permit Condition, Part I #33, and 40 CFR 279.54(d)(2)].

Type: Violation  
Rule: **279.54(d)(2)**  
Explanation: 1. The secondary containment in the FPA had a few cracks and one large piece of loose concrete in the center of the containment floor.  
2. The south wall of the SCA in the Used Oil Processing Area had a long crack in it and it appeared as though several concrete blocks had separated or had been insufficiently patched or caulked.  
Corrective Action: No further action is required. The facility is in compliance per December 30, 2016, and January 25, 2017 emails.

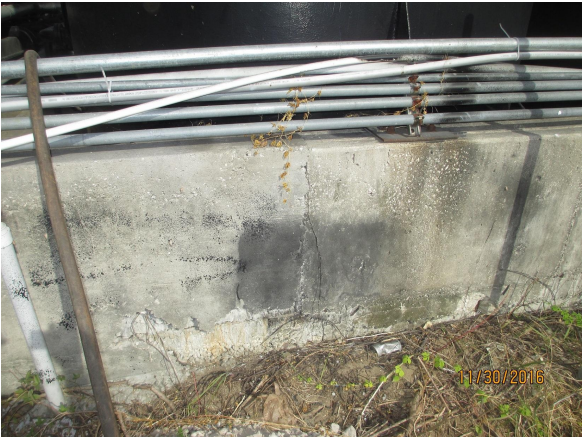
Photo 11

An inspection of the south wall of the SCA in the Used Oil Processing Area had a long crack where it appeared as though several concrete blocks had separated or had been insufficiently patched or caulked (Photo 11). At the time of the inspection this area had not been repaired [Permit Condition, Part I #33, and 40 CFR 279.54(d)(2)]. The soil directly under the SCA wall was stained with what appeared to be used oil from inside the SCA (Photo 12). At the time of the inspection, the facility had failed to clean-up the release [Permit Condition, Part II #8, and 40 CFR 279.54(g)].

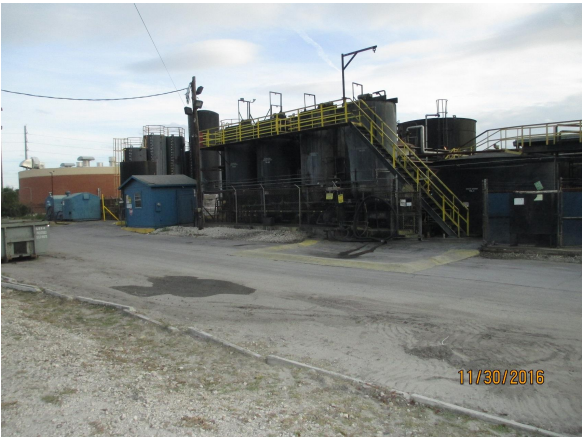
Photo 13

The gravel and soil adjacent to the three off-loading areas outside the SCA for the Oily Water Treatment Area's receiving stations was stained with what appeared to be used oil (Photos 13-15). At the time of the inspection, the facility had failed to clean-up the releases [Permit Condition, Part II #8, and 40 CFR 279.54(g)].

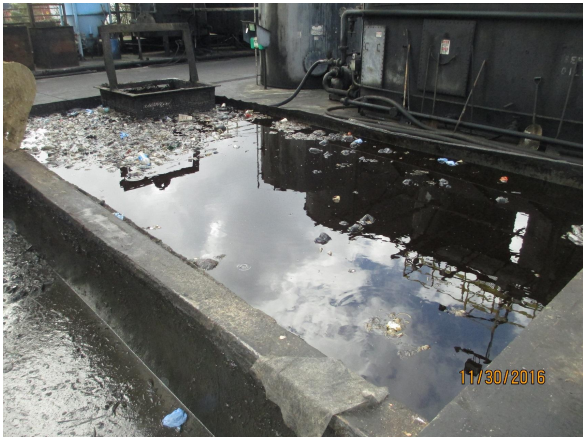
Photo 16

Two open, concrete and steel lined Tanks, 61 and 62, are dedicated for solids and sludge solidification and have a total capacity of 16,000 gallons (Photo 16). The facility is authorized under its Solid Waste permit to generate wastewater treatment solids and oily solids waste from the facility's wastewater treatment processes and used oil processing.

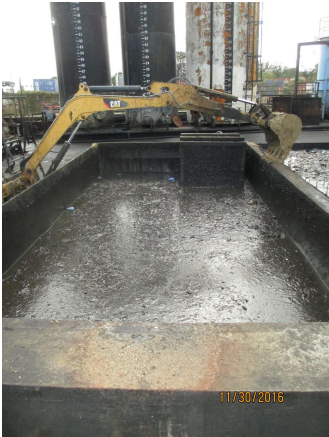
Photo 17

A back loader equipped with a heavy screen cage is used to physically separate the liquids from the solids in each tank (Photo 17). Facility staff use a large suction hose to transfer the trapped oily waste liquid to the oil/water separator. Removal of liquid oily waste from the tank during the solidification process reduces the overall waste volume by more than half. Bails of absorbent paper material are used for solidification of leftover tank sludge. Waste solids are placed into 20-cubic yard roll-off containers and shipped to the same

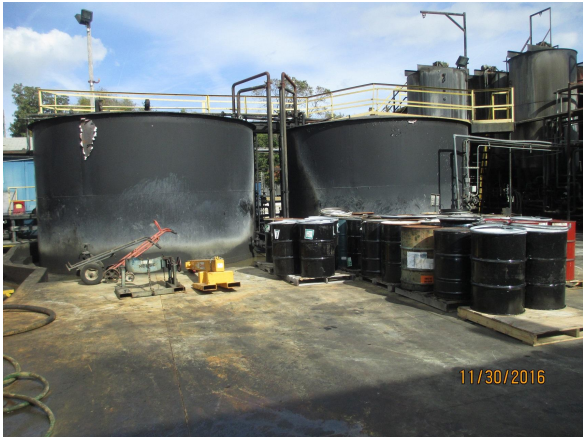
Photo 18

The Container Storage Area is approximately 1,000 square feet. At the time of the inspection, 30 55-gallon drums were stored in this area (Photo 18). Eight drums were empty and 22 drums were closed and labeled as non-hazardous waste. All drums were on an oil-impervious surface.
