**Florida Department of  
Environmental Protection  
Hazardous Waste Inspection Report**

**Facility Name:** Veolia ES Technical Solutions LLC  
**On-Site Inspection Start Date:** 06/14/2017      **On-Site Inspection End Date:** 06/14/2017  
**ME ID#:** 6716      **EPA ID#:** FL0000207449  
**Facility Street Address:** 342 Marpan Ln, Tallahassee, FL 32305-0904  
**Contact Mailing Address:** 342 Marpan Ln, Tallahassee, FL 32305-0904  
**County Name:** LEON      **Contact Phone:** (850) 877-8299

Routine Inspection for Transfer Facility facility  
Routine Inspection for Universal Waste Transporter facility  
Routine Inspection for TSD Facility facility  
Routine Inspection for LQG (>1000 kg/month) facility  
Routine Inspection for Hazardous Waste Transporter facility

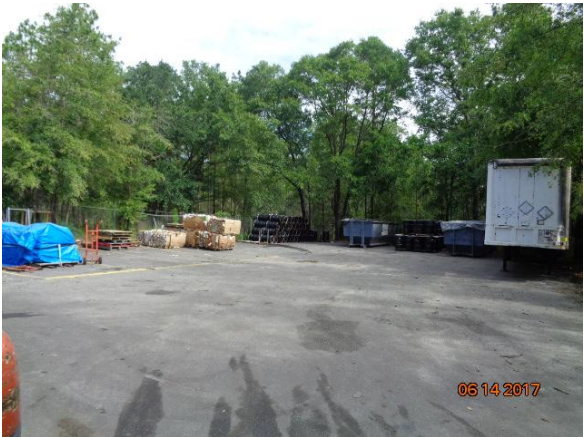
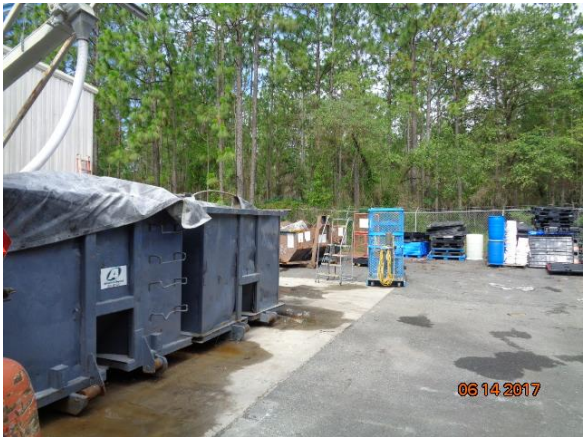
Outside North Storage Area

Two 20-yard roll-offs for collection of processed glass are staged in this area on a concrete pad. An additional two covered 20-yard roll-offs are present in the adjacent asphalt area. This adjacent asphalt paved area is used for collection of cardboard/paper products, wood pallet recycling and various empty container storage. The hazardous waste transfer area is also located here for the overnight holding of transport trucks in the event of an arrival after business hours. The trucks are immediately unloaded during the next business day. Currently present is a partially loaded trailer containing shat-r-shield type bulbs that will be shipped to the Phoenix Arizona Veolia facility that is capable of processing these type bulbs. This trailer was scheduled for transport to the alternative Veolia facility on June 15, 2017.

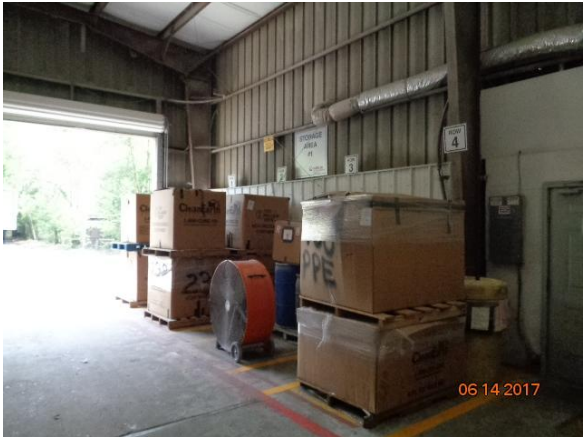
Storage Area #1

Veolia has two storage areas designated as "Container Storage Areas One and Two" (CSAs). The CSAs are permitted for up to 27 pallets (108 55-gallon drums) of MCMA; dental amalgam and traps; pre-retort phosphor powder; HID arc tubes; and site-generated hazardous waste (prep room debris and PPE, condensate water, and spent carbon). At the time of this inspection, there were six large Gaylord style boxes that contained sock filter wastes and belting wastes, three plastic 55-gallon drums that contained spent activated carbon from lamp recycling, one 55-gallon drum of mercury containing debris (PPE for microencapsulation) and one small cardboard box of regulated medical waste in Storage Area #1. All of these containers were labeled, neatly organized and kept in their assigned storage areas.

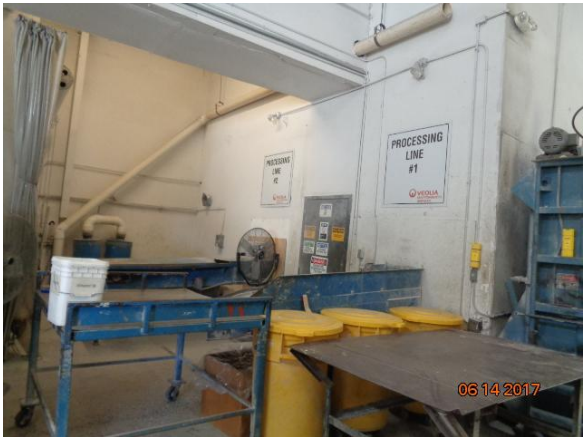
Fluorescent lamps are staged immediately adjacent to the lamp processing feed belts. Fluorescent lamps are hand fed into the lamp processing room via a conveyor belt. The Fluorescent Lamp Processing Room (labeled as Crush and Separate Room on the Facility Plan), is located in the northwest corner of the facility. It is designed to process approximately 200,000 feet of lamp equivalents per 8-hour shift. Lamps are crushed in a drum crusher and dry-separated into glass, aluminum and phosphor powder. Phosphor powder is collected by a bag tower and accumulated in 55-gallon drums. There are two processing lines that are used to facilitate this operation. The second processing line is used when there is a need to process a larger volume of materials.

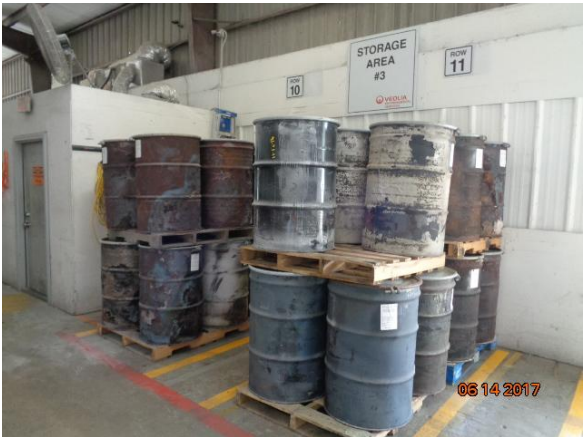
Storage Area #3

During the inspection the facility had six pallets of fluorescent linear tube lights still wrapped in stretch wrap, four cardboard fiber drums containing fluorescent linear tube lights and approximately twelve RecyclePak® cardboard boxes of varying sizes staged for processing starting in this area and stretching down the aisle space between the Retort Room and Storage Area #3.

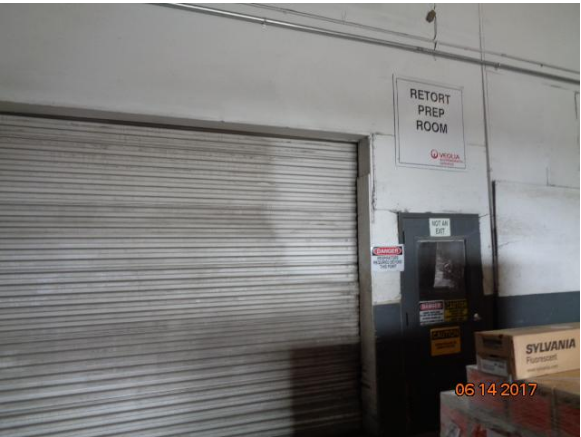
Entrance to Retort Prep Room

The retort room, located immediately south of the fluorescent lamp conveyor belts, is an enclosed negative pressure room. The prep area is separated from the retort oven by a roll-up door. The phosphor powder, crushed HID arc tubes, and MCMA's are prepared for the retort oven in the prep area. Drums of crushed HID arc tubes and phosphor powder from the lamp recycling operation have their lids removed in the prep area and are then placed in the retort oven. MCMA are manually disassembled and the liquid mercury is drained and accumulated for sale in the prep area. MCMA components are placed in the retort oven or segregated for off-site recycle/disposal. Manual processing of compact fluorescent lamps is no longer conducted at this Veolia facility. At the time of the inspection materials were being staged in this area as previously described in section C (Fluorescent Lamp Processing).

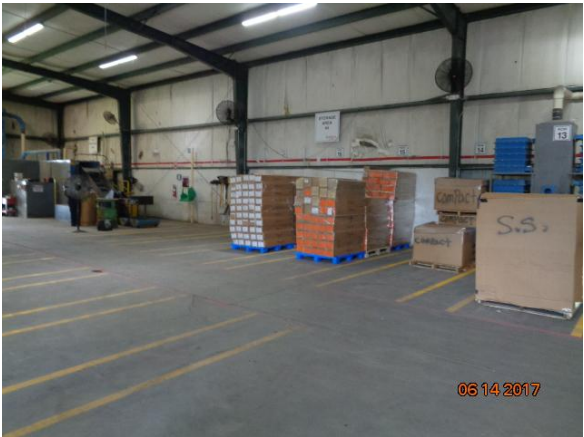
At the time of this inspection, Storage Area #4 contained six pallets of fluorescent linear tube lights with each

pallet holding between 42 and 56 lamp recycling boxes. Each of the lamp recycling boxes contained 25 lamps. These have been bound together with plastic stretch wrap to ensure these recycling boxes are easy to move as a singular unit and to keep them inside their assigned storage areas. Also contained in Storage Area #4 were three small Gaylord style boxes containing compact fluorescent light (CFL) bulbs, one large Gaylord style box holding shat-r-shield type bulbs and one large cardboard box with 2" x 2" wooden supports that also contained shat-r-shield type bulbs. These containers were neatly organized and kept in their assigned storage areas.

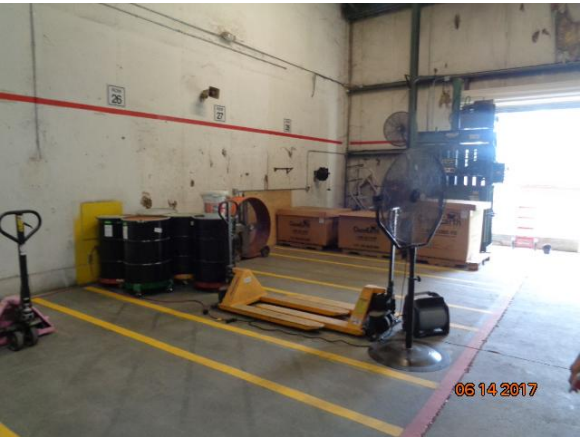
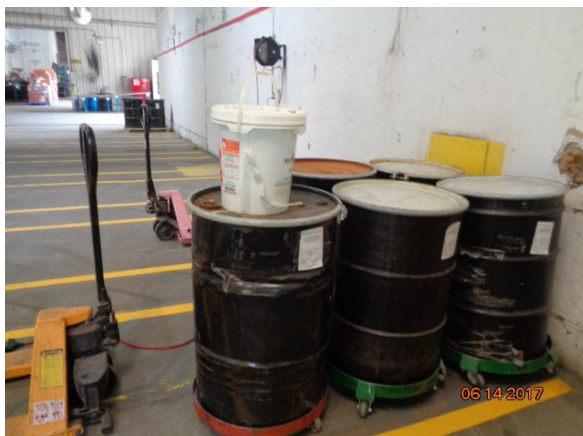
Also located at the south of the main facility building (but on the east wall) is Storage Area #5. Storage Area #5 contained three large Gaylord boxes that contained scrap brass, CFLs, and halogen lamps. These Gaylord boxes were neatly organized and kept in their assigned storage areas. Storage Area #5 also contained two 55-gallon drums of Universal Waste Mercury Lamps. These were labeled and stored on a wooden pallet. These drums and the pallet they were stored on were kept in their assigned storage area. Additionally in Storage Area #5 there were five 55-gallon drums and one 5-gallon RecyclePak®. The 55-gallon drums contained clean glass and the 5-gallon RecyclePak® contained Universal Waste lamps. These drums were neatly organized and kept in their assigned storage areas.

Since the last facility inspection, the facility has removed its maintenance area/cage from this area and now uses the former location as an extension of Storage Area #5 (as previously described).

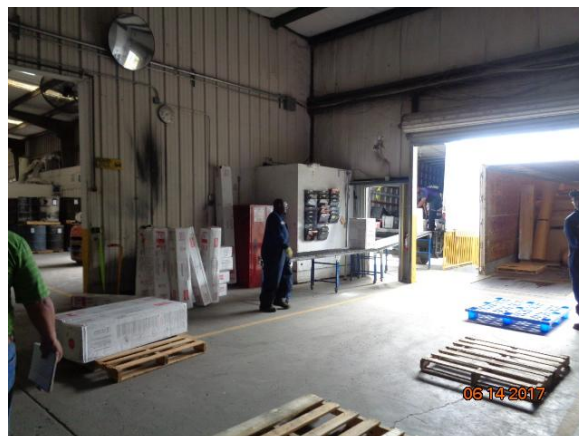
### Loading Dock

The loading and unloading area consists of two trailer docking areas for forklift transfer of materials to/from transport vehicles. Post-retort phosphor powder in 55-gallon drums is accumulated in this area along the east wall prior to off-site shipment for disposal in a Subtitle D landfill. This area is labeled as Storage Area #3 on the Facility Plan that is part of the facility's permit. The permit requires that post-retort phosphor powder be sampled to ensure effective retort processing prior to off-site shipment. During the inspection of the facility, this area contained fifteen 55-gallon drums of post-retort powder as well as nine 55-gallon drums of leaded glass. All of these 55-gallon drums were labeled, neatly organized and kept in their assigned storage areas.

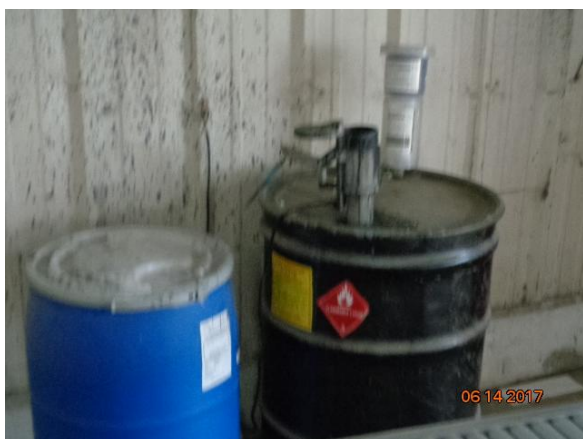
### Aerosol Can SAA

Adjacent to Storage Area #5 is the Satellite Accumulation Area for an aerosol can puncturer.

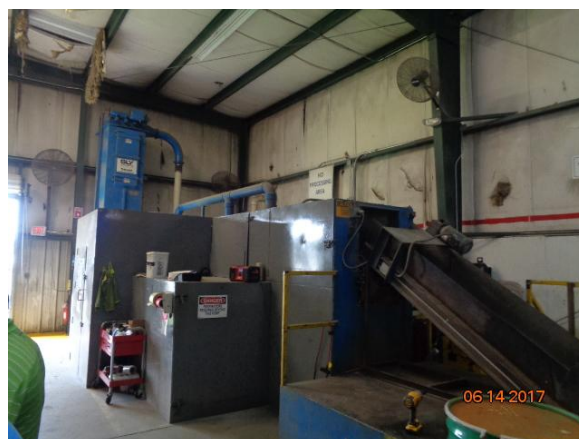
### HID Processing Area

HID lamps are processed through a custom built HID machine in the southern end of the main facility building. Veolia previously used a manual process in conjunction with the automated process but that has been discontinued. The HID lamp machine is comprised of conveyor belts, crushers, magnets and air pollution control equipment. It is enclosed and under negative pressure. It uses an automated process to dry-separate outer glass, metal bases and support wires from the arc tubes. The arc tubes are crushed and dropped into 55-gallon drums for further processing in the retort room. The remaining components are dropped into collection containers for recycle/disposal. The drums of crushed arc tubes are managed as SSA containers and moved to the CSA at the north end of the building within three days. The automatic feeder/conveyor has been reduced to allow for more area to stage the HID lamps for processing. A new conveyor belts has been used to help facilitate the increased processing of the HID lamps.

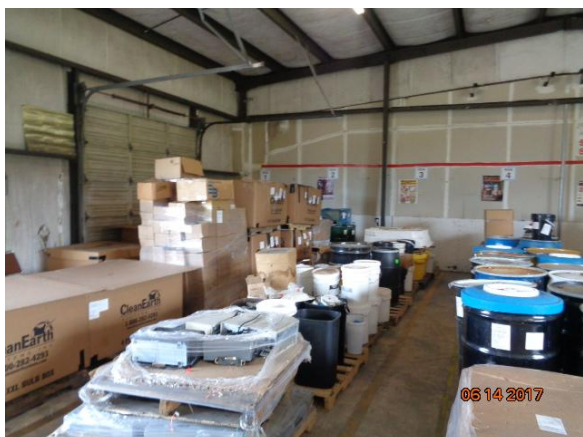
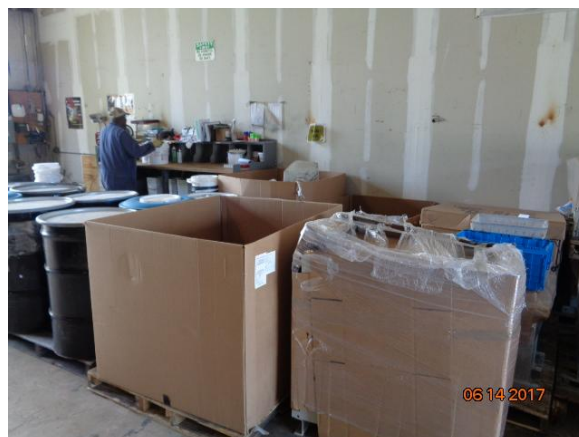
### Battery, E-Waste Area

The building is immediately south of the main building and is divided into two large storage areas. The Container storage area is used to hold empty fiber drums and cardboard boxes. Additionally this area is now the location where the Maintenance Cage has been relocated to from its previous location adjacent to Storage Area #5. No universal or hazardous wastes are stored in this area. The second room in this building is used for the storage of e-waste and battery storage. The space is permitted to store up to 72 pallets. At the time of the inspection, all pallets were properly labeled and protected from the environment. The battery sorting table is still in use to help in sorting the various battery types received by the facility.
