RE: Warning Letter No. WL18-125
Heritage-Crystal Clean, LLC
EPA/DEP ID: FLR 000 154 278
Duval County – Hazardous Waste

**Florida Department of
Environmental Protection
Hazardous Waste Inspection Report**

Facility Name: Heritage - Crystal Clean LLC

On-Site Inspection Start Date: 05/08/2018

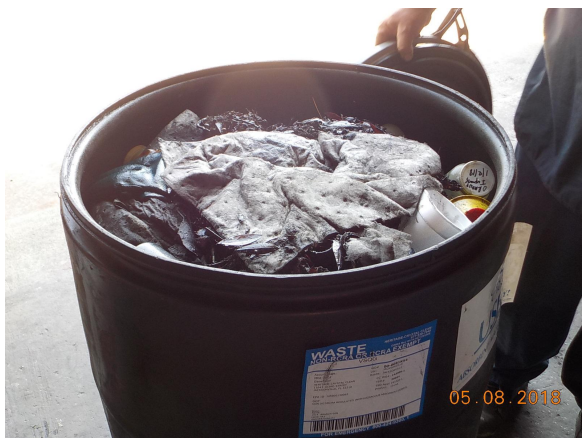
Photo 3

HCC generates a routine wastestream, "Branch Debris," during the transport and transfer of used oil. This wastestream includes solid wastes such as wipes, absorbents, PPE and similar items. HCC manages Branch Debris as non-hazardous waste, but it has not made a hazardous waste determination on this wastestream by having the waste analyzed for hazardous waste characteristics [40 CFR 262.11]. At the time of the inspection, two containers of Branch Debris were accumulating inside the Warehouse. Both containers were closed and labeled as non-hazardous waste. One of the containers was opened for inspection (Photo 3).

Type: Violation 3
Rule: **262.11**
Explanation: The facility failed to manage its residues from the transport and transfer of used oil, referred to as Branch Debris, by disposing of the waste without performing a hazardous waste determination that includes analytical testing for hazardous waste characteristics.
Corrective Action: In order to return to compliance, the facility should complete a hazardous waste determination for its Branch Debris. The facility may make a hazardous waste determination by having the wastestream analyzed by a certified laboratory for the following:

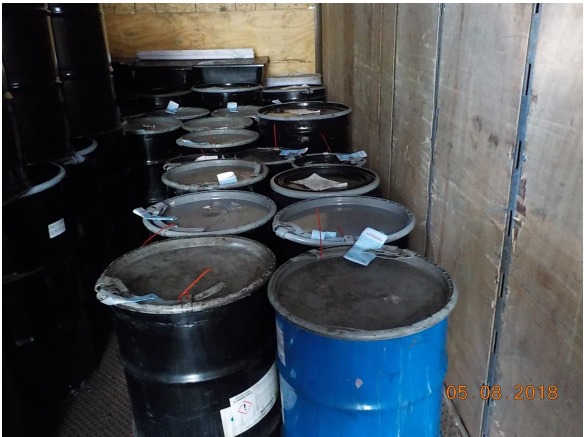
Photo 5

HCC transports hazardous waste in box trucks that return to the facility where the containers are transferred directly from the trucks into one of the semi-trailers located in the Waste Transfer Area described below. At least every ten days, a trailer with new products and supplies is brought into the facility, unhitched and then the trailer with the waste containers is attached to the truck cab and transported to HCC's facility in Atlanta. At the time of the inspection, the trailer contained approximately 20 drums of non-hazardous spent parts washer solvent (Photo 5). No hazardous waste was accumulating in the trailer.

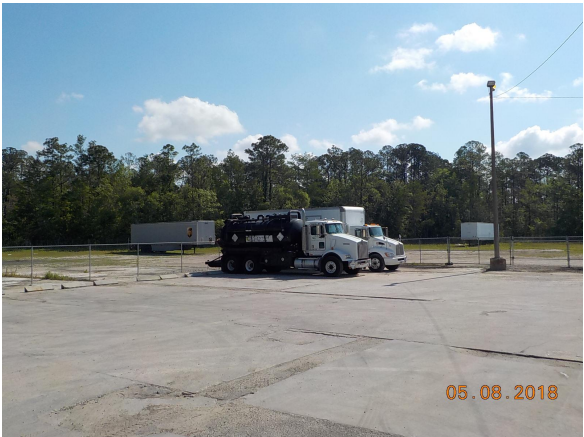
Photo 9

This parking area is located on the northside of the Main Warehouse and adjacent to the facility's northern property fence. The parking lot where the vacuum trucks are parked is unsealed asphalt, loose limerock and dirt. At the time of the inspection, there appeared to be several areas of what appeared to be used oil released in the vicinity of one of the vacuum trucks that had not been cleaned-up (Photos 6-8) [40 CFR 279.22(d)]. The northeast side of the parking lot is used for pump truck and box truck parking. One pump truck and one box truck were parked in the lot at the time of the inspection (Photo 9). All other vehicles were out of the yard for pick-ups or deliveries.

Type: Violation 1
Rule: **62-710.401(6)**
Explanation: Used oil in the vacuum truck is occasionally parked in the Truck Parking Lot at the facility for periods greater than 24-hours. The Truck Parking Lot is not oil-impermeable and does not have secondary containment.
Corrective Action: In order to return to compliance, the facility should either:
1) Park trucks containing used oil on an oil-impermeable surface with engineered secondary containment that has the capacity to hold 110% of the volume of the largest truck within the containment area; or
2) Ensure that any trucks containing used oil are not parked in the Truck Parking Lot for greater than 24-hours.

Type:	Violation 9
Rule:	279.22(d)(3)
Explanation:	The facility failed to respond to and clean-up several areas of what appeared to be used oil releases in the Truck Parking Lot.
Corrective Action:	<p>In order to return to compliance, the facility should immediately perform the following steps upon detection of a release of used oil to the environment:</p> <ol style="list-style-type: none">1. Stop and contain the release of used oil;2. Clean up and properly manage the released used oil and remove any contaminated materials or soil for proper disposal; and3. If necessary to prevent future releases, repair or replace any equipment leaking used oil before returning the equipment to service.

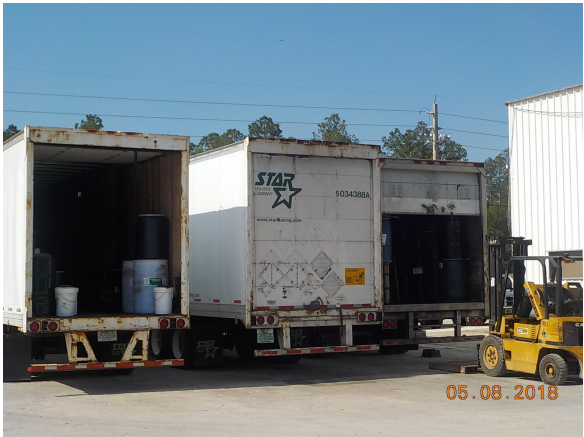
Used oil filters, hazardous waste, non-hazardous waste, universal waste and materials and supplies are transferred directly from incoming trucks into one of three unhitched semi-trailers parked on the east side of the Main Warehouse and southeast of the Truck Parking Lot described above (Photo 10). This area has an asphalt base that appears to be cracked in several areas adjacent to and under the semi-trailers.

The trailer on the left in Photo 10, and described above, is used to accumulate hazardous and non-hazardous wastes, universal waste and spent parts washer solvent. The trailer in the middle in Photo 10 is used to store new parts washer product and supplies (Photo 11). The trailer on the right in Photo 10, and described above, is used to accumulate used oil filters.

Type:	Violation 7
Rule:	62-710.850(5)(a)
Explanation:	The facility accumulated used oil filters in containers that were not stored on an oil-impermeable surface.
Corrective Action:	In order to return to compliance, the facility should store used oil filters in containers on an oil-impermeable surface.

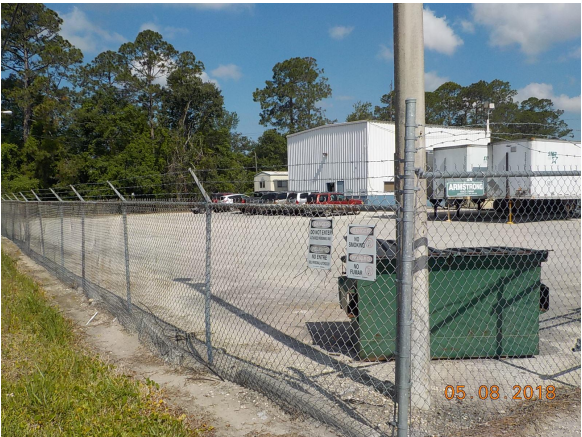
Photo 12

The facility is surrounded by a chain link fence topped with barbed wire. It appeared to be in good condition. The facility is accessed through a main entrance gate that is kept open during business hours when HCC employees are on-site. An exit gate is electronically controlled and motion-activated to open for trucks exiting the facility. Both gates are manually locked at night. At the time of inspection, the main gate was open for business, and the exit gate was closed. Adequate warning signage had been posted (Photo 12).
