SUBJ: Resource Conservation Recovery Act (RCRA) Compliance Evaluation Inspection (CEI)  
Stericycle Specialty Waste Solutions Inc.  
EPA ID Number: FL0000702985

**United States Environmental Protection Agency  
Region 4, Atlanta, Georgia  
Compliance Evaluation Inspection Report**

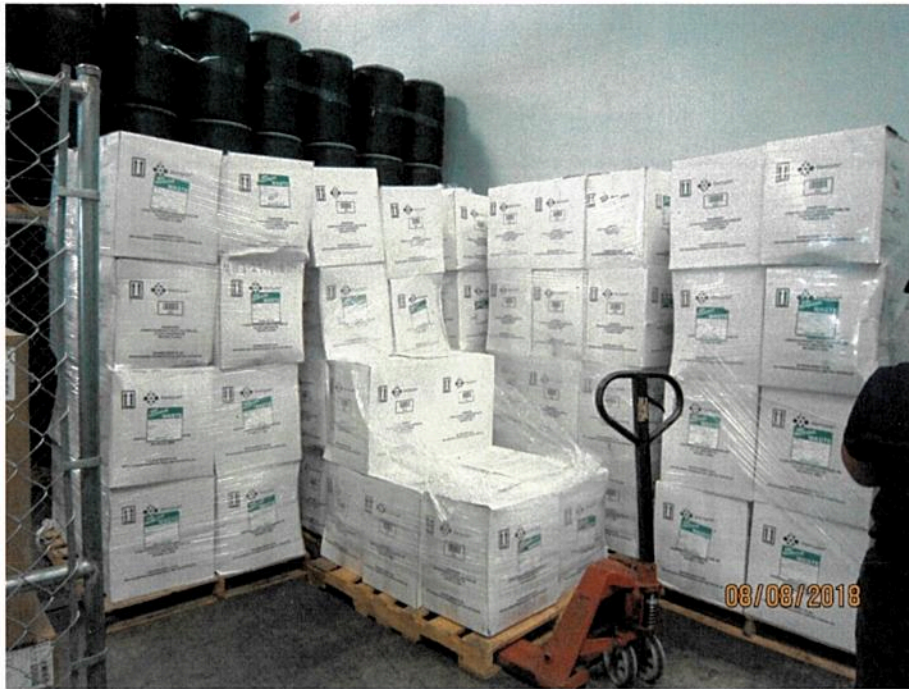
The inspectors observed eight wooden pallets, each containing 24 boxes, and one wooden pallet containing eight boxes, of non-hazardous, non-regulated pharmaceuticals labeled as "Non-viable outdated/expired pharmaceuticals" (Picture #1). A total of 200 boxes, equipped with double-bags were observed closed and labeled as non-hazardous pharmaceutical waste with accumulation start dates. Not all boxes could be inspected due to inadequate aisle space.

Picture #1 – Pallet of wastes that have been designated as containing non-hazardous, non-regulated pharmaceuticals (“Non-viable outdated/expired pharmaceuticals”)

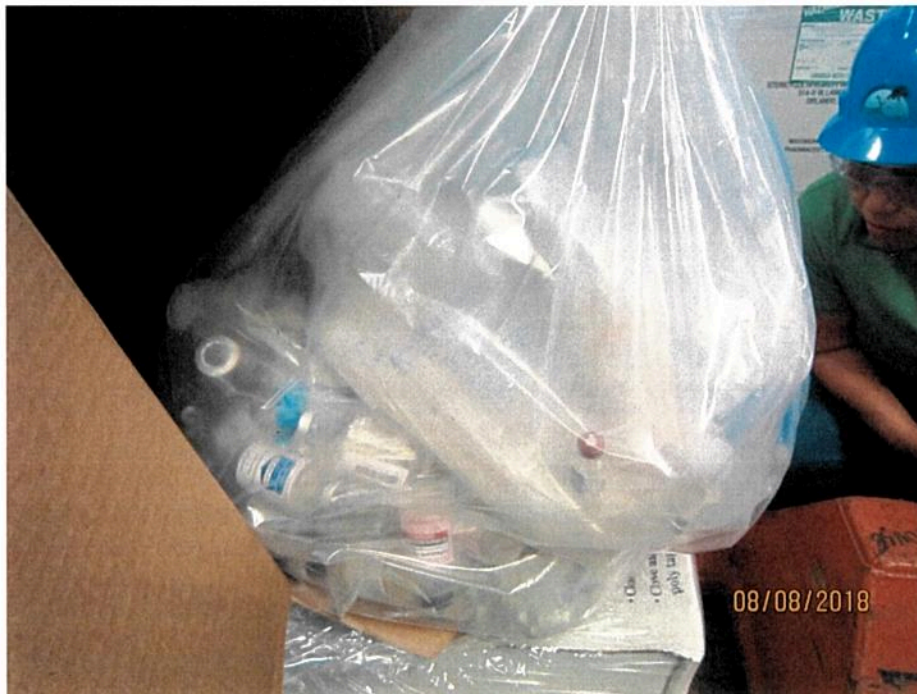
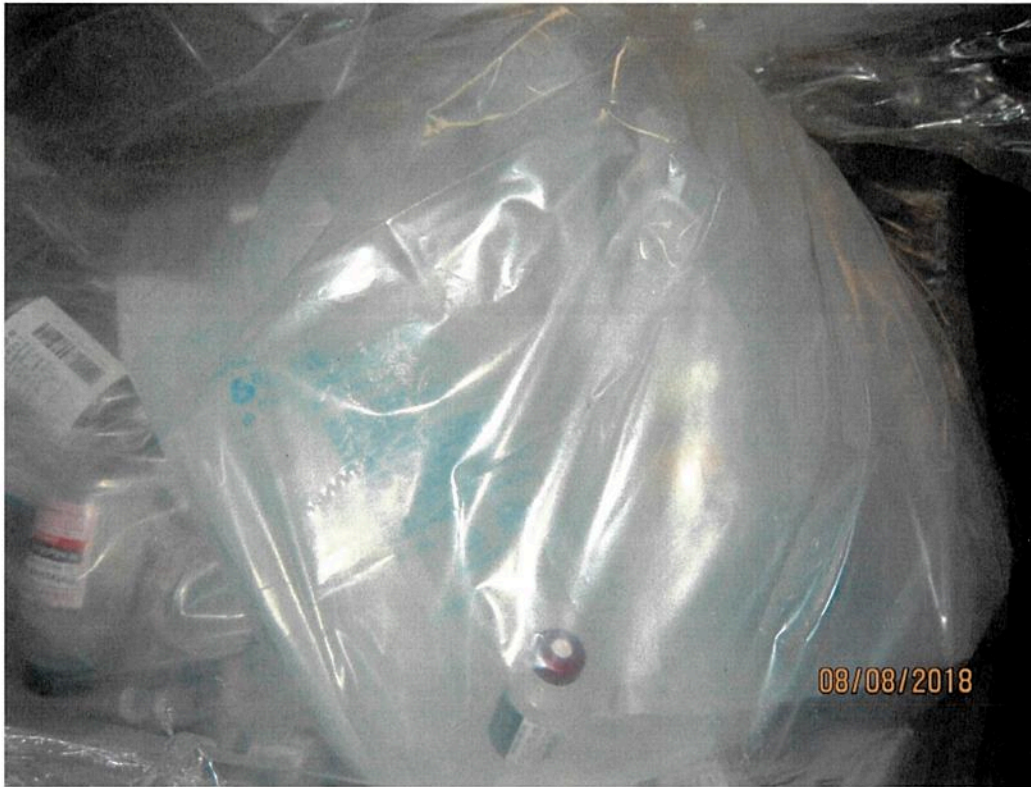
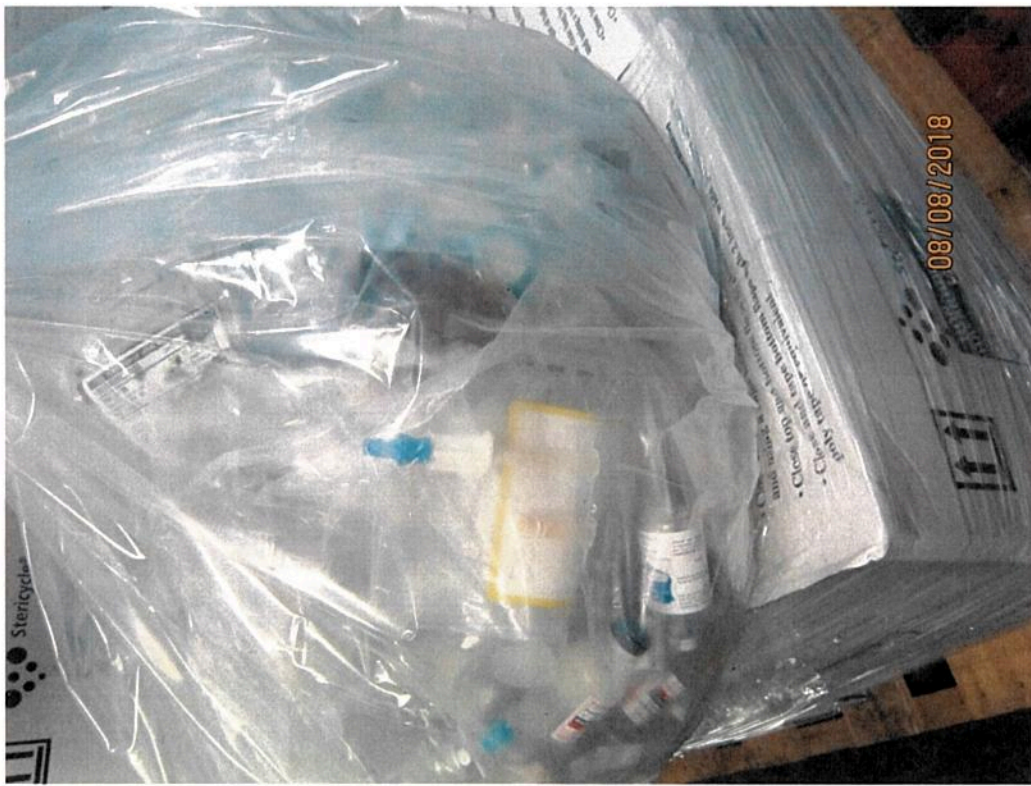
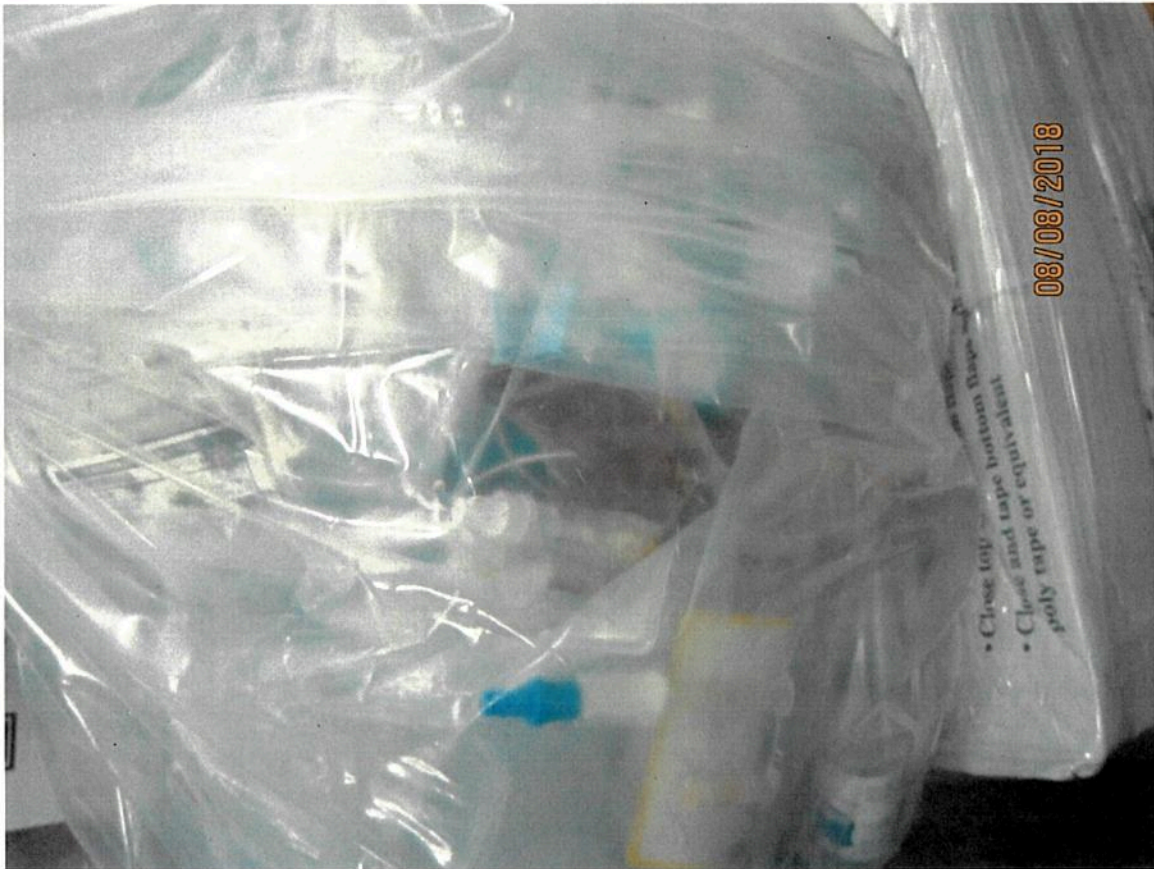
In order to confirm that the contents of the boxes were the non-hazardous pharmaceutical waste described on the label, the inspectors requested two boxes be opened during the inspection. *The inspectors observed that the two boxes designated as non-hazardous pharmaceutical waste contained both pharmaceutical waste (medicine vials and pill bottles) as well as biomedical waste (IV bags, needles, and blood), comingled within the same bags (Pictures #2-5).*

Picture #2 – Comingled pharmaceutical waste and biomedical waste within the same bag.

Picture #3 – Comingled pharmaceutical waste and biomedical waste within the same bag.

Picture #4 – Comingled pharmaceutical waste and biomedical waste within the same bag.

Picture #5 – Comingled pharmaceutical waste and biomedical waste within the same bag.

**Pursuant to Fla. Admin. Code Ann. r. 62-730.160(1) [40 C.F.R. § 262.11], a person who generates a solid waste, as defined in Fla. Admin. Code Ann. r. 62-730.030(1) [40 C.F.R. § 261.2], must determine if that waste is a hazardous waste following the methods articulated in to Fla. Admin. Code Ann. r. 62-730.160(1) [40 C.F.R. § 262.11].**

**Pursuant to Fla. Admin. Code Ann. r. 62-701.300(6)(b), no solid waste, including treated biomedical waste, shall be commingled with untreated biomedical waste unless the solid waste is being managed in the same manner as the untreated biomedical waste.**

**Pursuant to Fla. Admin. Code Ann. r. 62-730.186(3), if hazardous waste pharmaceuticals are not managed as universal waste in accordance with the Florida Universal Pharmaceutical Waste rules, Chapter 62-730.186, F.A.C., they shall be managed in accordance with Chapter 62-730 as hazardous waste, and shall be disposed of at a permitted hazardous waste treatment, storage or disposal facility.**

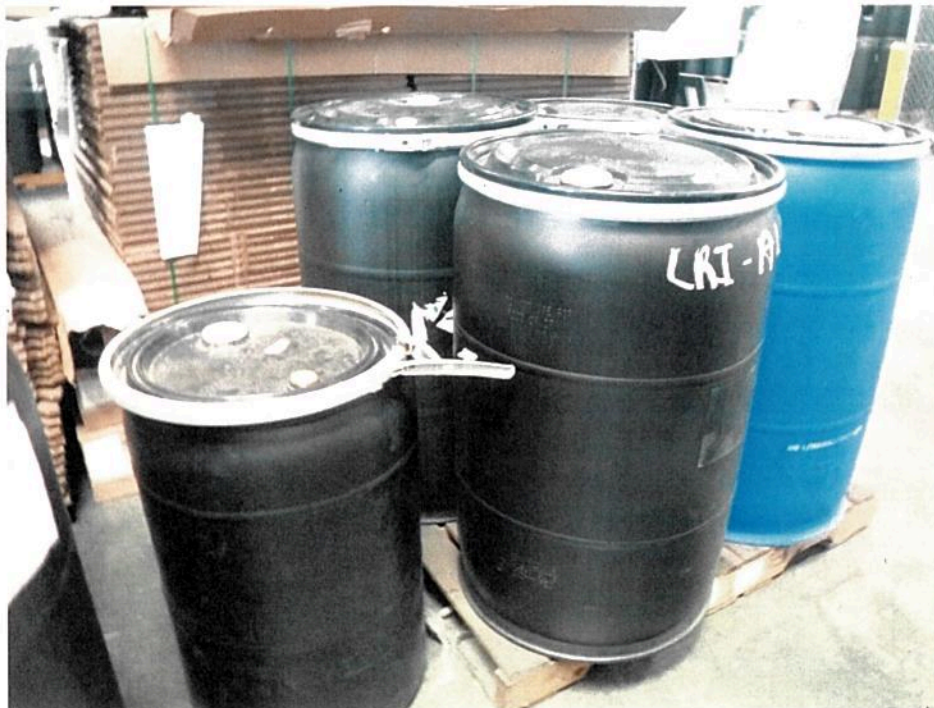
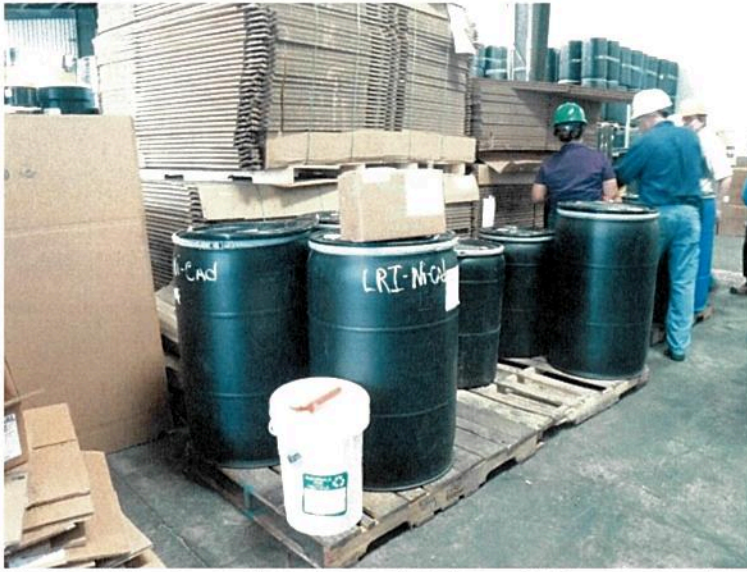
- One 55-gallon drum of universal waste NiCad batteries closed and labeled with an accumulation start date of 4/27/2018;
- One 55-gallon open drum of universal waste NiCad batteries with an accumulation start date of 5/3/2018 (Pictures #6-7);
- One 5-gallon closed and labeled container of non-PCB ballasts with an accumulation start date of 8/6/2018;
- One 5-gallon cardboard box closed and labeled universal waste alkaline & NiCd batteries with an accumulation start date of 7/5/2018.

Picture #6 – Open Container of Universal Waste Batteries.

Picture #7 – Open Container of Universal Waste Batteries.

**Pursuant to Fla. Admin. Code Ann. r. 62-737.400(5) [40 C.F.R. § 273.33(a)(1)], a large quantity handler of universal waste must manage universal waste batteries in a way that prevents releases of any universal waste or component of a universal waste to the environment. *The container must be closed, structurally sound, compatible with the contents of the battery, and must lack evidence of leakage, spillage, or damage that could cause leakage under reasonably foreseeable conditions.***

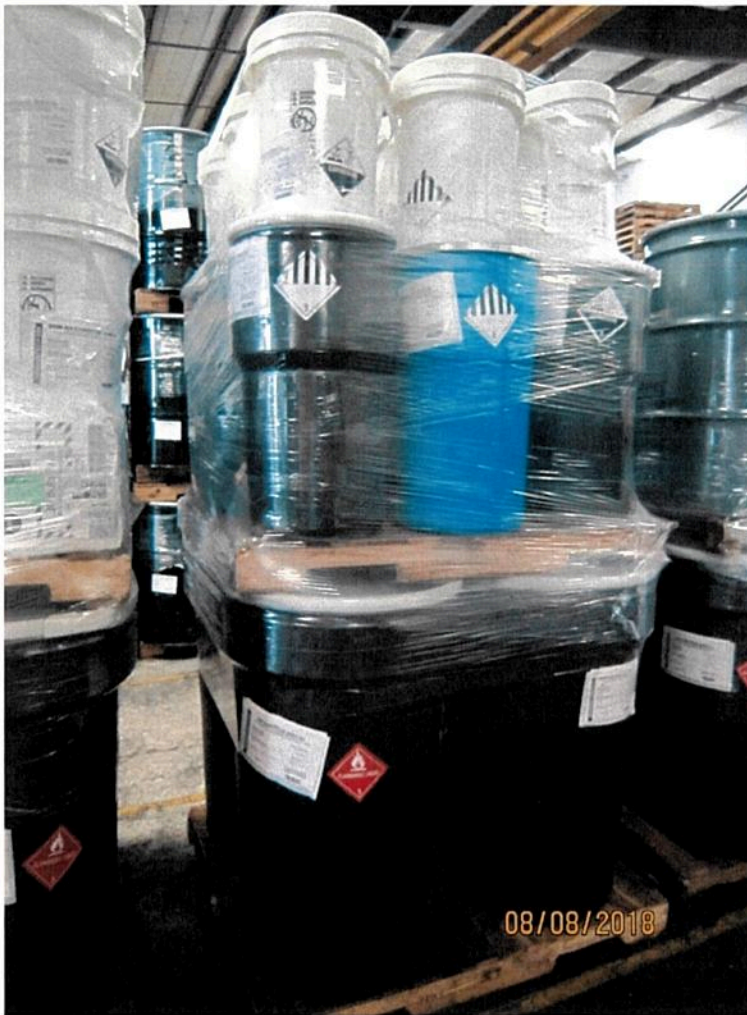
In the center of the warehouse was a staging area of recently unloaded retail store waste from a Stericycle truck. There was one row of different types of waste such as non-hazardous waste, flammable waste, and corrosive wastes stored and shrink-wrapped together. Eleven wooden pallets containing approximately 85 containers ranging from 5-gallons to 55-gallons of non-hazardous waste, flammable waste, and corrosive waste were stored side by side and stacked on top of each other were observed. There was inadequate space to inspect all the containers (Picture #8). Containers that were inspected were closed, labeled, and marked with an accumulation start date.

Picture #8 – Flammable and corrosive wastes containers stored together with inadequate aisle space.

Pursuant to Fla. Admin. Code Ann. r. 62-730.171(4)(a), a transfer facility shall comply with 40 C.F.R. Part 265 Subparts I (management of containers), with the exception of 265.13, as adopted by reference in subsection 62-730.180(2), F.A.C. Fla. Admin. Code Ann. r. 62-730.180(2) [40 C.F.R. § 265.35], requires the owner or operator of a transfer facility is required to maintain aisle space to allow the unobstructed movement of personnel, fire protection equipment, spill control equipment, and decontamination equipment to any area of facility operation in an emergency, *unless* aisle space is not needed for any of these purposes.

**Pursuant to Fla. Admin. Code Ann. r. 62-730.171(4)(a) , which incorporates Fla. Admin. Code Ann. r. 62-730.180(2) [40 C.F.R. § 265.177], requires a storage container holding a hazardous waste that is incompatible with any waste or other materials stored nearby in other containers, piles, open tanks, or surface impoundments must be separated from the other materials or protected from them by means of a dike, berm, wall, or other device.**
