**RE: Warning Letter No. WL19-052 (Significant Non-Complier)**  
**Evo Corporation**  
**EPA/DEP ID: NCD 982 114 803**  
**Duval County – Hazardous Waste**

**Florida Department of  
Environmental Protection  
Hazardous Waste Inspection Report**

Complaint Inspection for VSQG (<100 kg/month) facility

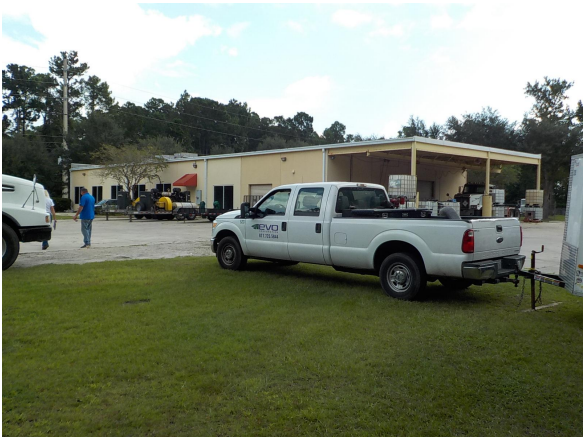
Photo 1

Evo is an industrial cleaning operation. The facility primarily cleans equipment, cleans up spills and collects and transports non-hazardous waste for industrial facilities. Evo also transports hazardous waste on occasion. The facility consists of a Warehouse Building (Photo 1) that contains offices and a warehouse space for storage of ancillary equipment. The building has a covered overhang where vehicle maintenance is performed (Photo 2). There is also a large Storage Yard (Photos 3 and 4) that surrounds the Warehouse Building where the facility parks vehicles and other large equipment while not in use. Evo uses eight vacuum boxes, ten roll-off containers, five air-mover vacuum trucks, three roll-off container trucks, one roll-off

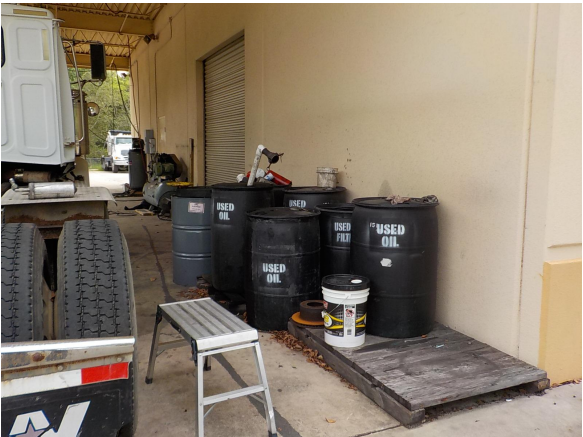
Photo 7

Evo performs vehicle maintenance in the exterior area to the south of the building under the overhang. There were four 55-gallon drums and one 5-gallon bucket of used oil in this area. These containers were not

double-walled and were not stored on an oil-impermeable surface within secondary containment (Photo 7) [62-710.401(6), FAC]. The 5-gallon bucket of used oil was not labeled as "Used Oil" (Photo 8) [40 CFR 279.22(c)]. All other containers of used oil were properly labeled. There were two 55-gallon drums of used oil filters also in this area. The drums were properly labeled, but were not stored on an oil-impermeable surface [62-710.850(5)(a), FAC].

Type: Violation  
Rule: 62-710.401(6)  
Explanation: Overhang of the Warehouse Building - Four single-walled 55-gallon drums and one 5-gallon bucket of used oil were not located on secondary containment.  
Corrective Action: No further action is required. As described in an email dated September 25, 2018, the used oil containers were relocated inside the Warehouse Building onto a secondary containment pallet.
