RE: Warning Letter No. WL18-125
Heritage-Crystal Clean, LLC
EPA/DEP ID: FLR 000 154 278
Duval County – Hazardous Waste

**Florida Department of
Environmental Protection
Hazardous Waste Inspection Report**

Facility Name: Heritage - Crystal Clean LLC

Facility Street Address: 11643 103rd St, Jacksonville, FL 32210-8686

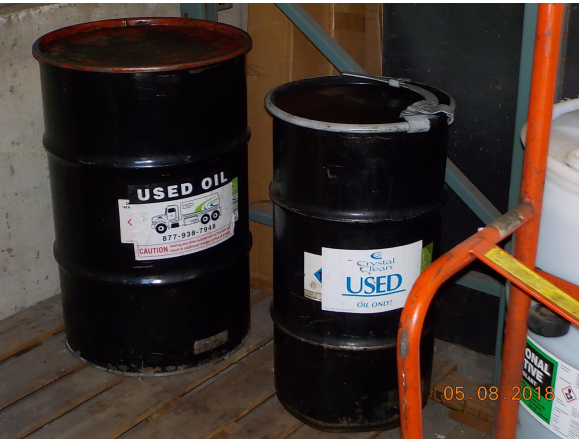
Photo 3

HCC generates a routine wastestream, "Branch Debris," during the transport and transfer of used oil. This wastestream includes solid wastes such as wipes, absorbents, PPE and similar items. HCC manages Branch Debris as non-hazardous waste, but it has not made a hazardous waste determination on this wastestream by having the waste analyzed for hazardous waste characteristics [40 CFR 262.11]. At the time of the inspection, two containers of Branch Debris were accumulating inside the Warehouse. Both containers were closed and labeled as non-hazardous waste. One of the containers was opened for inspection (Photo 3).

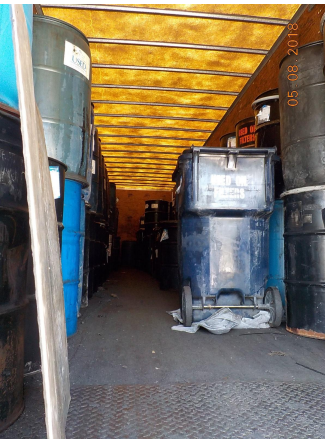
Photo 5

HCC transports hazardous waste in box trucks that return to the facility where the containers are transferred directly from the trucks into one of the semi-trailers located in the Waste Transfer Area described below. At least every ten days, a trailer with new products and supplies is brought into the facility, unhitched and then the trailer with the waste containers is attached to the truck cab and transported to HCC's facility in Atlanta. At the time of the inspection, the trailer contained approximately 20 drums of non-hazardous spent parts washer solvent (Photo 5). No hazardous waste was accumulating in the trailer.

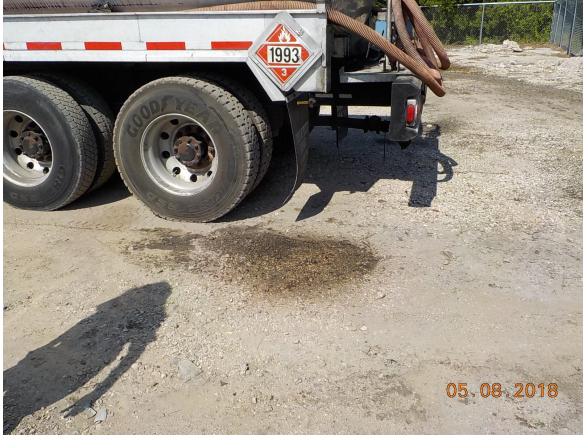
Photo 9

This parking area is located on the northside of the Main Warehouse and adjacent to the facility's northern property fence. The parking lot where the vacuum trucks are parked is unsealed asphalt, loose limerock and dirt. At the time of the inspection, there appeared to be several areas of what appeared to be used oil released in the vicinity of one of the vacuum trucks that had not been cleaned-up (Photos 6-8) [40 CFR 279.22(d)]. The northeast side of the parking lot is used for pump truck and box truck parking. One pump truck and one box truck were parked in the lot at the time of the inspection (Photo 9). All other vehicles were out of the yard for pick-ups or deliveries.

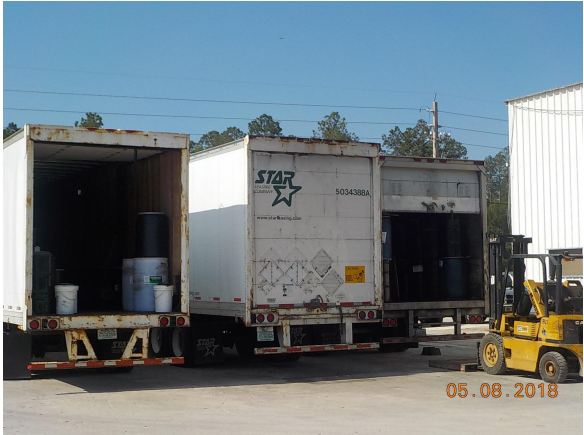
Used oil filters, hazardous waste, non-hazardous waste, universal waste and materials and supplies are transferred directly from incoming trucks into one of three unhitched semi-trailers parked on the east side of the Main Warehouse and southeast of the Truck Parking Lot described above (Photo 10). This area has an asphalt base that appears to be cracked in several areas adjacent to and under the semi-trailers.

The trailer on the left in Photo 10, and described above, is used to accumulate hazardous and non-hazardous wastes, universal waste and spent parts washer solvent. The trailer in the middle in Photo 10 is used to store new parts washer product and supplies (Photo 11). The trailer on the right in Photo 10, and described above, is used to accumulate used oil filters.

Type:	Violation 7
Rule:	62-710.850(5)(a)
Explanation:	The facility accumulated used oil filters in containers that were not stored on an oil-impermeable surface.
Corrective Action:	In order to return to compliance, the facility should store used oil filters in containers on an oil-impermeable surface.
