**Florida Department of
Environmental Protection
Hazardous Waste Inspection Report**

Facility Name: Veolia ES Technical Solutions LLC
On-Site Inspection Start Date: 06/17/2019 **On-Site Inspection End Date:** 06/17/2019
ME ID#: 6716 **EPA ID#:** FL0000207449
Facility Street Address: 342 Marpan Ln, Tallahassee, FL 32305-0904
Contact Mailing Address: 342 Marpan Ln, Tallahassee, FL 32305-0904
County Name: Leon **Contact Phone:** (850) 877-8299

Inspection Date: 06/17/2019

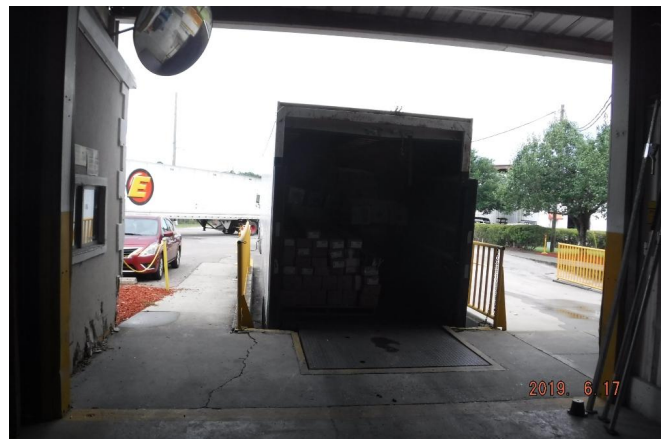
D. Loading Dock and Processed Powder Storage: The loading and unloading area consists of two trailer docking areas for forklift transfer of materials to/from transport vehicles. Post-retort phosphor powder in 55-gallon drums is accumulated in this area along the east wall prior to off-site shipment for disposal in a Subtitle D landfill. This area is labeled as Storage Area #3 on the Facility Plan that is part of the facility's permit. The permit requires that post-retort phosphor powder be sampled to ensure effective retort processing prior to offsite shipment. During the inspection of the facility, nothing was located in this area as the inspection occurred at the end of the day near facility closing. Staff were in the process of sweeping the facility floors and ensuring organization of the Storage Areas.

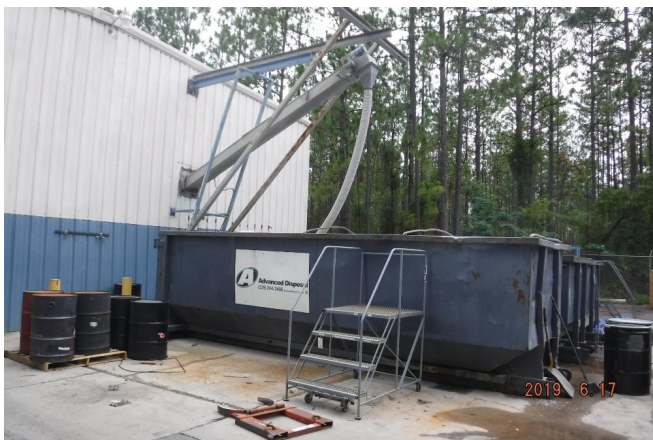
Outside Storage

A. Outside North Storage Area: Two 20-yard roll-offs for collection of processed glass are staged in this area on a concrete pad. An additional two covered 20-yard roll-offs are present in the adjacent asphalt area. This adjacent asphalt paved area is used for collection of cardboard/paper products, wood pallet recycling and various empty container storage. The hazardous waste transfer area is also located here for the overnight holding of transport trucks in the event of an arrival after business hours. The trucks are immediately unloaded during the next business day.

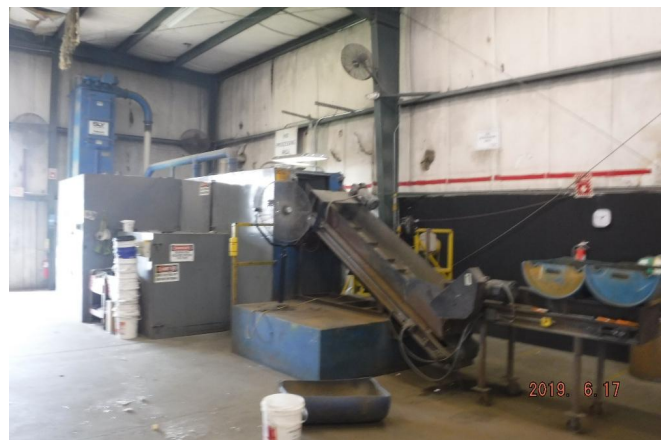
HID Processing

H. HID Processing: HID lamps are processed through a custom built HID machine in the southern end of the main facility building. Veolia previously used a manual process in conjunction with the automated process but that has been discontinued. The HID lamp machine is comprised of conveyor belts, crushers, magnets and air pollution control equipment. It is enclosed and under negative pressure. It uses an automated process to dry-separate outer glass, metal bases and support wires from the arc tubes. The arc tubes are crushed and dropped into 55-gallon drums for further processing in the retort room. The remaining components dropped into collection containers for recycle/disposal. The drums of crushed arc tubes are managed as SSA containers and moved to the CSA at the north end of the building within three days. The automatic feeder/conveyor has been reduced to allow for more area to stage the HID lamps for processing. A new conveyor belts has been used to help facilitate the increased processing of the HID lamps. Since the last facility inspection, the facility has removed its maintenance area/cage from this area and now uses the former location as an extension of Storage Area #5 (as previously described).
