**Florida Department of
Environmental Protection
Hazardous Waste Inspection Report**

Facility Name: Veolia ES Technical Solutions LLC
On-Site Inspection Start Date: 06/17/2019 **On-Site Inspection End Date:** 06/17/2019
ME ID#: 6716 **EPA ID#:** FL0000207449
Facility Street Address: 342 Marpan Ln, Tallahassee, FL 32305-0904
Contact Mailing Address: 342 Marpan Ln, Tallahassee, FL 32305-0904
County Name: Leon **Contact Phone:** (850) 877-8299

A routine inspection was conducted on June 17, 2019 at Veolia Environmental Services (Veolia) to ensure compliance with State and Federal hazardous waste and used oil regulations. Veolia was last inspected August 14, 2018 with no violations cited. This facility is a Mercury Reclamation and Recovery Facility located at 342 Marpan Lane in Tallahassee, Florida and has been in operation since 1995. Veolia employs approximately 12 people in the transport and processing of mercury containing lamps and devices, mercury contaminated debris, electronic waste, batteries, scrap metal, and PCB waste. Waste for recycle is picked up in NC, SC, GA, FL, TN, LA, MS, AR and AL and transported to Veolia for processing.

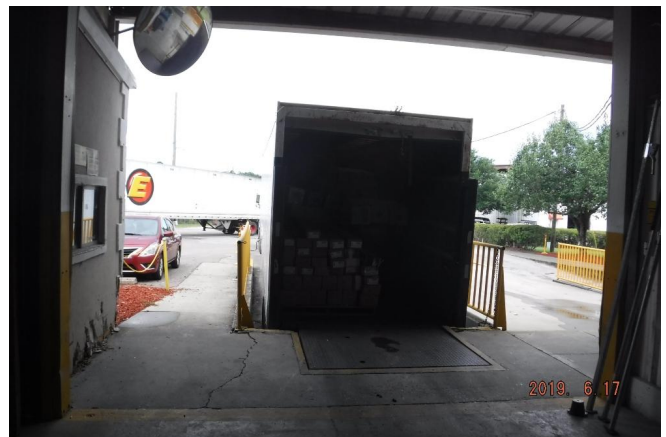
D. Loading Dock and Processed Powder Storage: The loading and unloading area consists of two trailer docking areas for forklift transfer of materials to/from transport vehicles. Post-retort phosphor powder in 55-gallon drums is accumulated in this area along the east wall prior to off-site shipment for disposal in a Subtitle D landfill. This area is labeled as Storage Area #3 on the Facility Plan that is part of the facility's permit. The permit requires that post-retort phosphor powder be sampled to ensure effective retort processing prior to offsite shipment. During the inspection of the facility, nothing was located in this area as the inspection occurred at the end of the day near facility closing. Staff were in the process of sweeping the facility floors and ensuring organization of the Storage Areas.

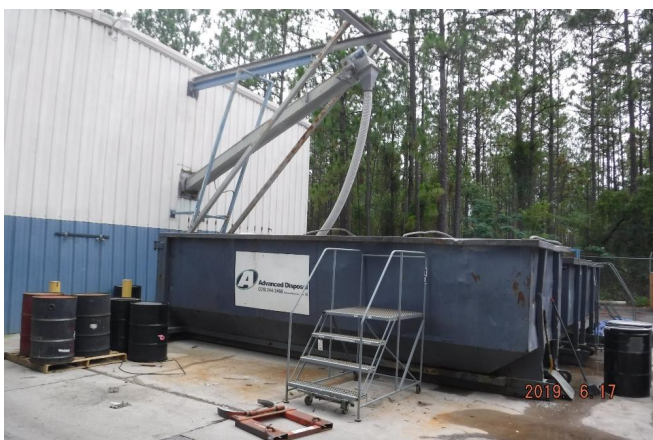
Outside Storage

A. Outside North Storage Area: Two 20-yard roll-offs for collection of processed glass are staged in this area on a concrete pad. An additional two covered 20-yard roll-offs are present in the adjacent asphalt area. This adjacent asphalt paved area is used for collection of cardboard/paper products, wood pallet recycling and various empty container storage. The hazardous waste transfer area is also located here for the overnight holding of transport trucks in the event of an arrival after business hours. The trucks are immediately unloaded during the next business day.

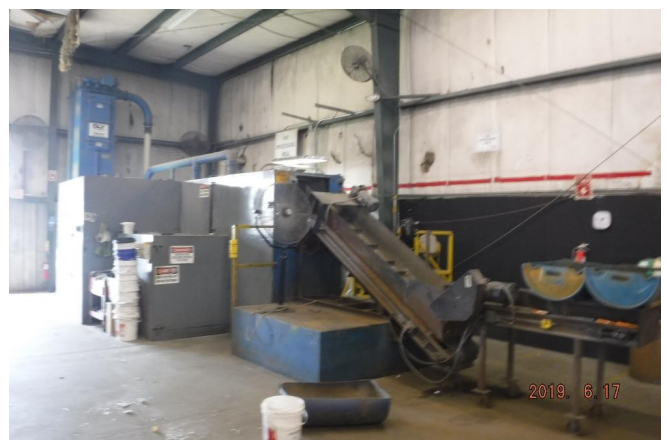
HID Processing

H. HID Processing: HID lamps are processed through a custom built HID machine in the southern end of the main facility building. Veolia previously used a manual process in conjunction with the automated process but that has been discontinued. The HID lamp machine is comprised of conveyor belts, crushers, magnets and air pollution control equipment. It is enclosed and under negative pressure. It uses an automated process to dry-separate outer glass, metal bases and support wires from the arc tubes. The arc tubes are crushed and dropped into 55-gallon drums for further processing in the retort room. The remaining components dropped into collection containers for recycle/disposal. The drums of crushed arc tubes are managed as SSA containers and moved to the CSA at the north end of the building within three days. The automatic feeder/conveyor has been reduced to allow for more area to stage the HID lamps for processing. A new conveyor belts has been used to help facilitate the increased processing of the HID lamps. Since the last facility inspection, the facility has removed its maintenance area/cage from this area and now uses the former location as an extension of Storage Area #5 (as previously described).

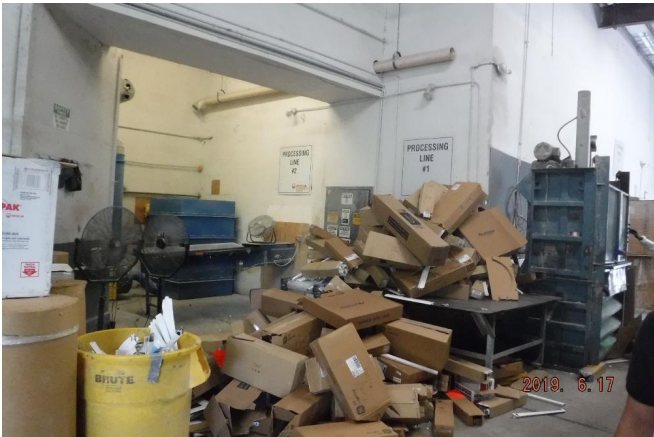
C. Fluorescent Lamp Processing: Fluorescent lamps are staged immediately adjacent to the lamp processing feed belts. Fluorescent lamps are hand fed into the lamp processing room via a conveyor belt. The Fluorescent Lamp Processing Room (labeled as Crush and Separate Room on the Facility Plan), is located in the northwest corner of the facility. It is designed to process approximately 200,000 feet of lamp equivalents per 8-hour shift. Lamps are crushed in a drum crusher and dry-separated into glass, aluminum and phosphor powder. Phosphor powder is collected by a bag tower and accumulated in 55-gallon drums. There are two processing lines that are used to facilitate this operation. The second processing line is used when

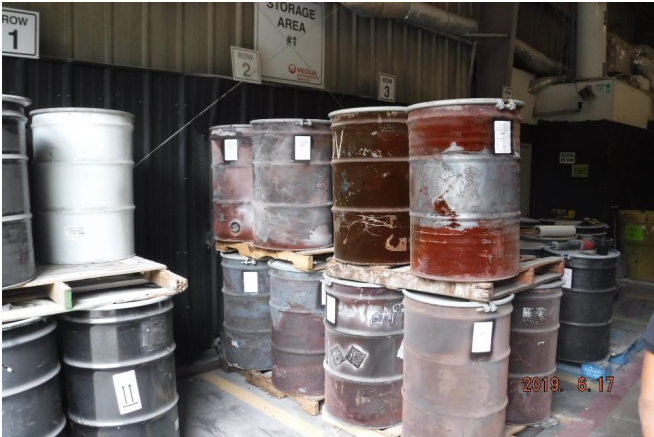
Storage Area 1

B. Container Storage Areas: Veolia has two storage areas designated as "Container Storage Areas One and Two" (CSAs). The CSAs are permitted for up to 27 pallets (108 55-gallon drums) of MCMA; dental amalgam and traps; pre-retort phosphor powder; HID arc tubes; and site-generated hazardous waste (prep room debris and PPE, condensate water, and spent carbon). At the time of this inspection, there were 31 drums of leaded glass and a spill kit in Storage Area #1. All of these containers were labeled, neatly organized and kept in their assigned storage areas. Additionally, there were 3 Gaylord type boxes of shat-r-shield type bulbs in Storage Area #2. All of these containers were labeled, neatly organized and kept in their assigned storage areas.

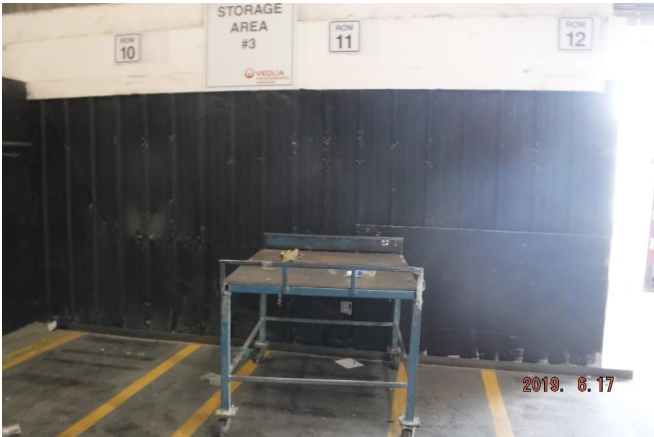
Storage Area 3

there is a need to process a larger volume of materials. During the inspection the facility had nothing located in Storage Area #3.

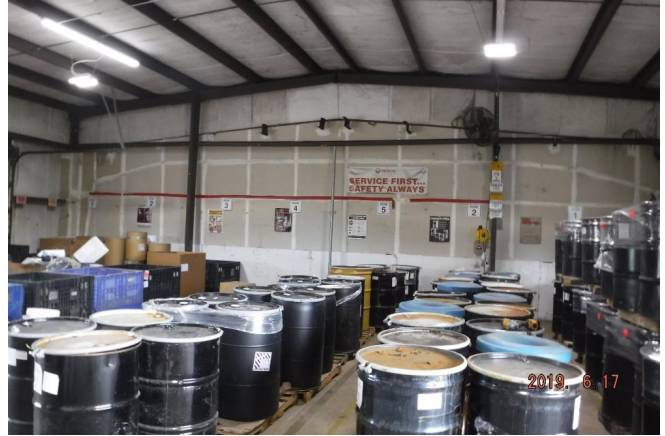
I. South Building Battery, Container and E-Waste Storage: The building is immediately south of the main building and is divided into two large storage areas. The Container storage area is used to hold empty fiber drums and cardboard boxes. Additionally, this area is now the location where the Maintenance Cage has been relocated to from its previous location adjacent to Storage Area #5. No universal or hazardous wastes are stored in this area. The second room in this building is used for the storage of e-waste and battery storage. The space is permitted to store up to 72 pallets. At the time of the inspection, all pallets were properly labeled and protected from the environment. The battery sorting table is still in use to help in sorting the various battery types received by the facility.
