Re: Warning Letter #WL19-00070HW13SED  
TG Oil Services Inc.  
EPA ID: FLR000222836  
Miami Dade County

**Florida Department of  
Environmental Protection  
Hazardous Waste Inspection Report**

**Facility Name:** TG Oil Services Inc  
**On-Site Inspection Start Date:** 08/15/2019 **On-Site Inspection End Date:** 08/15/2019  
**ME ID#:** 124783 **EPA ID#:** FLR000222836  
**Facility Street Address:** 7815 W 2nd Ct Unit 2 , Hialeah , Florida 33014-4317  
**Contact Mailing Address:** 7815 W 2nd Ct Bay 2, Hialeah, Florida 33014  
**County Name:** Miami-Dade **Contact Phone:** (954) 874-0930

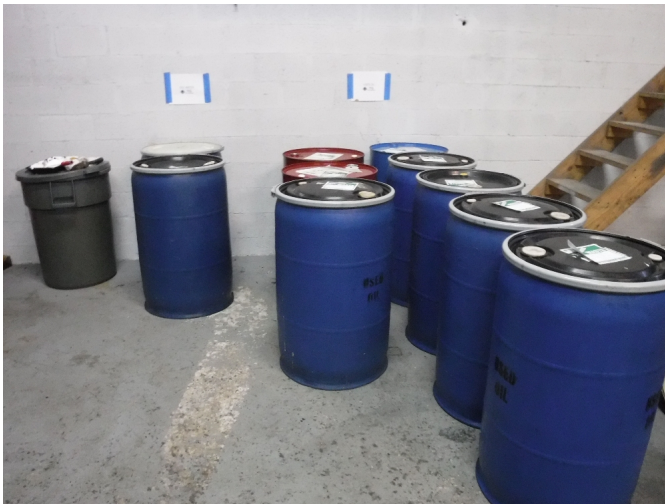
Explanation: TG had two( 2) 55-gallon UO drums, eight(8) 55-gallon oily water drums and three(3) 55-gallon drums of oily sludge on-site without a secondary containment.

UO drums without secondary containment

Corrective Action: Compliance assistance was provided and on 08/21/19, TG submitted via email to the Department a PO for secondary containment to be placed under these drums. The picture of this corrective action was sent to the Department via email on 08/30/19.

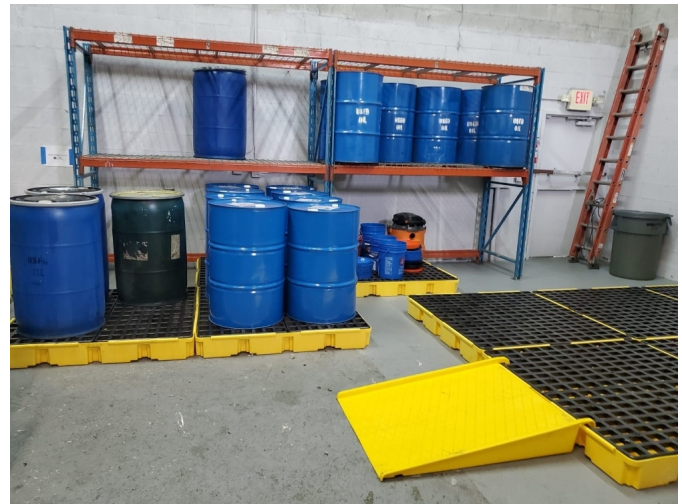
UO drums with secondary containment

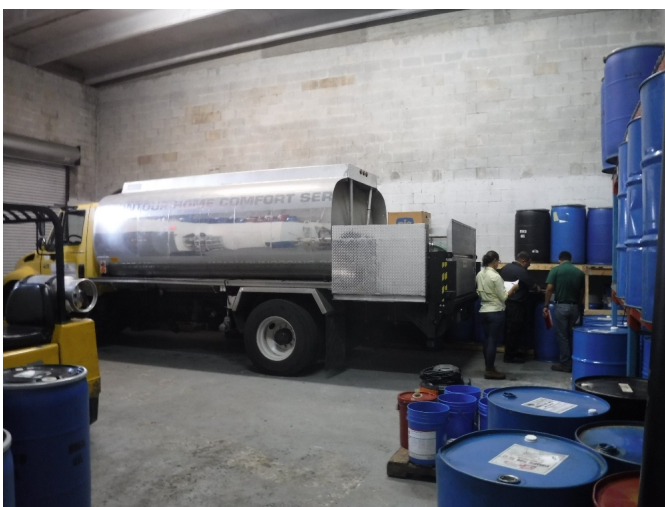
>One (1) vacuum truck with the capacity of 2,400 gallons (US DOT 3011682). Since this truck container is divided into different compartments, it was filled with approximately 700 gallons of product oil (Hydraulic Fluid AW32) and 240 gallons of UO.

Vacuum truck at oil department

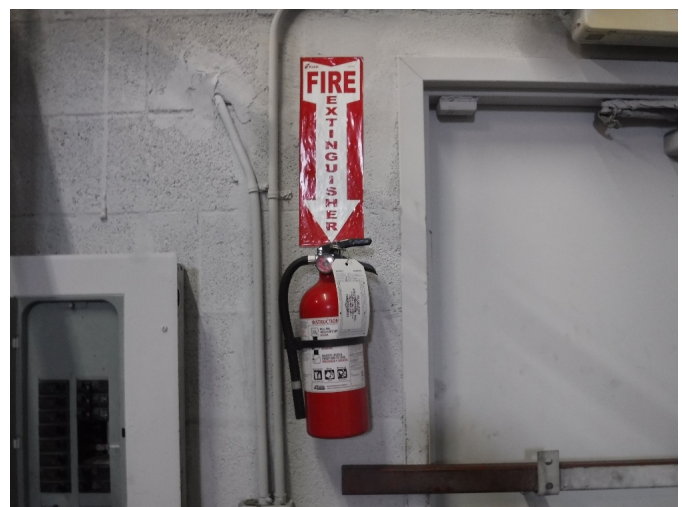
During the inspection, no spill kits were observed in this area. The Department required the facility to have one available in case of an emergency spill, even though there were no signs of oil spills on the floor. Fire extinguishers were observed near these premises.

Fire extinguisher at the oil department

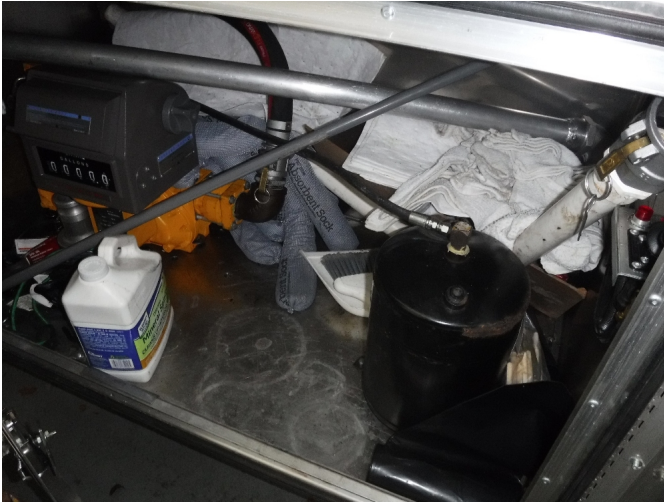
## Spill kit at vacuum truck
