**Florida Department of
Environmental Protection
Hazardous Waste Inspection Report**

Facility Name: Safety-Kleen Systems Inc
On-Site Inspection Start Date: 12/11/2019 **On-Site Inspection End Date:** 12/11/2019
ME ID#: 48680 **EPA ID#:** FLD984167791
Facility Street Address: 5610 Alpha Dr, Boynton Beach, Florida 33426-8329
Contact Mailing Address: 5610 Alpha Dr, Boynton Beach, Florida 33426-8329
County Name: Palm Beach **Contact Phone:** (561) 523-4719

Routine Inspection for TSD Facility Facility

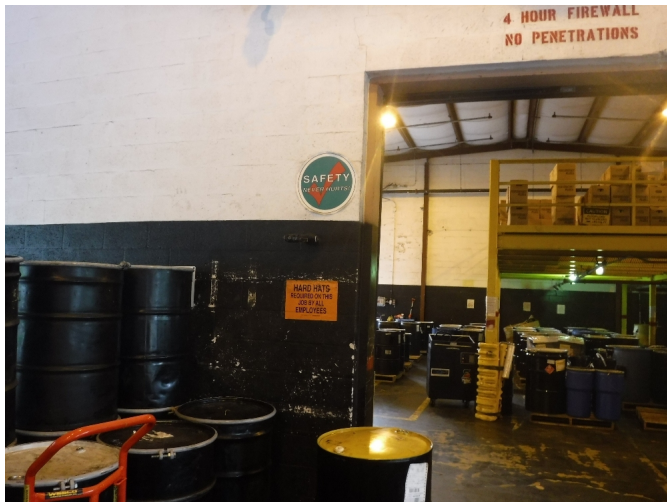
HW Container Storage

All hazardous waste containers were observed to be closed and labeled with the words "Hazardous Waste" and an indication of the hazards of the contents. The facility palletizes all containers and ensures containers are stacked only one pallet high, in accordance with Part II, Subpart B.1., Specific Condition 1.b., of Permit No. 49625-010-HO. Each label was observed to have the generator's EPAID number and the manifest tracking numbers. The facility maintains adequate aisle space in the 10-day storage area [40 CFR 264.35].

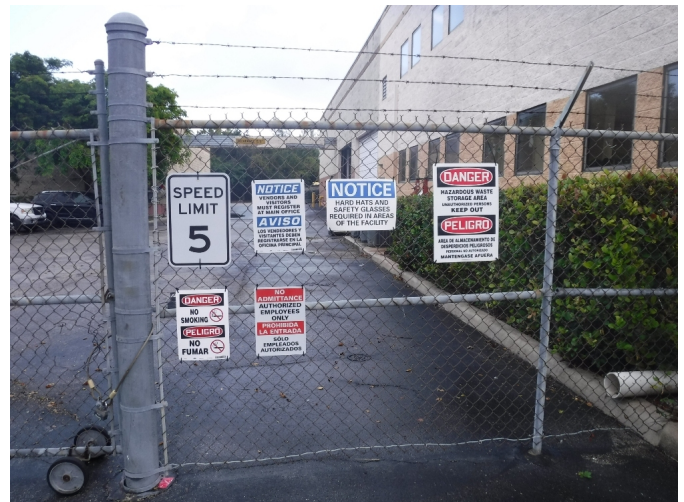
Security and Signage

The facility maintains a copy of the permit on-site. All monitoring and test data for the tank system and containers were available on-site during the inspection. SKS-BB is operated in a manner that prevents unknowing or unauthorized entry [40 CFR 264.14(a)]. The inspectors observed fence-line and gates around the facility to control entry [40 CFR 264.14(b)(2)]. SKS-BB maintains a 24-hour surveillance system that continuously monitors and controls entry and conducts weekly safety and security checks of the premises. No deficiencies were observed.

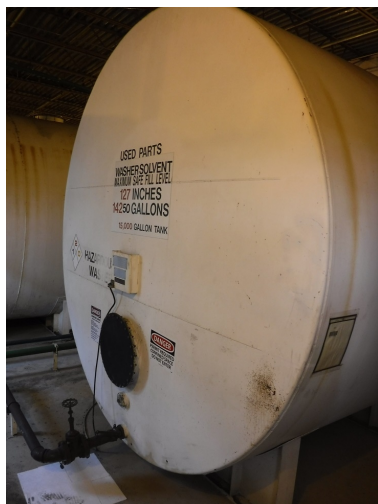
15,000-gallon HW AST

During the inspection, the 15,000-gallon AST for parts waster solvent was observed to be labeled with the words "Hazardous Waste" and a National Fire Protection Association (NFPA) diamond, indicating that the waste is a mild irritant and moderate heat is required for ignition. The used oil ASTs were observed to be labeled with the words "Used Oil" and an NFPA diamond. The Tank Storage building has "No Smoking" signs conspicuously placed inside and outside [40 CFR 264.17(a)]. Waste solvent stored in the 15,000-gallon AST is periodically shipped for reclamation.

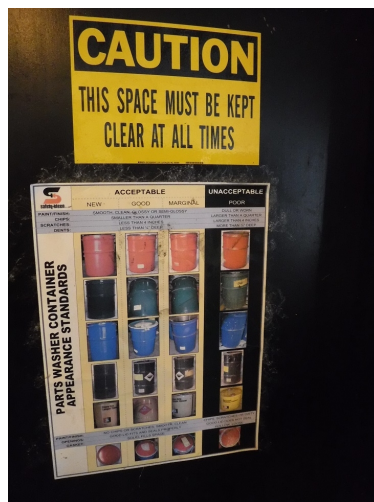
SKS Container Guidance

During the inspection, three 55-gallon containers of used oil were observed in storage. The facility also stores several 30-gallon red metal containers holding solvent product in this area. SKS-BB sells this solvent product as part of the Fluid Recovery Services (FRS) offered by the company for parts washers and solvent pickup. Several empty 55-gallon drums were observed in this area. After wastes are picked up from the client, SKS-BB will provide these containers to clients as part of the FRS contracts.
