Re: **Compliance Assistance Offer**
Flagler Construction Equipment
Facility ID No.: FLR 000 213 686
Columbia County – Hazardous Waste Program

**Florida Department of
Environmental Protection
Hazardous Waste Inspection Report**

Facility Name: Flagler Construction Equipment
On-Site Inspection Start Date: 07/21/2020 **On-Site Inspection End Date:** 07/21/2020
ME ID#: 114928 **EPA ID#:** FLR000213686
Facility Street Address: 539 SW Arrowhead Ter, Lake City, Florida 32024-3374
Contact Mailing Address: 539 SW Arrowhead Terrace, Lake City, Florida 32024
County Name: Columbia **Contact Phone:** (386) 758-7444

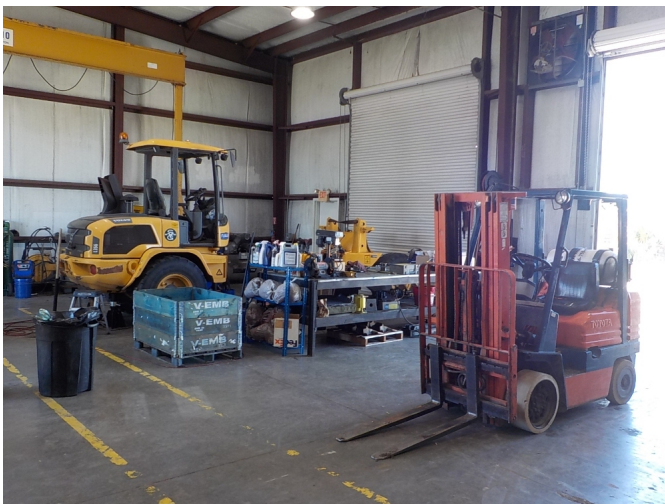
Photo 1

The warehouse side of the main building is used for materials and supply storage. Maintenance on forklifts, vehicles, and various other heavy equipment is performed in one of the two bays located adjacent to the warehouse storage areas (Photo 1). Used oil, used oil filters, oily rags and oily absorbent are generated in this area. Used oil is drained into drip pans or mobile carts located throughout the area. All used oil containers were properly labeled "Used Oil." Used oil is pumped from the drip pans and mobile carts into a 250-gallon double-walled aboveground storage tank that is located on the other side of the maintenance bay wall in the Vehicle Wash Bay, described below. Used oil filters are drained on a rack located in the maintenance bay and the used oil is pumped to the storage tank. Oily absorbents and spill cleanup debris are accumulated in a 55-gallon drum located inside the maintenance area. If antifreeze has to be drained from a vehicle, the facility collects the antifreeze and re-uses it in the vehicle once maintenance is complete. If the antifreeze is not reusable, it is collected and disposed of by Safety-Kleen on an as-needed basis.

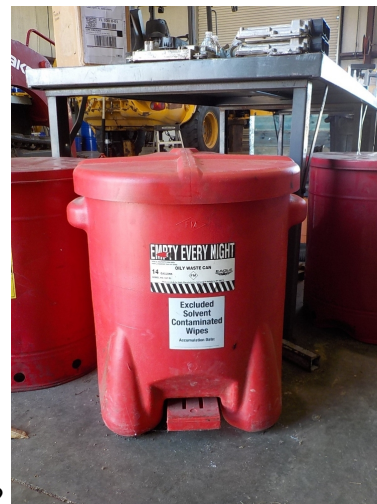
Photo 2

FCE uses Volvo Non-Chlorinated Brake Cleaner (50-70% acetone, 10-20% methylacetate, 10-20% carbon dioxide, 3-7% xylene, 3-7% heptane; flashpoint -4°F) and Volvo Multi-Purpose Degreaser (acetone 80-90%, carbon dioxide 5-10%; flashpoint -4°F) on wipes for cleaning. Spent Volvo brake cleaner and Volvo degreaser are non-hazardous when used on a rag. Shop rags are managed as "Excluded Solvent Contaminated Wipes," accumulated in 5-gallon containers and laundered weekly by Cintas. There was one container of excluded solvent contaminated rags accumulating at the time of the inspection (Photo 2). It was closed and properly labeled.

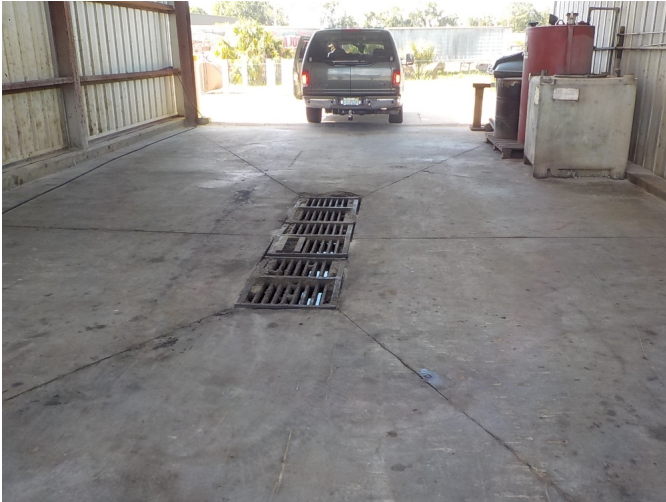
Photo 3

In the Vehicle Wash Bay, pressurized water and detergent are used to clean equipment and vehicles after maintenance (Photo 3). A grated trench drainage system in the floor collects washwater that gravity flows to a 1,000 underground holding vault that is located on the other side of the wash bay wall inside the attached Storage Building, described below.

Type:	Violation
Rule:	262.11
Explanation:	FCE had not made an accurate hazardous waste determination for the washwater from the Vehicle Wash Bay.
Corrective Action:	In order to return to compliance, the facility should make a hazardous waste determination on the washwater by having a representative sample of the washwater analyzed by a certified laboratory for the following: <ul style="list-style-type: none"> - Ignitability, pursuant to 40 CFR 261.21, via method 1010; - Toxicity Characteristic Leaching Procedure (TCLP) for RCRA Metals, pursuant to 40

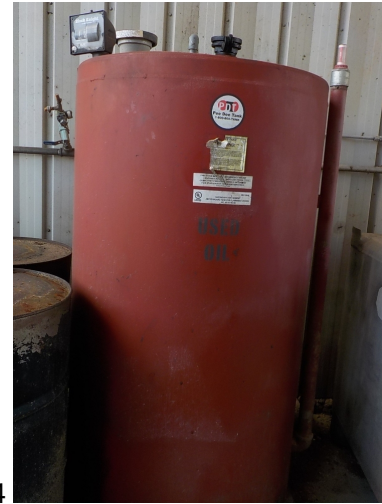
Photo 4

The 250-gallon double-walled aboveground used oil tank and Used Oil Filter container are also located inside the wash bay (Photos 4 and 5). Both containers were closed and properly labeled.

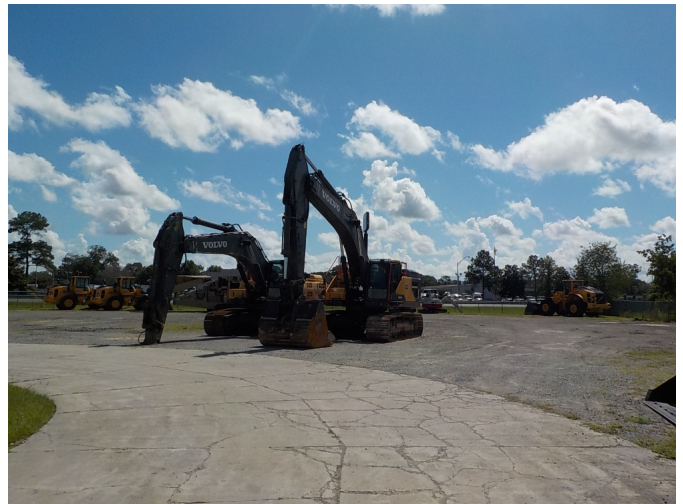
Photo 6

This yard is located east of the main building and is used as a laydown area for materials and to stage equipment for sale, lease and/or maintenance (Photo 6).
