**Florida Department of
Environmental Protection
Hazardous Waste Inspection Report**

Facility Name: Veolia ES Technical Solutions LLC
On-Site Inspection Start Date: 11/18/2020 **On-Site Inspection End Date:** 11/18/2020
ME ID#: 6716 **EPA ID#:** FL0000207449
Facility Street Address: 342 Marpan Ln, Tallahassee, Florida 32305-0904
Contact Mailing Address: 342 Marpan Ln, Tallahassee, Florida 32305-0904
County Name: Leon **Contact Phone:** (850) 877-8299

Routine Inspection for TSD Facility Facility

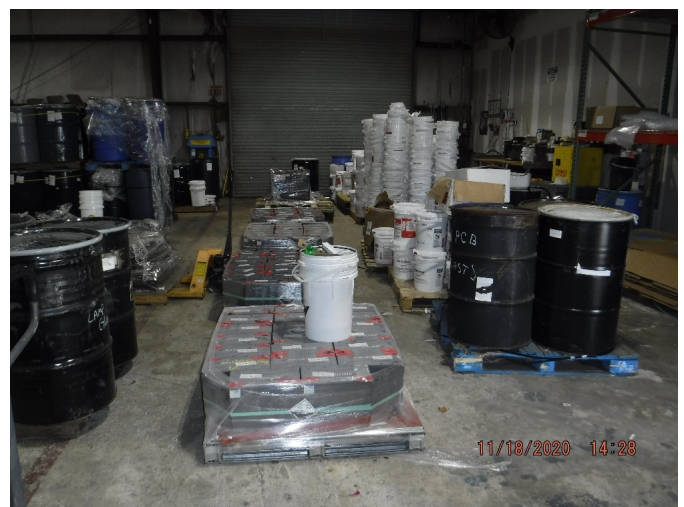
I. South Building Battery, Container and E-Waste Storage: The building is immediately south of the main building and is divided into two large storage areas. The container storage area is used to hold empty fiber drums and cardboard boxes. Additionally, this area is where the Maintenance Cage is located. No universal or hazardous wastes are stored in this area. The second room in this building is used for the storage of e-waste and battery storage. The space is permitted to store up to 72 pallets. At the time of the inspection, all pallets were properly labeled and protected from the environment (photos 6-7). The battery sorting table is still in use to help in sorting the various battery types received by the facility.

Photo 6: Battery & E-Waste Storage Area

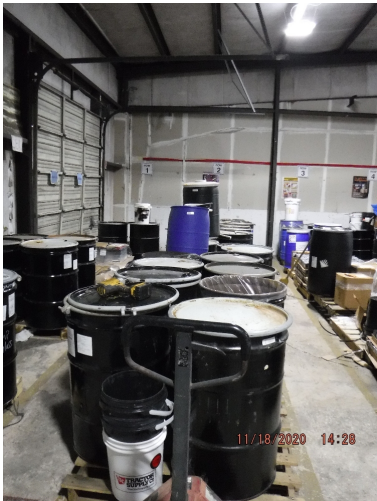
Photo 7: Battery & E-Waste Storage Area
