Re: Safety-Kleen Systems, Inc. HW Facility ID # FLD984171165 Seminole County

Hazardous Waste Inspection Report

Inspection Date: 02/04/2021

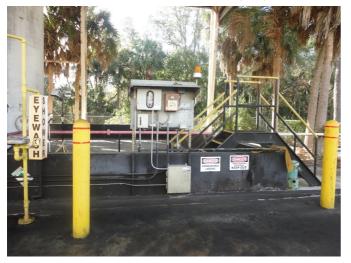
3. Tank farm release detection and signage

Inspection of the tank farm found the secondary containment area was in good condition and the tanks were all properly labeled. The tank farm itself contains two used oil tanks, one hazardous waste tank for storage of used parts washer solvent, one tank for storing antifreeze, and one tank for storing new mineral spirits, All tanks, except for the one containing antifreeze, are located within concrete secondary containment that is in good condition. The tanks are all labeled with their contents, hazards, and capacities. They are monitored continuously with electronic release detection and equipped with overfill alarms when they reach 95% capacity. Their fill ports are capped, locked, labeled, and located within a spill-box that was relatively clean and free of product.
