RCRA Inspection Report

Florida Transformer, LLC., DBA Emerald Transformer (FTI)
4509 State Highway 83 N
DeFuniak Springs, Florida 32433
EPA ID Number: FLR000168203
NAICS: 335311 - Power, Distribution, And Specialty Transformer Manufacturing

February 24, 2021 @ 9:15 A.M. (central)

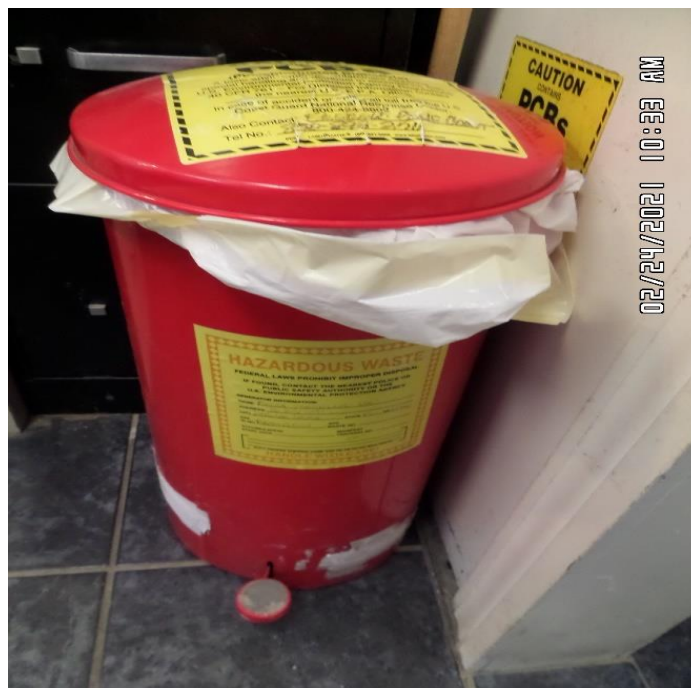
The laboratory is adjacent to the In-Processing Area. The inspection team met with Teresa McKinney, Lab Tech. Unit samples are tracked through the bar code log that corresponds to a sample-processing log maintained by the laboratory. Samples are extracted from the transformers into pre-numbered 25mL vials that contain 10mL Hexane and 1mL of sulfuric acid and analyzed by gas chromatography to determine the PCB concentration. The sample residues from the PCB content determination exhibit the characteristics of ignitibility (D001) and corrosivity (D002). As for safety equipment, the lab has a safety shower and fire extinguisher outside the lab. At the time of the inspection, the laboratory was storing a 5-gallon SAA container of sample residue vials. The container was closed and labeled, but the label was missing a hazard identification (See Figure 1).

Figure 1 - Container storing PCB vials. The container did not have the hazard indication

Pursuant to Fla. Admin. Code Ann. r. 62-730.160(1) [40 C.F.R. § 262.15(a)(5)], which is a condition of the SAA Permit Exemption, a generator is required to mark or label its containers (i) with the words “Hazardous Waste” and (ii) with an indication of the hazards of the contents.

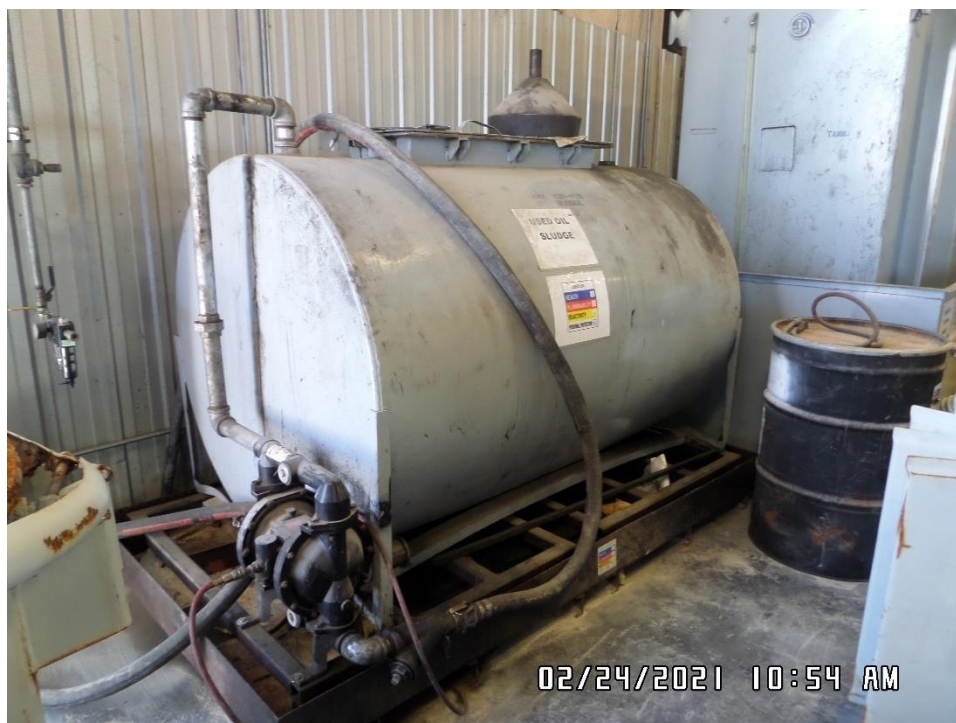
Also, the inspection team noticed a large single-walled aboveground storage tank (AST) storing used oil (Tank Q). The tank is inside the building with a shallow metal secondary containment and did not have a capacity of 110% of the volume of the tank (See Figure 2).

Figure 2 - Used Oil AST with secondary containment

Pursuant to 62-710.401(6), F.A.C., no person may store used oil in tanks or containers unless they are clearly labeled with the words “used oil,” are in good condition (no severe rusting, apparent structural defects or deterioration), and not leaking (no visible leaks). If tanks or containers are not stored inside a structure, the contents shall be closed, covered, or otherwise protected from the weather. If tanks or containers are not double-walled, they shall be stored on an oil-impermeable surface such as sealed concrete or asphalt and must have secondary containment which has the capacity to hold 110% of the volume of the largest tank or container within the containment area. For underground storage tanks with capacities greater than 110 gallons and above ground storage tanks with capacities greater than 550 gallons, the facility shall comply with Chapters 62-761 and 62-762, F.A.C. At the time of the inspection Tank Q and three 55-gallon containers did not have proper secondary containment.

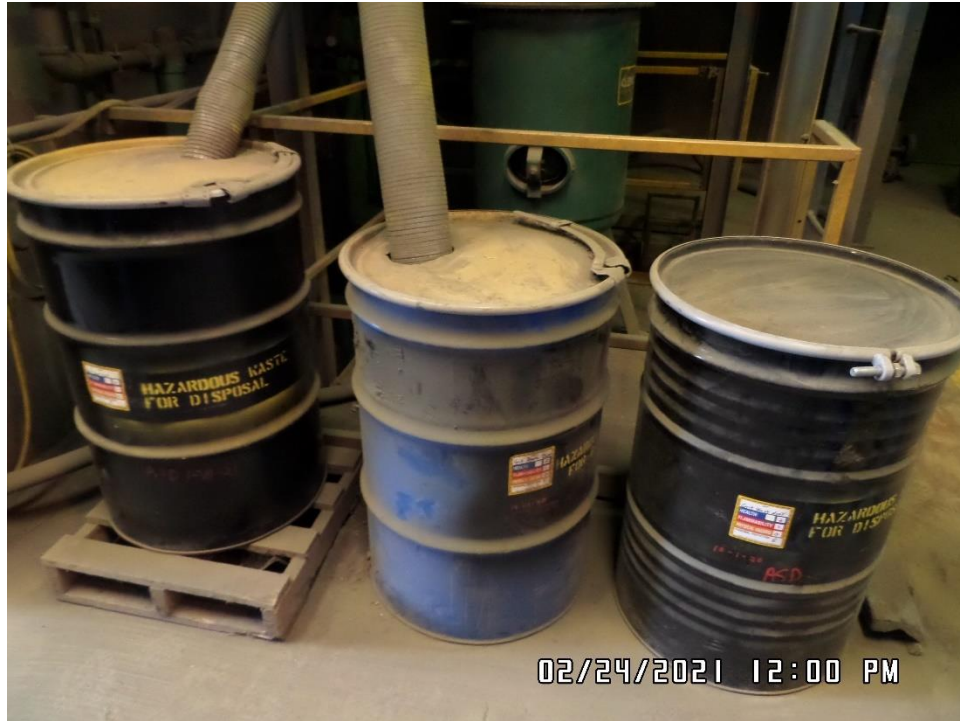
The blasting unit collects the blasting media and reuses it until the blasting media loses its ability to remove the paint. The blasting unit has three 55-gallon drums collecting the spent blast media (SBM) via hoses. The inspection team noticed that the hoses connected to the containers were not completely sealed and were leaving gaps (See Figure 3).

Figure 3 - Containers storing SBM

Pursuant to Fla. Admin. Code Ann. r. 62-730.160(1) [40 C.F.R. § 262.15(a)(4)], which is a condition of the SAA Permit Exemption, a generator is required to keep containers of hazardous waste closed at all times during accumulation, except when adding, removing, or consolidating waste; or when temporary venting of a container is necessary for the proper operation of equipment, or to prevent dangerous situations, such as build-up of extreme pressure.

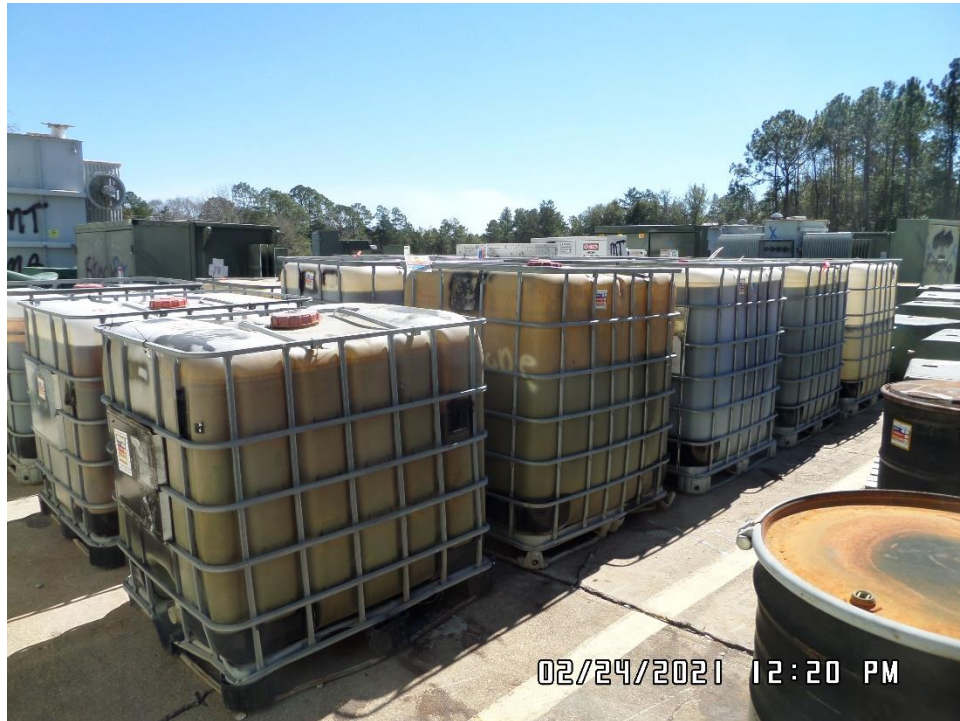
At the time of the inspection, the inspection team noticed approximately 15 275-gallon totes (See Figure 4) and four 55-gallon containers storing used mineral oil (See Figure 5) stored outside the Tank Farm. The totes and drums did not have secondary containment.

Figure 4 - 15 Totes storing used oil near the Tank Farm

Pursuant to 62-710.401(6), F.A.C., no person may store used oil in tanks or containers unless they are clearly labeled with the words “used oil,” are in good condition (no severe rusting, apparent structural defects or deterioration), and not leaking (no visible leaks). If tanks or containers are not stored inside a structure, the contents shall be closed, covered, or otherwise protected from the weather. If tanks or containers are not double-walled, they shall be stored on an oil-impermeable surface such as sealed concrete or asphalt and must have secondary containment which has the capacity to hold 110% of the volume of the largest tank or container within the containment area. For underground storage tanks with capacities greater than 110 gallons and above ground storage tanks with capacities greater than 550 gallons, the facility shall comply with Chapters 62-761 and 62-762, F.A.C.

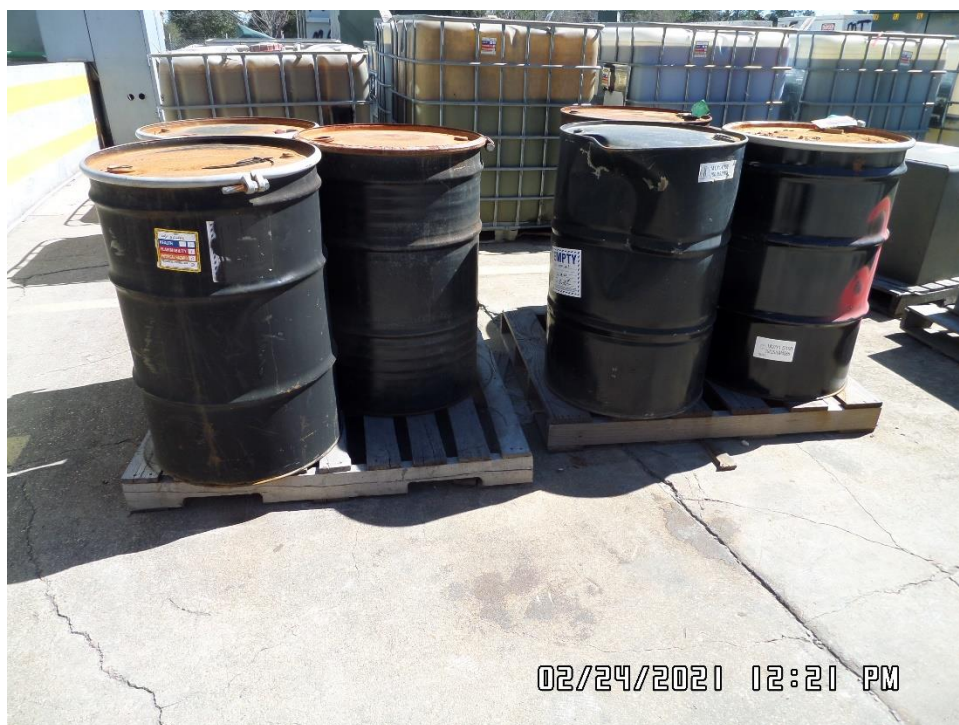
Figure 5 - 55-gallon drums of used oil stored near the Tank Farm

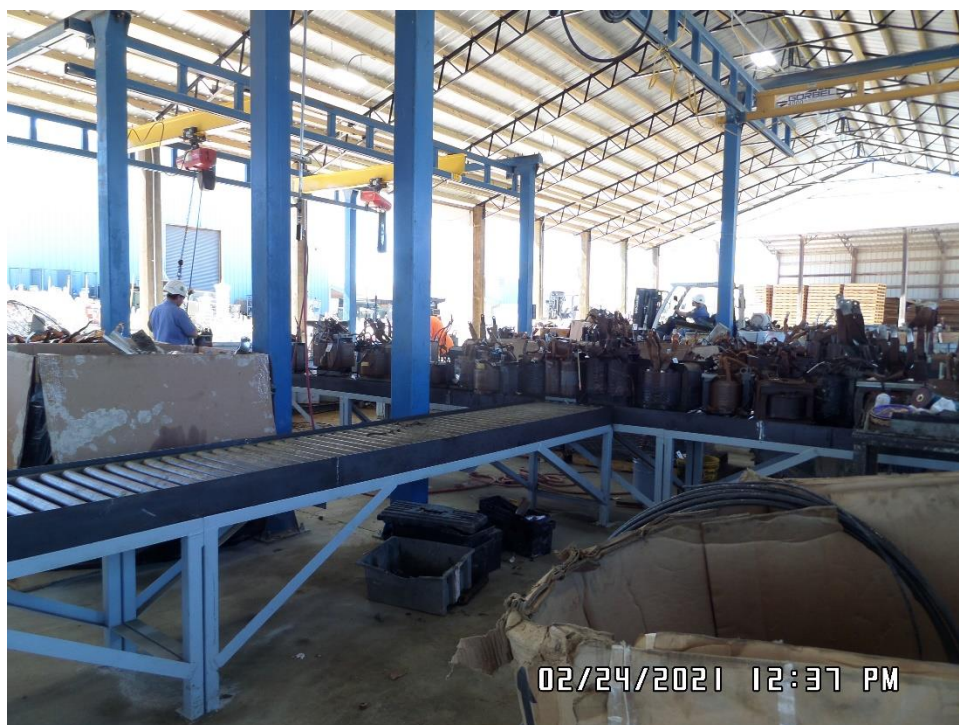
This is the area where operators drain and repair non-PCB transformers. The building has a roof with concrete floors with conveyor lines to move the transformers. The transformers are drained on rolling tables (See Figure 6). The tables are drained into 5-gallon buckets. Then the used oil is stored into a single-walled used oil AST (See Figure 7). The draining tables and used oil AST were not labeled with the word “Used Oil”. Also, the used oil AST did not have secondary containment.

Figure 6 - Used oil draining tables

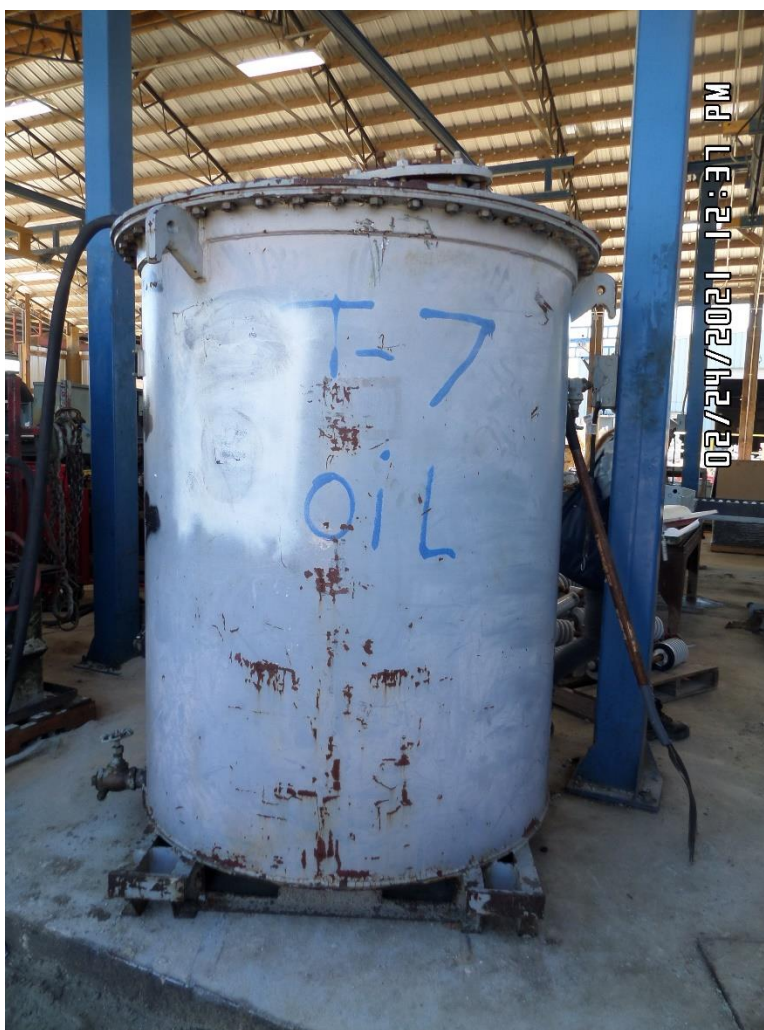
Figure 7 - Used Oil ABS located in the repair area

Pursuant to Fla. Admin. Code Ann. r. 62-710.210(2) [40 C.F.R. § 279.22(c)(1)], containers and aboveground tanks used to store used oil at generator facilities must be labeled or marked clearly with the words “Used Oil.”

Pursuant to 62-710.401(6), F.A.C., no person may store used oil in tanks or containers unless they are clearly labeled with the words “used oil,” are in good condition (no severe rusting, apparent structural defects or deterioration), and not leaking (no visible leaks). If tanks or containers are not stored inside a structure, the contents shall be closed, covered, or otherwise protected from the weather. If tanks or containers are not double-walled, they shall be stored on an oil-impermeable surface such as sealed concrete or asphalt and must have secondary containment which has the capacity to hold 110% of the volume of the largest tank or container within the containment area. For underground storage tanks with capacities greater than 110 gallons and above ground storage tanks with capacities greater than 550 gallons, the facility shall comply with Chapters 62-761 and 62-762, F.A.C.
