Re: Tampa Transflo Terminal  
Facility ID No. FLR000105338  
Hillsborough County

**Florida Department of  
Environmental Protection  
Hazardous Waste Inspection Report**

## Tampa Transflo Terminal Inspection Report

Inspection Date: 03/30/2021

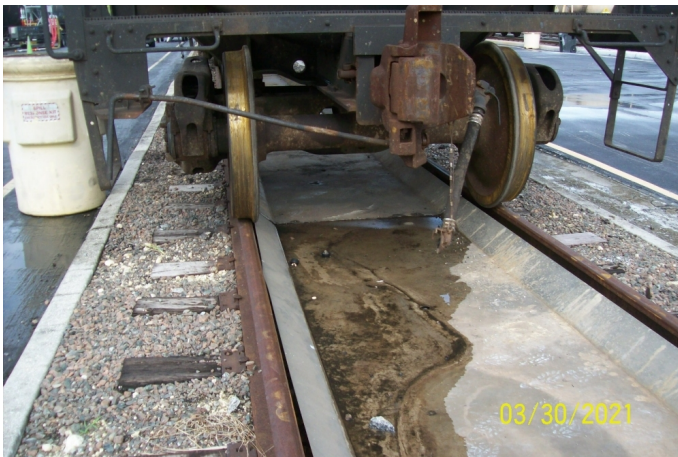
Track Pans

Used oil is transferred and stored on one half of track #5 (the other half is for cement transfers). According to Mr. Roberts, arriving rail cars are inspected within 24 hours of arriving and again prior to leaving. At the time of the inspection, there were (3) railcars present that were labeled used oil. Track pans are in place, and any spills which are not contained by the pan will drain to a trench which drains through a junction box to the facility's central storm water collection sump. Knife valves are able to isolate the trenches and a secondary valve is present if needed to prevent the discharge of the facility's storm water system in the event of a spill. Emergency equipment, including spill kits, decontamination showers and fire extinguishers are in place next to the tracks. Staff are all equipped with communication devices while working on site.

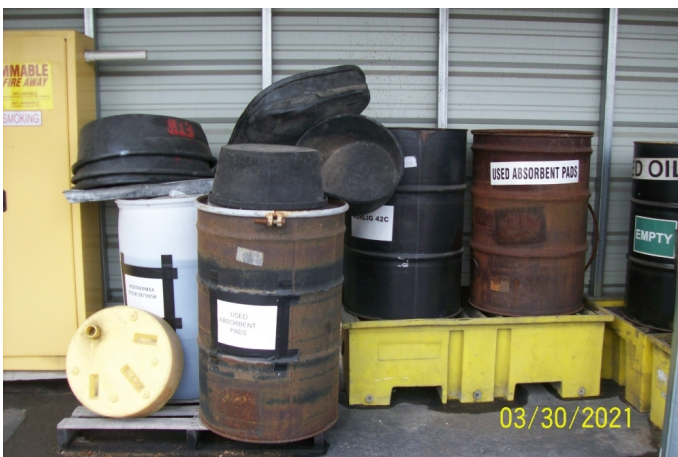
Storage Shed

At the time of the inspection, a storage shed on the property contained: (3) 55-gallon drums of used absorbents, (2) 55-gallon drums of used oil filters, (1) 55-gallon drum of aerosol cans, (1) 55-gallon drum of used oil, and (1) 55-gallon drum of product (cement additive). A second 55-gallon used oil drum was empty at the time of the inspection. The aerosol cans are being managed as universal waste under the new rule 40 CFR 273.6. All containers were properly closed and labeled as required.
