**Florida Department of  
Environmental Protection  
Hazardous Waste Inspection Report**

**Facility Name:** JJ Metal Services  
**On-Site Inspection Start Date:** 06/04/2021 **On-Site Inspection End Date:** 06/04/2021  
**ME ID#:** 123232 **EPA ID#:** FLR000221192  
**Facility Street Address:** 2300 W 80th St Bay 2, Hialeah, Florida 33016-5591  
**Contact Mailing Address:** 8231 SW 13 Terrace, Miami, Florida 33144  
**County Name:** Miami-Dade **Contact Phone:** (786) 231-4417

## JJ Metal Services Inspection Report

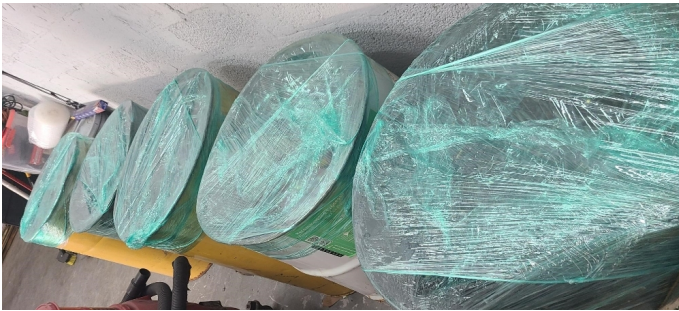
> Five 55-gallon metal drums of steel waiting to be transported for reclamation. The inspector requested shipping papers from the facility's reclaimed metals and the manifests from the last three years, per 40 CFR 261.2(f).

Five steel drums waiting for recycling pick up

Type:	Violation
Rule:	<b>261.2(f)</b>
Explanation:	The facility could not provide document claims that recycled materials are not solid wastes and are conditionally exempt from regulation.
Corrective Action:	The facility was requested to provide these records for the Department review.

This violation was resolved via submittal to the Department on 07/06/2021.

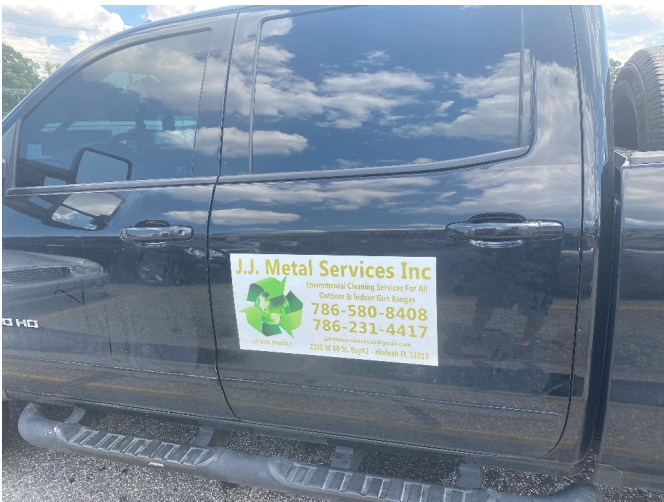
JJ Metal fleet is composed of one trailer, only for equipment, a 26-foot truck, and a pickup truck. At the time of the inspection, the pickup truck was under maintenance. On 06/08/2021 the facility submitted a picture of this vehicle with the placard US DOT 3048813, compliant to 40 CFR 263.10. Additionally, a picture from the truck was submitted on 06/17/2021.

DOT HWT placard

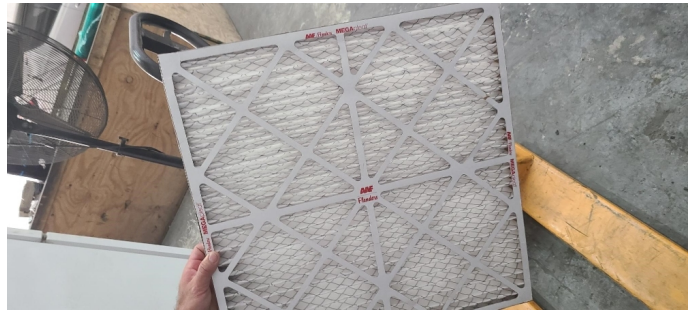
According to the manager, the removed lead-contaminated exhaust filters are placed in a Gaylord box located at the owner's house at the time of the inspection. This waste stream is comingled with the lead-contaminated gunpowder for disposal at a Treatment, Storage, or Disposal Facility (TSDF) or recycling.

Exhaust filter (product)

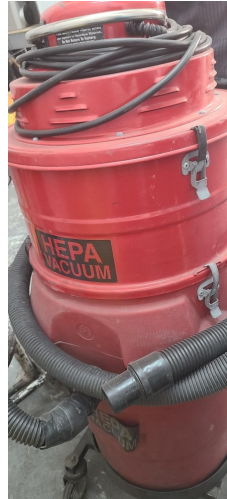
> One HEPA Vacuum with a 13-gallon attached container partially full of gunpowder. The inspector requested the facility to assure the waste determination as non-hazardous on this lead-contaminated material, per 40 CFR 262.11.

Lead contaminated Heppa filter container

Type:	Violation
Rule:	<b>262.11</b>
Explanation:	The Hepa Vacuum with a 13-gallon attached container partially full of gunpowder observed on-site, and lead-contaminated filters did not have an accurate waste determination.
Corrective Action:	The facility was requested to verify the waste determination as non-hazardous on this lead-contaminated waste stream.
