**Florida Department of
Environmental Protection
Hazardous Waste Inspection Report**

Facility Name: Crowley Liner Services
On-Site Inspection Start Date: 06/22/2021 **On-Site Inspection End Date:** 06/22/2021
ME ID#: 21129 **EPA ID#:** FL0000360560
Facility Street Address: 4300 Macintosh Rd, Fort Lauderdale, Florida 33316
Contact Mailing Address: 4300 McIntosh Road, Ft Lauderdale, Florida 33316
County Name: Broward **Contact Phone:** (305) 470-4087

Crowley Liner Services Inspection Report

Inspection Date: 06/22/2021

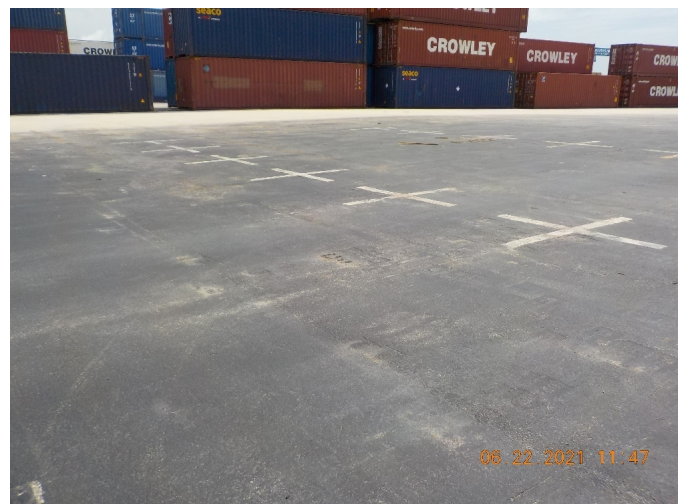
Empty hazardous waste container staging area

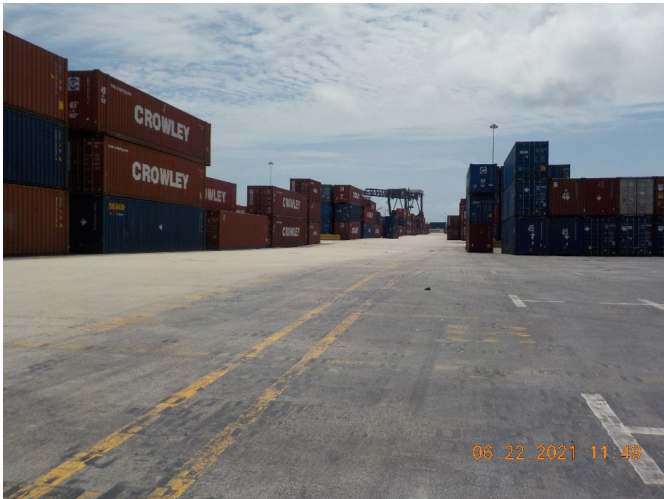
Facility does not take wastes off/out of cargo containers. They accept shipping containers, move them into the parking area, and ship them off all without unloading. The only time any of the containers are opened is if the Coast Guard or Customs mandates it for an inspection. The terminal planner receives the information for incoming shipments, and segregates hazardous waste cargo containers to the designated storage area in the processing yard. The hazardous waste storage area was empty at the time of the inspection. Crowley has a contract with Cliff Berry Inc. (CBI) which describes CBI as their cleanup contractor in case of any environmental emergency response on their property at the port.

Cargo container processing yard

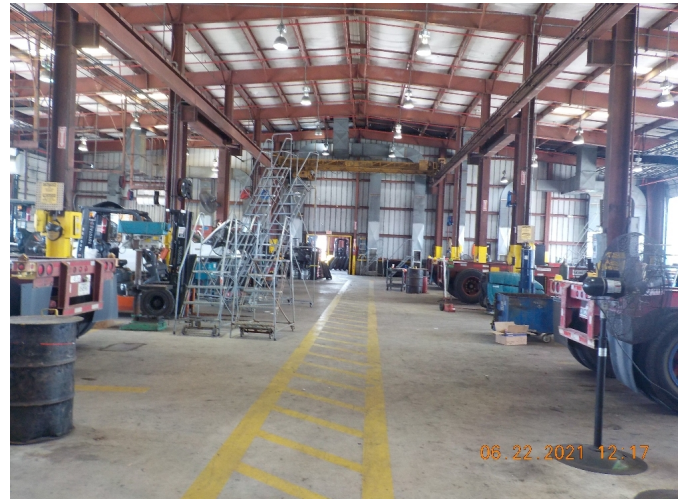
Facility performs maintenance on their own vehicles in a 12-bay maintenance shop and generates the following waste streams: Used oil, used oil filters, and spent antifreeze. At the time of the inspection, the following was observed:

Vehicle maintenance building

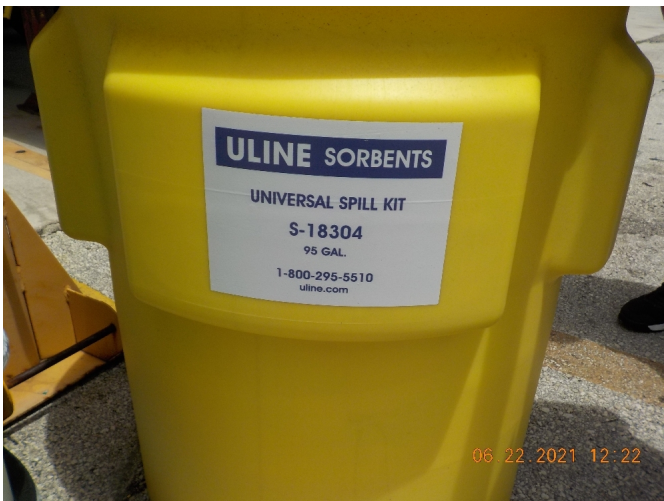
Used oil – Four 55-gallon steel drums closed and properly labeled; outdoors in a covered storage area; within secondary containment; managed by CBI. A spill kit is maintained and readily available directly adjacent to this area.

Spill kit located adjacent to used oil storage
