Re: Cummins, LLC. Compliance Assistance Offer

Hazardous Waste Inspection Report

Facility Name: Cummins LLC

On-Site Inspection Start Date: 06/15/2021 On-Site Inspection End Date: 06/15/2021

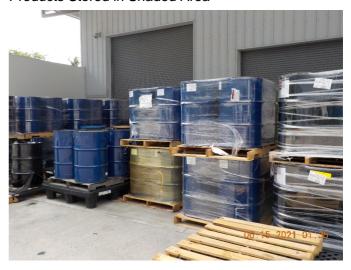
This area is located next to the warehouse and is used to store products such as Antifreeze/Coolant, grease, and others hydraulic fluids. Additionally, the inspector observed 16 spent lead-acid batteries over a pallet. Even though the batteries were in a shaded area, the inspector observed rainwater reaching the pallet. The inspector offered compliance assistance and requested the facility relocate spent batteries to an area protected from the weather. On 07/01/2021, the facility provided a picture demonstrating that the spent lead-acid batteries were relocated indoors to protect them from the elements.

Products Stored in Shaded Area

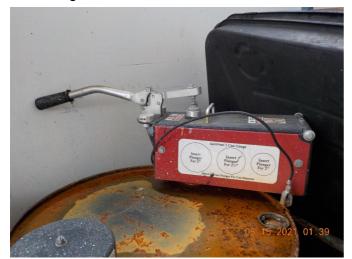
The inspector also observed one aerosol can puncturing device installed over a 55-gallon drum labeled as "Hazardous Waste," with the purpose of collecting remaining liquids.

Puncturing Device

Finally, during the inspection, the inspector observed that the facility punctures aerosol cans. The inspectors provided compliance assistance and explained to the facility that on 02/07/2020, the EPA added hazardous

waste aerosol cans to the universal wastes outlined in title 40 of the Code of Federal Regulations (CFR), part 273, thereby giving generators the opportunity to choose the management method that best suits its operations. The State of Florida adopted the requirements of 40 CFR Part 273 into the Florida Administrative Code (FAC 62-730) on October 30, 2020. The facility operating as a VSQG of hazardous waste, is encouraged to manage aerosol cans wastes as universal wastes and comply with requirements under 40 CFR 273 that include the following: to maintain a procedure detailing how to safely puncture and drain the universal waste aerosol cans, maintain a copy of the manufacturer's specification and instruction on site; and ensure employees operating the device are trained in the proper procedure, and send empty cans for recycling.

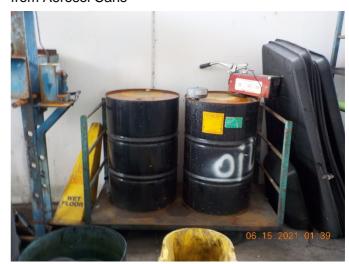
Labaled Hazardous Waste Drum for Drained Liquids from Aerosol Cans

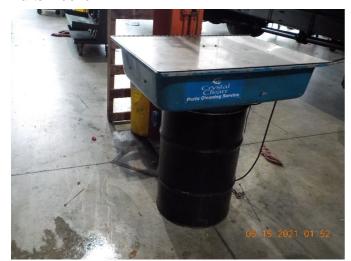
- >Two red 14-gallon containers for oily rags, labeled with the words "Oily Waste Can."
- >Two parts washers installed over 55-gallon drums. Both maintained and serviced by Heritage Crystal Clean.
- These use nonhazardous Naphtha and are scheduled for service for recycling every 12 weeks.
- >One 55-gallon yellow bin for oily absorbent pads, that are used to clean minor spills of used oil.

Parts Washer
