**Re: Compliance Assistance Offer
Moran Environmental Recovery, LLC
EPA/DEP ID: FLD092718576
Duval County – Hazardous Waste**

**Florida Department of
Environmental Protection
Hazardous Waste Inspection Report**

Facility Name: Moran Environmental Recovery LLC
On-Site Inspection Start Date: 07/22/2021 **On-Site Inspection End Date:** 07/22/2021
ME ID#: 44626 **EPA ID#:** FLD092718576
Facility Street Address: 251 Levy Rd, Atlantic Beach, Florida 32233-2613
Contact Mailing Address: 251 Levy Road, Atlantic Beach, Florida 32233-0569
County Name: Duval **Contact Phone:** (781) 815-1100

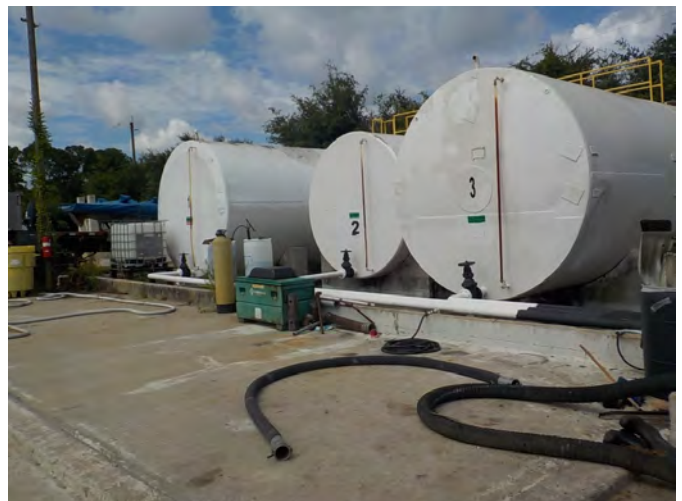
Photo 4

A large concrete pad and tank farm is located in the rear of the facility (Photos 4 and 5). The concrete pad is used to temporarily park tanker trucks of used oil and wastewater, and as a wash-out area for empty trucks and empty containers when they return to the facility. If MER picks up a load of used oil from a customer, and is not immediately able to transport it to Water Recovery for processing, the truck is parked on the concrete pad for less than 24-hours and then taken to Water Recovery the next morning. There are six horizontal steel aboveground storage tanks (ASTs) and one vertical poly AST located within secondary containment in the tank farm area. Two of the tanks are used to collect wash water from the concrete pad and the other tanks are currently out of service. The facility washes out the inside of its empty skids / tanker trucks on the concrete pad using a dilute solution of Zep Morado Super Cleaner (pH 13.5). The pad is sloped to a sump that collects the wash water and rainwater from the pad. The wash water from the sump, and rainwater that collects in a valve pit located within the secondary containment area (See Photo 5) is pumped into one of the wastewater tanks located within the containment area. The wash water is transported to Water Recovery approximately quarterly or more frequently as needed. The valve pit and sump are cleaned out as needed to remove accumulated solids and the sludge is also transported to Water Recovery for disposal. MER manages both the wash water and the sludge as non-hazardous waste but it has not made a hazardous waste determination on these wastestreams by having the waste analyzed for hazardous waste characteristics [40 CFR 262.11].
