**Florida Department of  
Environmental Protection  
Hazardous Waste Inspection Report**

**Facility Name:** Tropical Shipping & Construction Co Ltd  
**On-Site Inspection Start Date:** 11/04/2021      **On-Site Inspection End Date:** 11/04/2021  
**ME ID#:** 50031      **EPA ID#:** FLR000095737  
**Facility Street Address:** Port of Palm Beach - 5 E 11th, Riviera Beach, Florida 33404-6920  
**Contact Mailing Address:** Port of Palm Beach - 5 E 11th, Riviera Beach, Florida 33404  
**County Name:** Palm Beach      **Contact Phone:** (800) 367-6200

Routine Inspection for Hazardous Waste Transporter Facility

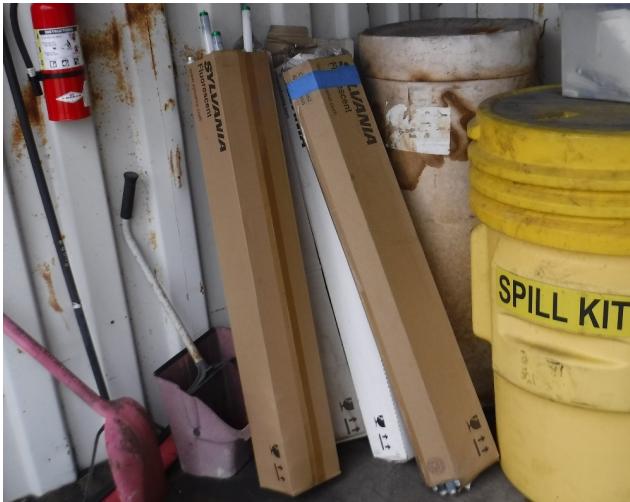
- >Four open and unlabeled boxes with spent mercury lamps (total 77 lamps). The facility failed to maintain universal waste lamps containers closed in accordance to 40 CFR 273.13(d)(e), and failed to label universal waste lamps in accordance to 40 CFR 273.14(e) & 62-737.400(5)(b) F.A.C.
- >One 27.5-fl oz container of West System 205 Fast Hardener, over a secondary containment, identified as hazardous waste.
- >Two 1-quart of Ashland Derakana 411-350, Vinyl Ester Resin, over a secondary containment, identified as hazardous waste.
- >One 55-gallon drum labeled with the words "Non-Hazardous Waste"

Explanation: The facility failed to maintain universal waste lamps containers closed and structurally sound container. Specifically, the inspector observed four open cardboard containers with a total of 77 spent mercury lamps.

Before - Open Boxes of UW Lamps

Corrective Action: The facility shall close and secure the cardboard containers of universal waste lamps to prevent breakage and leakage. Please provide a photographic evidence to the Department.

\*\*Resolved Violation\*\* On 11/29/2021, the facility provided pictures demonstrating that the universal waste lamps are stored in a closed structurally sound container.

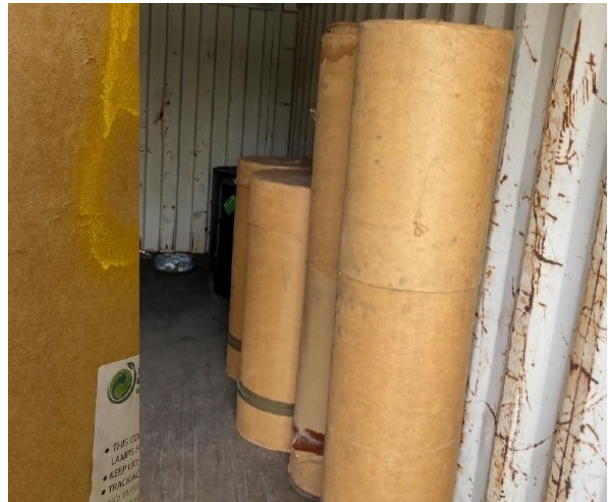
After - Closed and Secured Boxes for UW Lamps

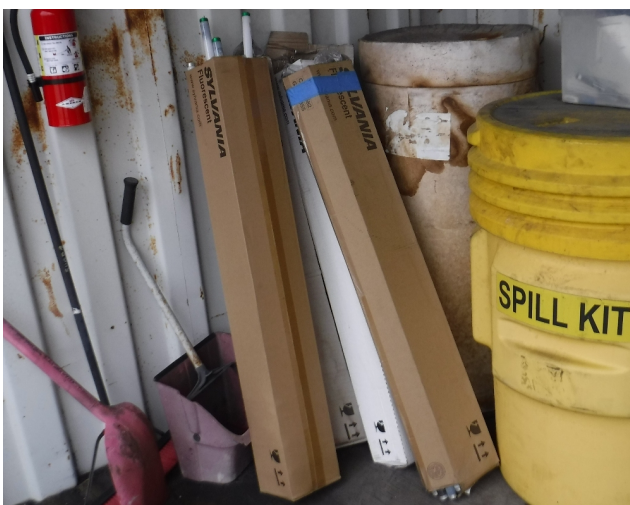
Explanation: The facility failed to label the spent mercury lamps containers. Specifically, the inspectors observed four unlabeled cardboard containers of spent mercury lamps (total 77 lamps).

Before - Unlabeled Boxes of UW Lamps

**\*\*Resolved Violation\*\*** On 11/29/2021, the facility provided pictures demonstrating that the universal waste lamps containers were properly labeled with the words "Universal Waste Lamps," and start accumulation date 05/19/2021.

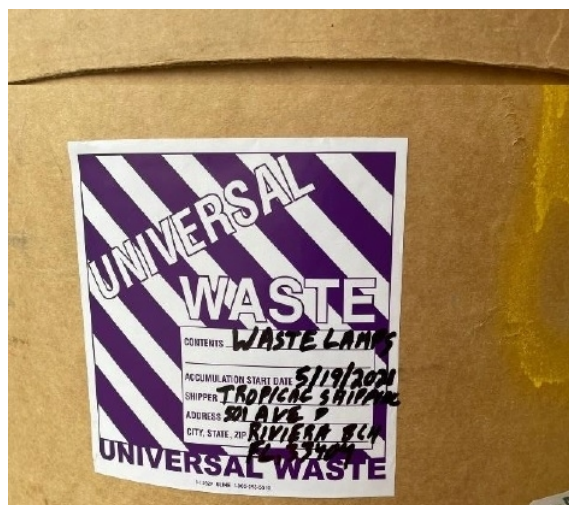
After - Properly Labeled Container with UW Lamps

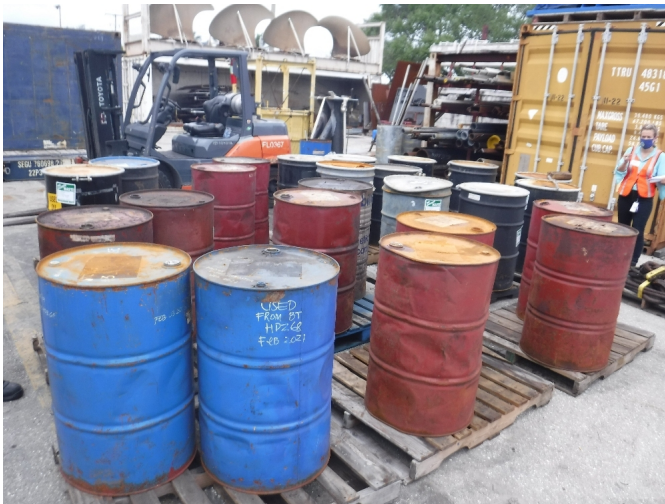
- >Three 55-gallon drums labeled with the words "Used Oil," without secondary containment.
- >Thirteen 55-gallon drums of used oil missing the label "Used Oil," without secondary containment.
- >Eight 55-gallon drums with non-hazardous waste
- >One 55-gallon drum of oily debris.

The drums were stored near to a stormwater drain and without a secondary containment. Additionally, these were rusty and dent. No visible leaks were detected.

Based on this information, the facility failed to label thirteen 55-gallon drums of used oil, and failed to provide a secondary containment for sixteen 55-gallon drums, in accordance with 40 CFR 279.22(c)(1) and 62-710.401(6) F.A.C.

Explanation: The facility failed to label thirteen 55-gallon drums of used oil and to provide a secondary containment for sixteen 55-gallon drums of used oil that were stored adjacent to the Marine & Purchasing Shop.

Unlabeled 55-gallon Drums of Used Oil, no Secondary Containment      After - Used Oil Shipment Receipt

**\*\*Resolved Violation\*\*** On 11/29/2021, the facility provided documentation demonstrating that the drums were properly identified and shipped out.

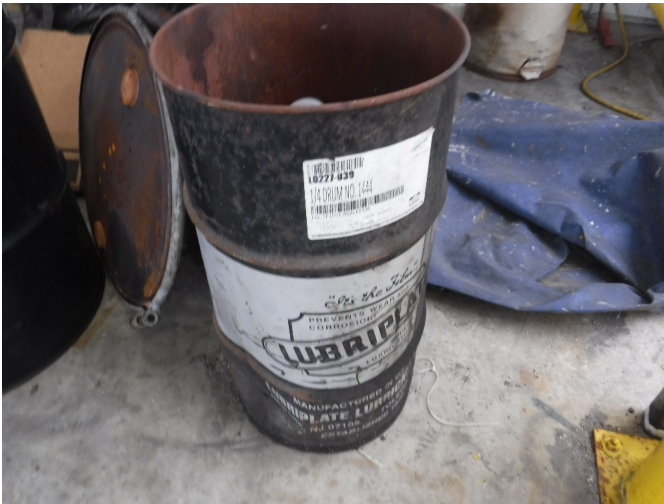
Explanation: The facility failed to label one 55-gallon drum of used oil filters in Shop 2 and failed to properly label one 55-gallon blue drum for used oil filters, labeled with the words "Filters," in Shop 1.

Before- Unlabeled 55-gallon Drum of Used Oil Filters

**\*\*Resolved Violation\*\*** On 11/29/2021, the facility provided pictures demonstrating that the drums were properly labeled.

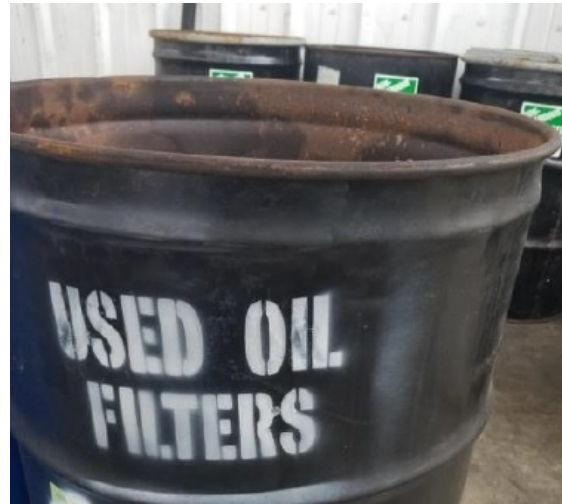
After - Properly Labeled Drum with Used Oil Filters

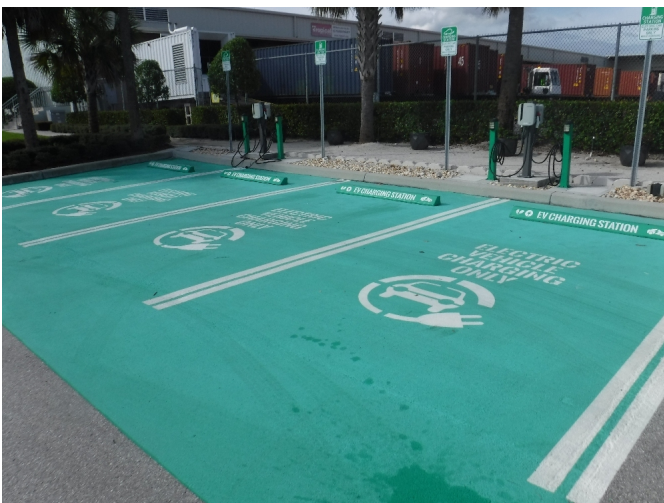
The Electric Vehicle Charging Station is located in the parking lot at the corporate office complex. The inspector observed two dual head electric vehicle charging stations, and one electric vehicle use for security, according to the Pollution Prevention (P2) Project implemented on 04/22/2021. The charging stations are available for Tropical employees use at no cost.

Electric Vehicle Charging Station (P2 Project)

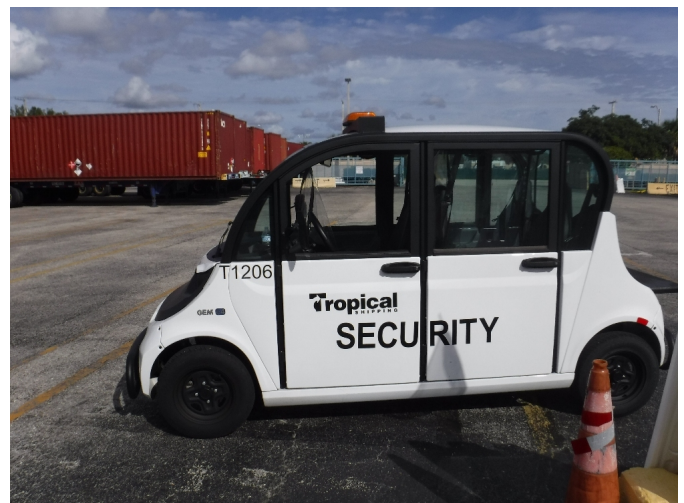
Electric Vehicle (P2 Project)

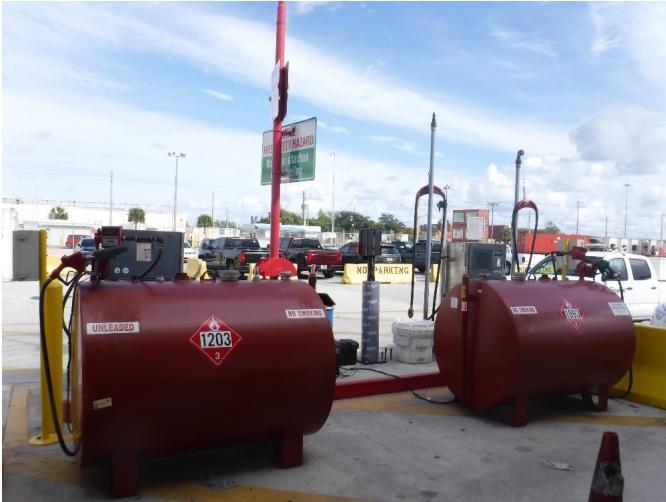
Adjacent to the Shops 1 & 2, there is a Gas/Diesel Station available to provide fuel for Tropical vehicles. The inspectors observed one 500-gallon tank of Diesel and one 500-gallon tank of Gasoline.

Tropical representatives informed that these tanks are temporary. The facility ceased the use of one 20,000-gallon Underground Storage Tank (UST) of Diesel, and one 10,000-gallon UST of Gasoline that will be eventually replaced by one 15,000-gallon AST and one 5,000-gallon AST, respectively.

Gas/Diesel Station

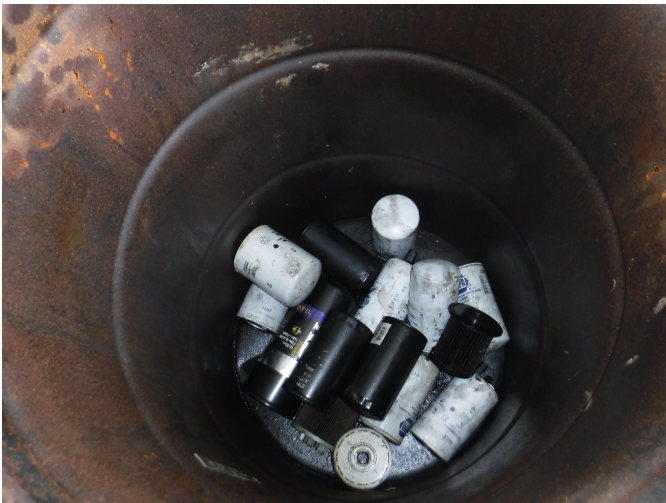
Used Oil Filters

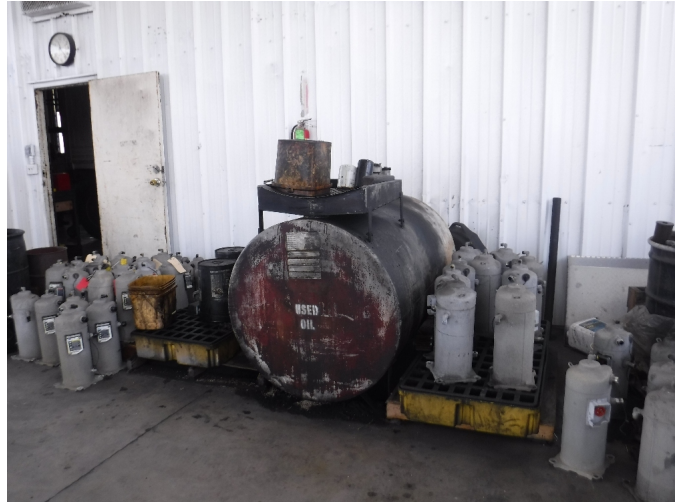
Labeled Tank Used Oil

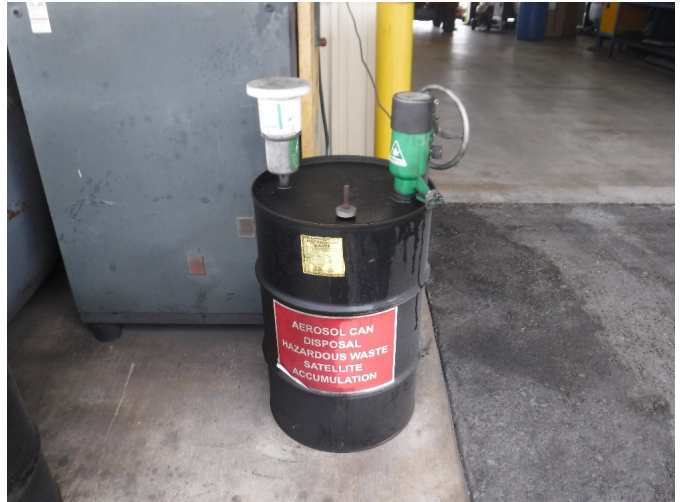
- >One 30-gallon drum with a puncturer system installed on top. The drum was labeled with the words "Hazardous Waste - Aerosol Can Disposal Satellite Accumulation Area." Aerosol cans are managed as universal waste under 40 CFR 273.
- >One 30-gallon drum labeled with the words "Punctured Aerosol Cans for Scrap."
- >One 55-gallon blue drum for used oil filters, labeled with the words "Filters"
- >One 250-gallon double wall tank, labeled with the words "Used Oil" [40 CFR part 279.22(c)(1), 62-710.401(6) F.A.C.].
- >One 500-gallon tank labeled "Hydraulic Oil" (product)
- >One 500-gallon tank labeled "Engine Oil"

Aerosol Can Puncturer System

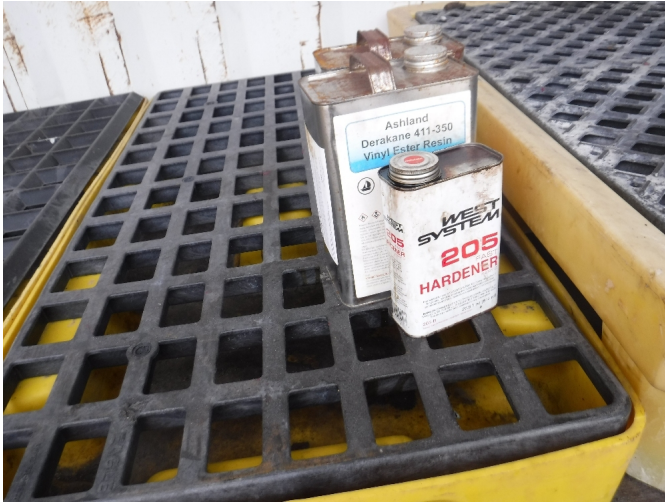
## Hazardous Waste in the CAA

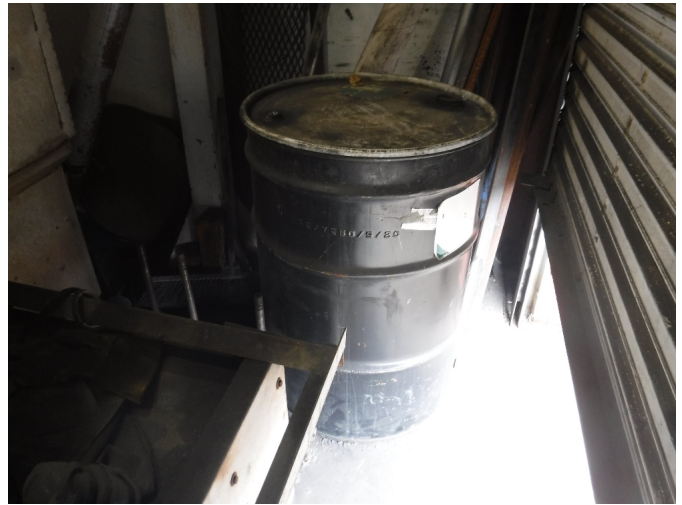
- >One closed 55-gallon steel drum for spent sandblast media, labeled as non-hazardous waste, the name of the facility, and the address.
- >One sandblaster.

repaired in the Marine Shop. Spent sandblast media is collected in 55-gallon drums labeled, managed and disposed of as nonhazardous waste. The Safety Data Sheet (SDS) of the blast media indicates that it is based in Silica, Aluminum Oxide, and Iron Oxide, considered nonhazardous. Also, the facility maintains a Toxic Characteristic Leaching Procedure (TCLP) analytical result for metals, conducted on 02/27/2020, to spent sand blast media, demonstrating that it does not exhibit characteristics for toxicity.

## 55-gallon of Non Hazardous Waste (Spent Sandblast Media)
