**Florida Department of
Environmental Protection
Hazardous Waste Inspection Report**

Facility Name: HEPACO LLC
On-Site Inspection Start Date: 03/23/2022 **On-Site Inspection End Date:** 03/23/2022
ME ID#: 119817 **EPA ID#:** NCD986194306
Facility Street Address: 2711 Burch Drive , Charlotte, North Carolina 28269
Contact Mailing Address: 2711 Burch Dr, Charlotte, North Carolina 28269
County Name: All FL Cntys **Contact Phone:** (704) 598-9782

Inspection Date: 03/23/2022

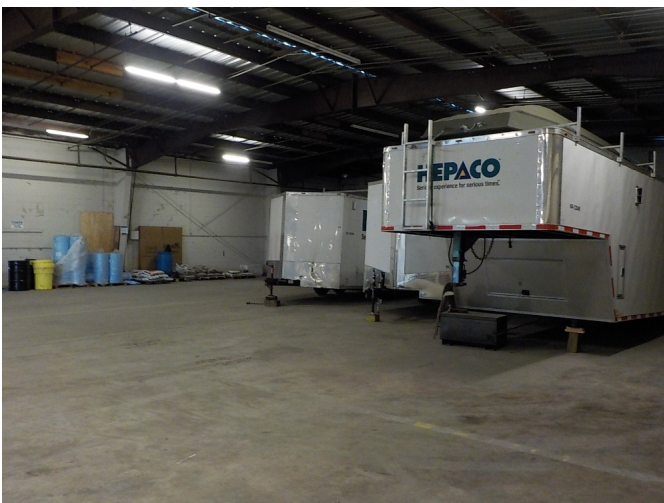
Photo 1

The office area and warehouse are located in the same building. The warehouse area is used for the storage of parts, materials and equipment (Photo 1). Mr. Moats stated that no vehicle maintenance is performed on-site, and that no used oil, used oil filters, or hazardous waste is generated at the facility. A flammable locker was observed in the warehouse that was used for storage of product fuels, and aerosol paints and lubricants (Photos 2 and 3). Subsequent to the inspection, a HEPACO representative provided clarifying information that HEPACO utilizes aerosol products primarily at its client sites, and any waste generated from use of aerosols is managed by the client. No aerosol cans were observed in the trash at the time of the inspection. However, the facility is reminded that spent aerosol cans may contain liquid product and/or flammable propellants which can cause the aerosol can to be a D001 and/or other hazardous waste. Additionally, aerosol cans with broken or clogged nozzles may be considered a hazardous waste. Unless an aerosol can is completely empty of both liquid and propellant, as defined in 40 CFR 261.7, it should not be thrown into the trash. If generated at the facility, any unusable and/or spent aerosol cans should either be safely punctured and properly drained into a closed container which should then be managed as hazardous waste, or be placed unpunctured into a closed container which should then be managed as a hazardous waste. Alternatively, the facility may choose to manage hazardous waste aerosol cans as a universal waste, provided they meet the requirements of 40 CFR 273.

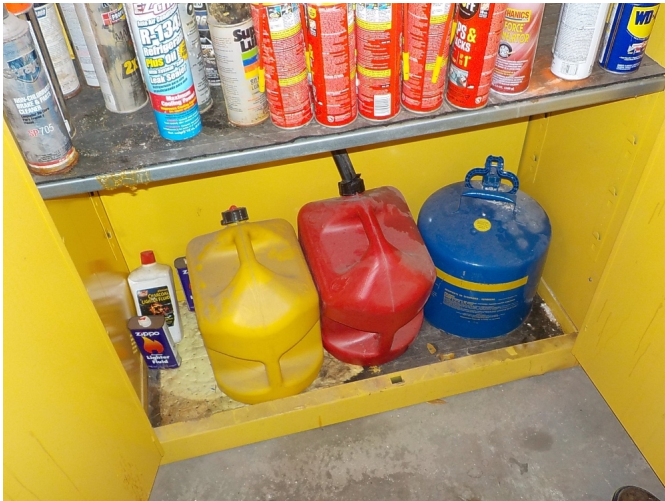
Photo 4

At the time of the inspection there were eleven 55-gallon drums of non-hazardous petroleum-impacted waste, generated by customers, that were staged inside the warehouse pending transportation for disposal (Photo 4). One of the drums labeled as "Diesel-Impacted Pads" appeared to have leaked onto the concrete floor (Photos 5 and 6) [40 CFR 279.22(d)(3)]. HEPACO personnel responded to the release during the inspection by transferring the contents into a new container and using absorbent media to clean-up the spill.

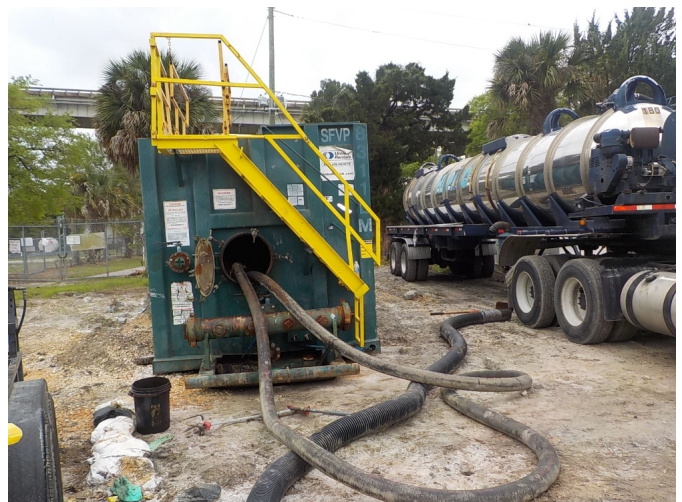
Photo 8

At the time of the inspection, HEPACO was in the process of cleaning a mobile FRAC tank (Photo 8). Mr. Moats stated that the tanks are only used for non-hazardous waste and are cleaned after each use. The rinsewater is collected and disposed based on the type of waste it previously contained. It appeared that some rinsewater had been discharged, or overflowed, onto the surrounding limerock. This is an Area of Concern. The facility does not have a stormwater permit for this type of discharge. The facility should either relocate its cleaning process to an impervious surface that allows for collection of any overflow wastewater, or ensure proper collection and disposal of all wastewater generated during container cleaning.
