Re: US Ecology Tampa, Inc.
Facility ID No. FLD981932494
Hillsborough County

**Florida Department of
Environmental Protection
Hazardous Waste Inspection Report**

Inspection Date: 12/22/2022

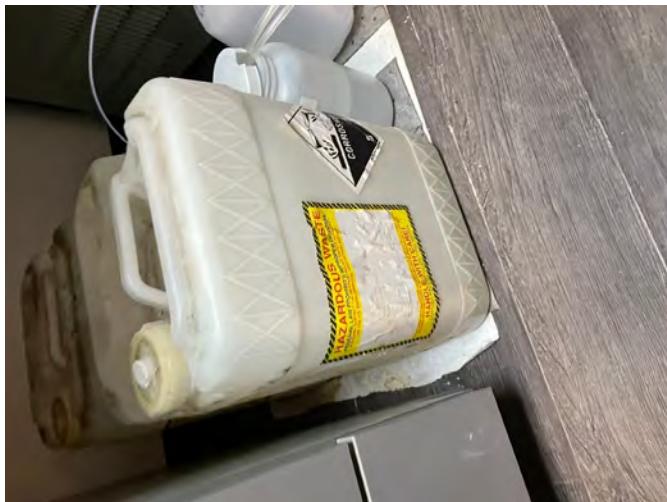
Inductively Coupled Plasma satellite accumulation jug

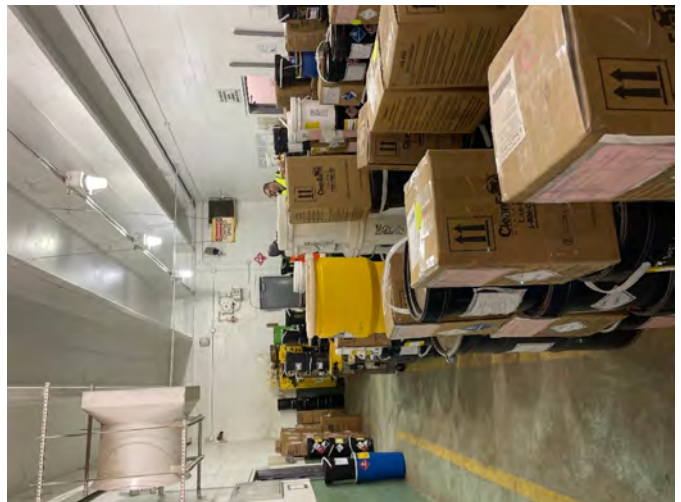
Bay #2, Hazardous Waste Container Storage Building

Bay 1 is used for the weighing and processing of inbound waste; some consolidation of waste into new containers is performed. Acidic hazardous wastes are also stored in this bay. Bay 2 houses Flammable and Reactive hazardous wastes. Bay 3 is used to store Caustic, Oxidizer and Toxic hazardous wastes; most of the consolidation of waste into new containers is done in this bay. A walk-through of the building confirmed that all containers of hazardous waste were labeled with the words "hazardous waste", an indication of the hazards of the contents, an accumulation start date, and were closed. None of the containers had been stored for longer than the permitted one-year time limit; the oldest container observed was dated February 3, 2022. The facility uses a barcode and scanning system to keep track of hazardous waste containers. Sufficient aisle space was maintained to allow for the inspection of all containers in the building.

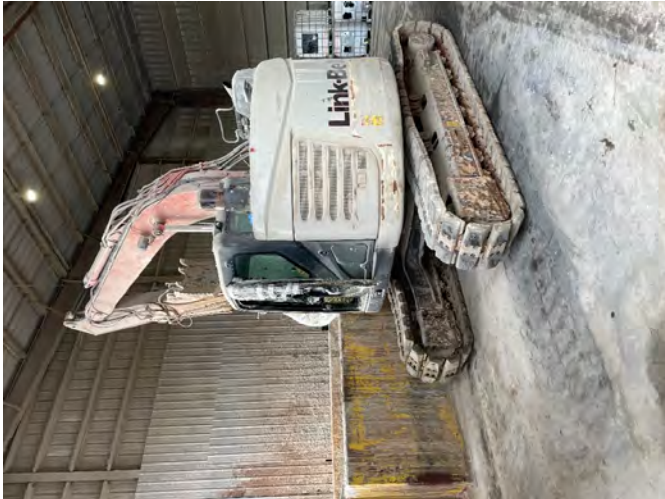
Excavator in the Hazardous Waste Treatment Building

The waste treatment building houses separate mix tubs for solid and hazardous waste. The facility uses two excavators for mixing waste. Each excavator is dedicated to either hazardous or solid waste mixing, therefore decontamination of equipment between batches of hazardous waste is not needed. The hazardous waste mix tub is certified as meeting 40 CFR 265 Subpart J requirements. Hazardous waste codes associated with the hazardous wastes treated in this building include D002, D004, D011, and K062. The facility is not authorized to treat hazardous waste with organic underlying hazardous constituents. Hazardous waste is treated with a ferric and sulfide reagent. Ash kept in a silo behind the building is added to the hazardous waste mix tub for solidification during processing. Sawdust is added to the solid waste mix tub during processing for solidification. The treatment building is authorized to store a limited number of containers of hazardous waste (4,950 gallons) prior to treatment. At the time of the inspection, the treatment building was not actively treating batches of hazardous waste and the volume of hazardous waste stored in the building was under under the 4,950 gallons

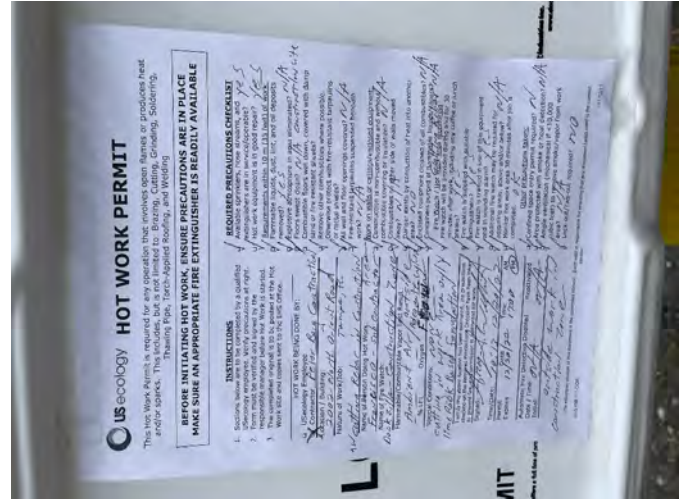
Hot Work Permit

At the time of the inspection, there were renovations taking place in front of the hazardous waste container storage building. The associated construction permit can be observed in the inspection photos.

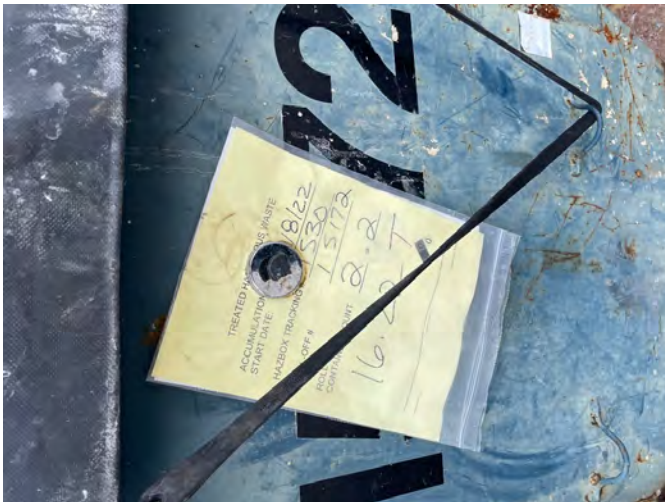
Treated hazardous waste roll-off container

The storage area has a permitted maximum capacity of 40 20-yard roll-offs (800 cubic yards). At the time of the inspection, 13 treated hazardous waste 20-yard roll-off containers were observed in the storage area. All of the roll-off containers were in good condition; the accumulation start date labels and container identification numbers were easily observable. The oldest container observed was dated December 12, 2022 and contained 16.22 tons of treated hazardous waste.

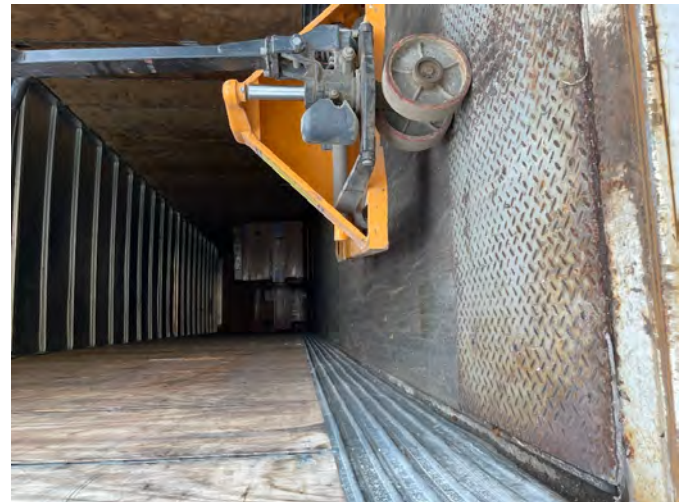
Universal waste storage box truck

Universal waste lamps are stored in a box truck located on the North Property. The containers were closed and properly labeled. Containers of universal waste batteries were staged in front of Bay 3. The containers were
