## HAZARDOUS WASTE INSPECTION REPORT

1. **INSPECTION TYPE:** ☒ Routine ☐ Complaint ☐ Follow-Up ☐ Permitting ☐ Pre-arranged  
**FACILITY NAME:** Onyx Environmental Services - Tallahassee **DEP/EPA ID #:** FL0000207449  
**STREET ADDRESS:** 342 Marpan Lane, Tallahassee, Florida 32305  
**MAILING ADDRESS:** 342 Marpan Lane, Tallahassee, Florida 32305  
**COUNTY:** Leon **PHONE:** (850) 878-2259 **DATE:** April 26, 2005 **TIME:** 3:00 A.M.

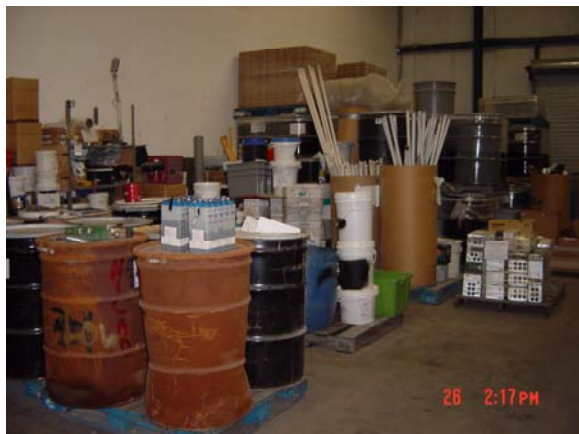
Picture A

Waste batteries (lead-acid, Ni-Cd, alkaline, magnesium, and lithium) are brokered thru the facility. A storage area is provided on the southeast side of the facility and the bulk containers are transported to Inmetco in Ellwood City PA for metals recovery smelting. Waste electronic ballasts are also stored on the southeast side of the facility and then transported to OES, Stoughton, MA for cold dry separation of metals and potting compound (Picture A).

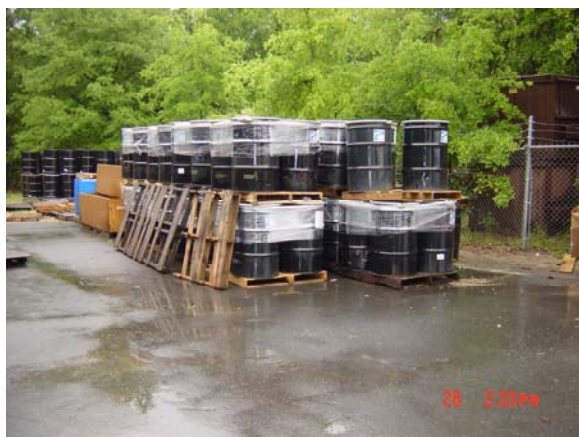
Picture C

Near the center of the building the bulbs and lamps are placed on one of two conveyor belts crushed under negative pressure and the residue separated into glass, metal end caps, and mercury containing phosphor powder. The metal end caps are collected in bulk storage containers for recycling as scrap metal with R & L Metals in Tampa, FL. The glass is collected in roll-offs located outside on the north end of the building and is transported to the Leon County Landfill for use as daily cover material (Picture B). This area in and around the glass, metal and cardboard collection and storage locations has been paved with asphalt to provide a stable surface for the materials and aid in daily housekeeping of the area (Picture C).
