# Florida Department of Environmental Protection

Volusia County - SW  
Tomoka Farms Road Landfill WACS # 27540  
Class I - Permit # S064-0078767-023  
Transmittal of Inspection Report

Florida Department of  
Environmental Protection  
Inspection Checklist

**Facility Name:** TOMOKA FARMS ROAD LANDFILL

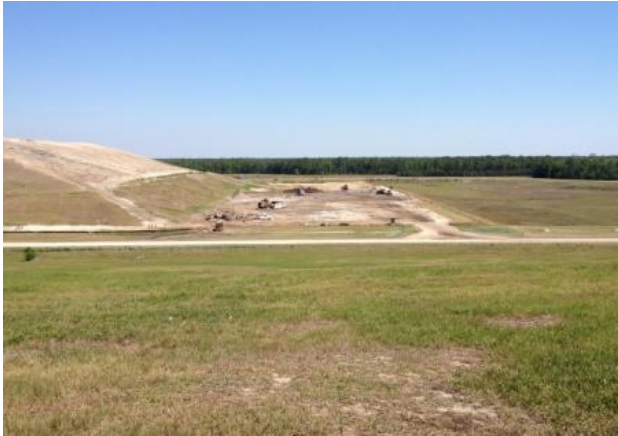
New Cell Overview

The facility sent a notification to the Department on March 6, 2012 stating they would be moving into Phase I, area 2. Area 2 is to the east and adjacent to the active North Cell hill (area 1). Area 2 was not used up to this point. Two working phases were utilized during the early part of the move to utilize select waste.

The facility is increasing the size of the berm on the east side of area 2 to 10 feet. The berm is between the unlined future expansion areas (areas 3 and 4). The berm is nearly complete and the facility is rebuilding the litter fence on top of it.

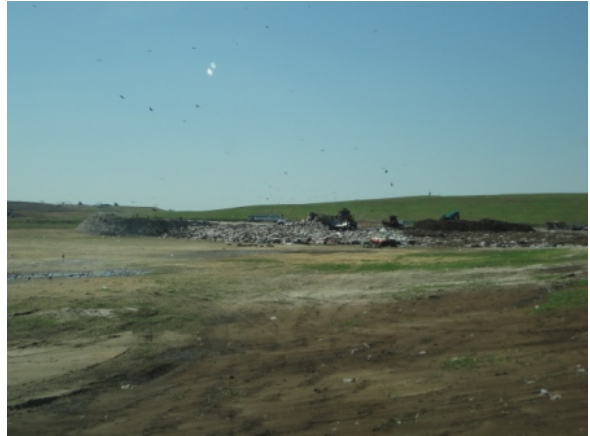
Class I Working Face

During the inspection, the facility was only using the new working face. Jennifer Stirk said that disposal started on the south side and is moving towards the north. The previous working face on the area 1 surface was covered and being graded at the time of inspection.

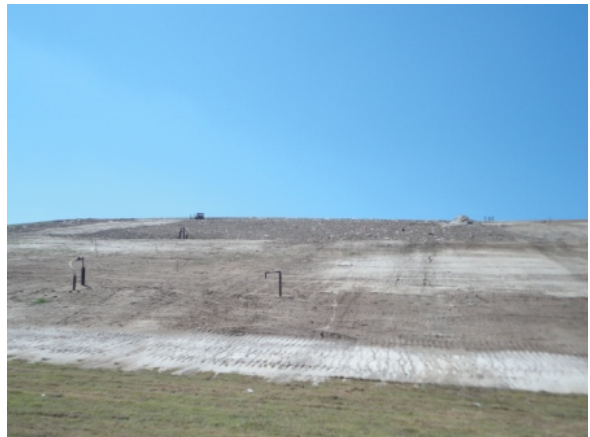
North South Slopes

HDR engineering continues to work on the gas system expansion. The gas expansion is in preparation of the partial closure of the North Cell side slopes. The work includes the installation of new header lines, vertical wells, and condensate sumps. Work is completed on the north side slopes and continues on the south side slopes. The facility regraded the north side slopes and restored the grade to a 3:1 (horizontal:vertical) ratio. There are still some areas of waste protruding through the cover on the upper areas of these side slopes.

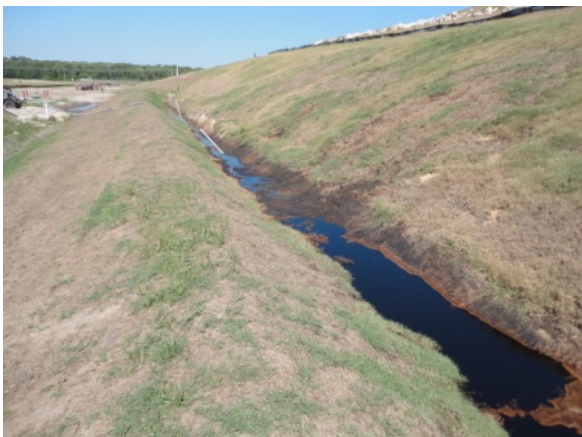
South Side Slope Toe Drain

As noted in the previous inspection, there was pooled leachate observed within the containment berm on the south side slopes. A response dated March 2, 2012 stated that the nearby construction associated with the gas system expansion could have attributed to the accumulation of sediment over the toe drain. Please continue to work towards a permanent solution regarding this issue.

Leachate is again pooling within the toe berm on the south side slopes. Jennifer Stirk said this just started to occur after a rain event just a few days prior to the inspection. As noted in previous inspections, leachate seeps from the side slopes just upslope of the toe drain. The leachate is collected and contained within the toe berm. Jennifer Stirk said that the seepage may have increased due to the gas system construction nearby. A pump is still in place in case the leachate level within the berm significantly increases. Jennifer said the pump has not been needed since a one time use in December and she expects the leachate to resume draining.

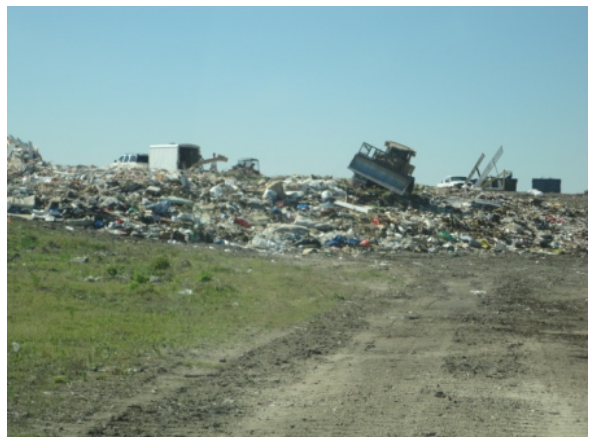
Class III Working Face

The working face is located on the western side of the surface near the center of the cell surface. Jennifer Stirk said that disposal moved here in the past few days from the northeast corner areas. The facility is grading and covering the previous disposal areas.

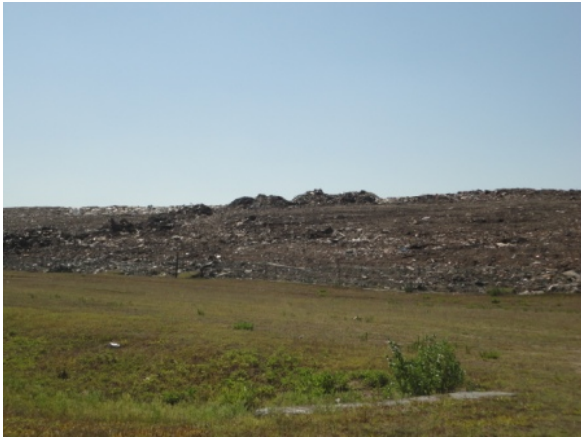
Class III North Side Slopes

Explanation: Cover is inadequate in the area of the previous working face with areas of exposed waste.

Corrective Action: An additional layer of cover must be applied to this area to cover exposed waste.

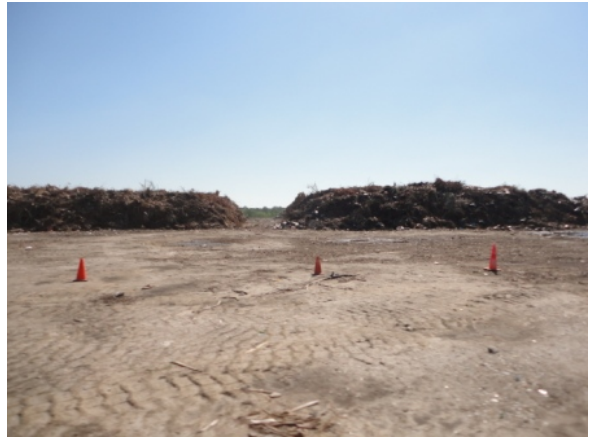
Yard Trash Area

The facility was processing yard trash at the time of inspection. The facility continues to use mulch to mix in with cover material.
