**FLORIDA DEPARTMENT OF  
ENVIRONMENTAL PROTECTION**

Re: Tomoka Farms Road Landfill  
SW WACS # 27540  
Volusia County  
OCD-CAP-14-2600

Florida Department of  
Environmental Protection  
Inspection Checklist

**Facility Name:** TOMOKA FARMS ROAD LANDFILL

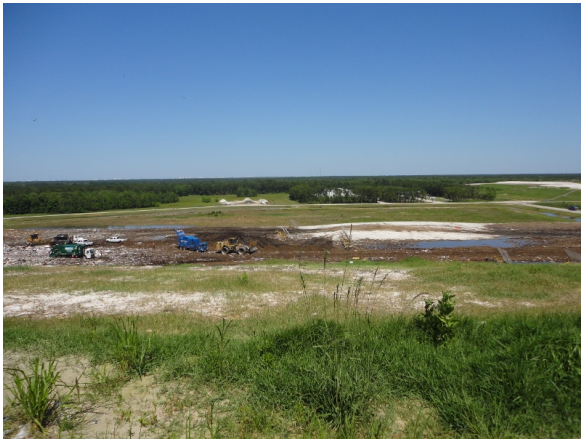
The Class I working face is located near the center of phase I, area 2 of the north cell. Disposal is moving towards the south along the current lift.

Class I working Face

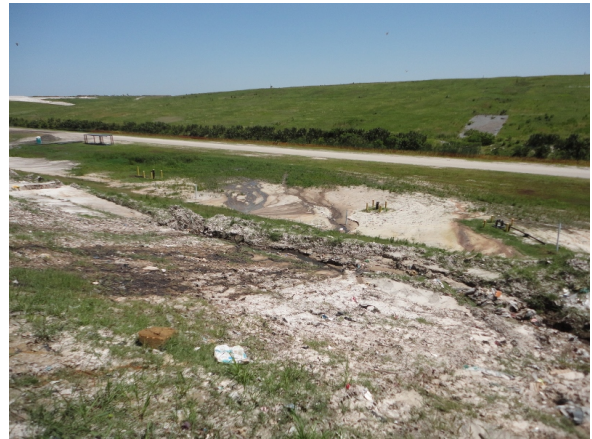
Explanation: Leachate was actively flowing from the wellhead of the 8B horizontal gas collection line and other seepage areas of the south side slope. Leachate was not being collected by the leachate collection system and was observed flowing outside the lined area of the landfill.

There was a significant amount of leachate flowing from the east side of North Cell's south side slope. This is located in the area of the recent horizontal gas collector installation as part of Phase I of the landfill gas collection system construction. The leachate was flowing primarily from the horizontal 8B wellhead and from other areas along the slope. Leachate flow downslope was visible outside of the lined area. There was also a significant amount of erosion and exposed waste in this area, with some waste having washed down the slope with eroded soil outside the liner area.

South Side Slope Leachate

Corrective Action: The facility must ensure that all leachate is collected by the leachate collection system.

On May 14, Junos Reed submitted documentation showing that leachate is contained within the lined area of the landfill.

In an email sent on May 14, 2014, Junos Reed stated that the erosion had been repaired and the exposed waste was covered. All soil and waste that had washed out beyond the lined area was hauled to the Class I working face. The toe berm downslope of the seepage area was repaired to stop the flow of leachate beyond the liner and a temporary 4" line was run from the horizontal 8B stub out to a leachate clean out riser downslope. This will remain in place until the newly installed horizontal gas collectors are connected to the gas collection system. This is scheduled to occur around May 28.

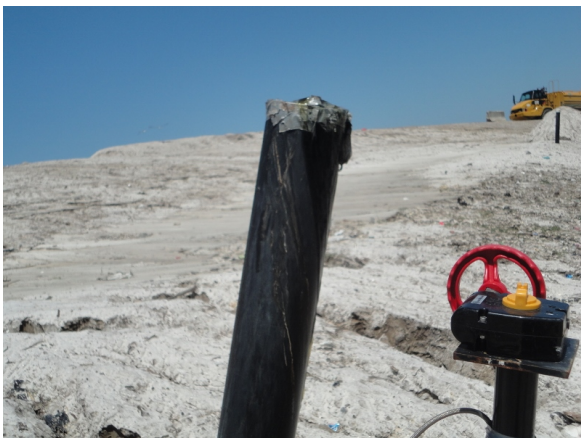
Well head Leachate Flow

The facility started work the day of the inspection to redirect leachate flow to prevent it from flowing downslope. Junos Reed stated that the facility will excavate a hole into the waste near the 8A wellhead and cover it with drainage stone.

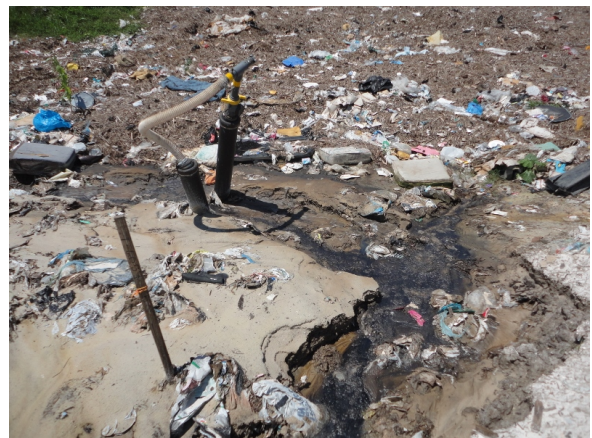
Explanation: Due to recent heavy rains, erosion was present on areas of the Class I south side slope. The erosion resulted in exposed waste. Some of the waste washed downslope and was observed outside the lined area of the landfill.

Leachate and Exposed Waste

Corrective Action: The facility must repair all eroded areas and cover exposed waste. Waste outside of the lined area must be collected and taken to the class I working face.

On May 14, 2014, Junos Reed submitted a response to the Department documenting the completion of these corrective actions.

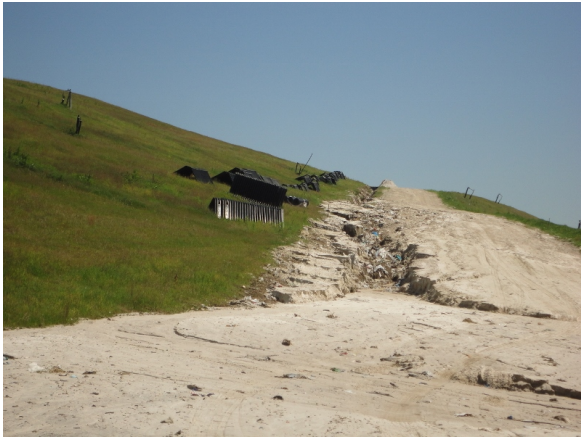
The facility recently started the installation of a Smart Ditch lining system along the NW access road. However, the constructed trench washed out during the placement of the ditch covers. The Smart Ditch covers were removed and placed aside while the trench is being reworked.

Smart Ditch Construction
