From: John Power <jpower@pascocountyfl.net>
Sent: Monday, February 23, 2015 9:04 AM
To: Betancourt, Amaury
Cc: Ronald J. Walker; Michael A. Frestick
Subject: FW: pictures
Attachments: 100_0792[1].JPG; 100_0791[1].JPG; 100_0790[1].JPG; 100_0789[1].JPG; 100_0788[1].JPG; 100_0780[1].JPG; 100_0779[1].JPG; 100_0778[1].JPG; 100_0777[1].JPG; 100_0776[1].JPG

Amaury, attached are pictures that show where the deficiencies indicated in your recent site inspection report have been addressed as they relate to the Landfill Operations.

Subject: Followup from 01/23/2015 Air & Solid Waste inspection at Pasco County Resource Recovery Facility

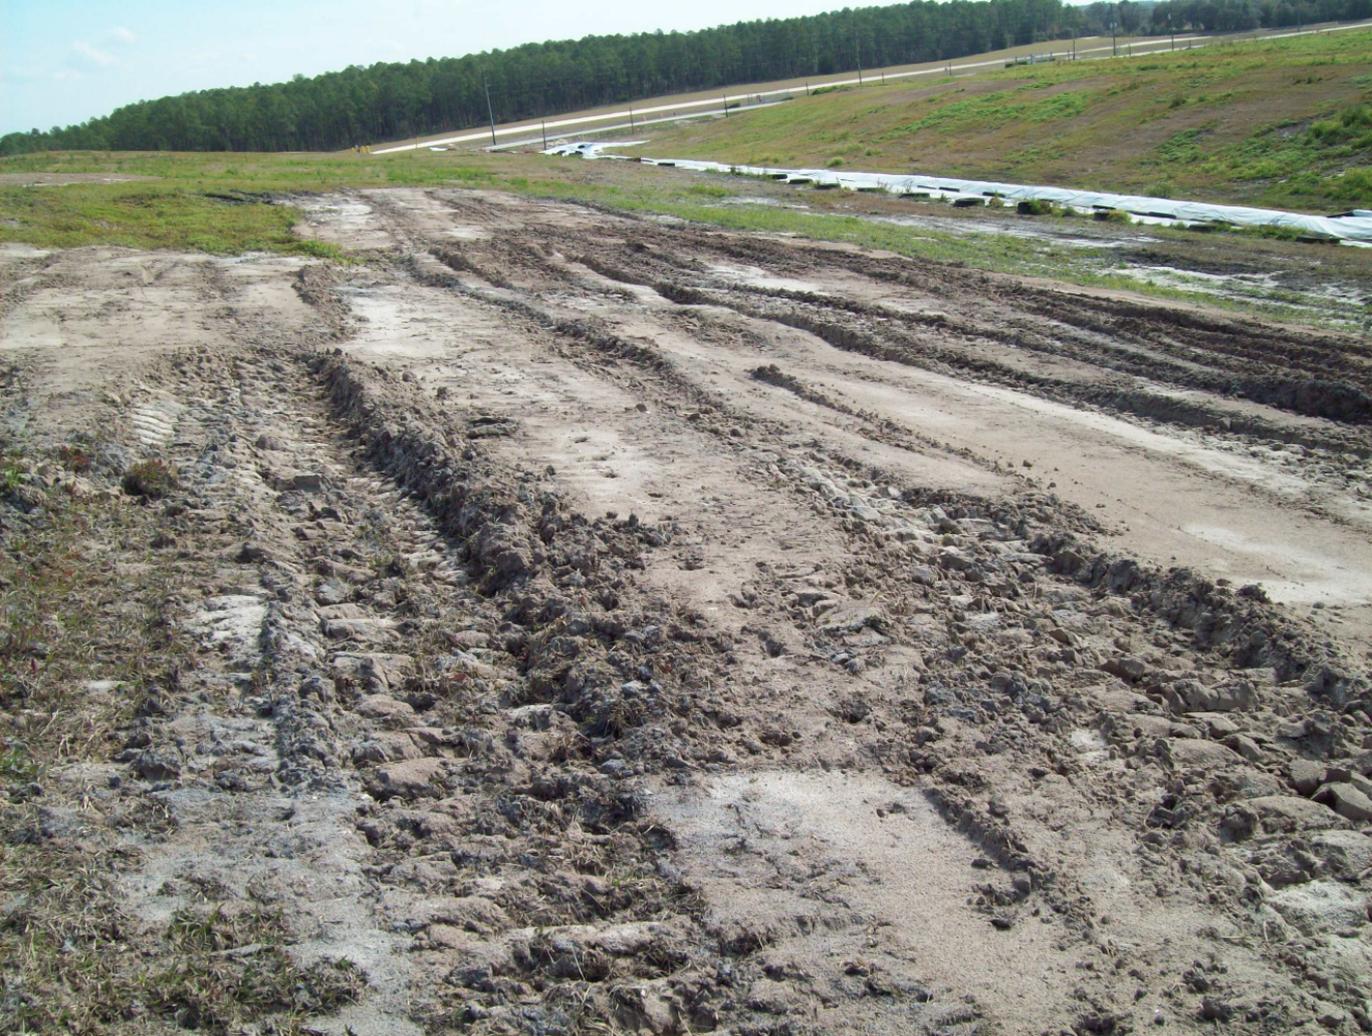
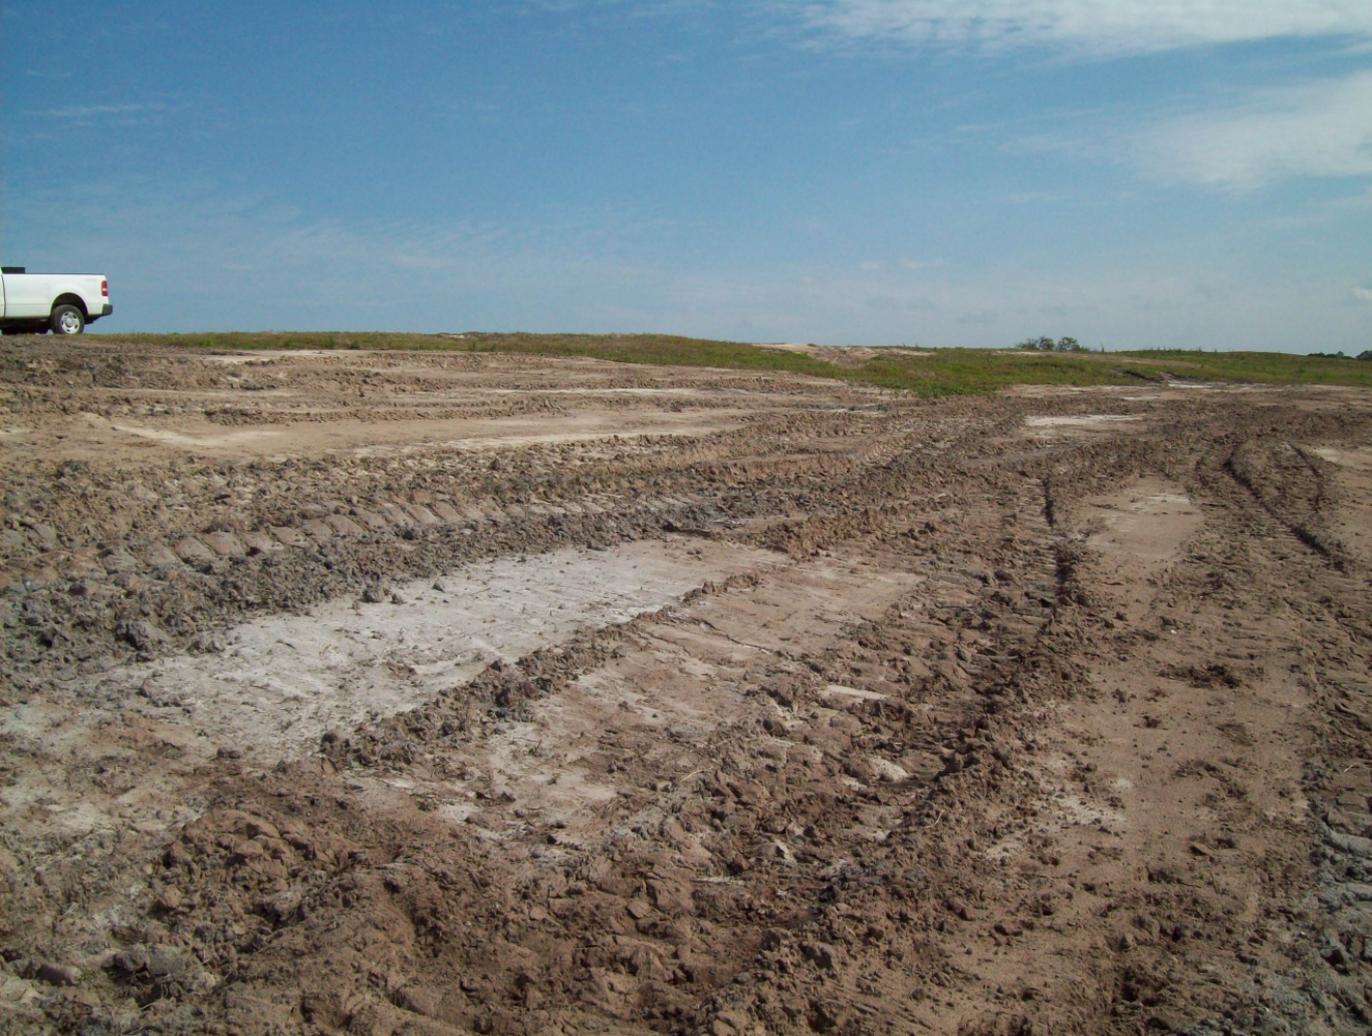
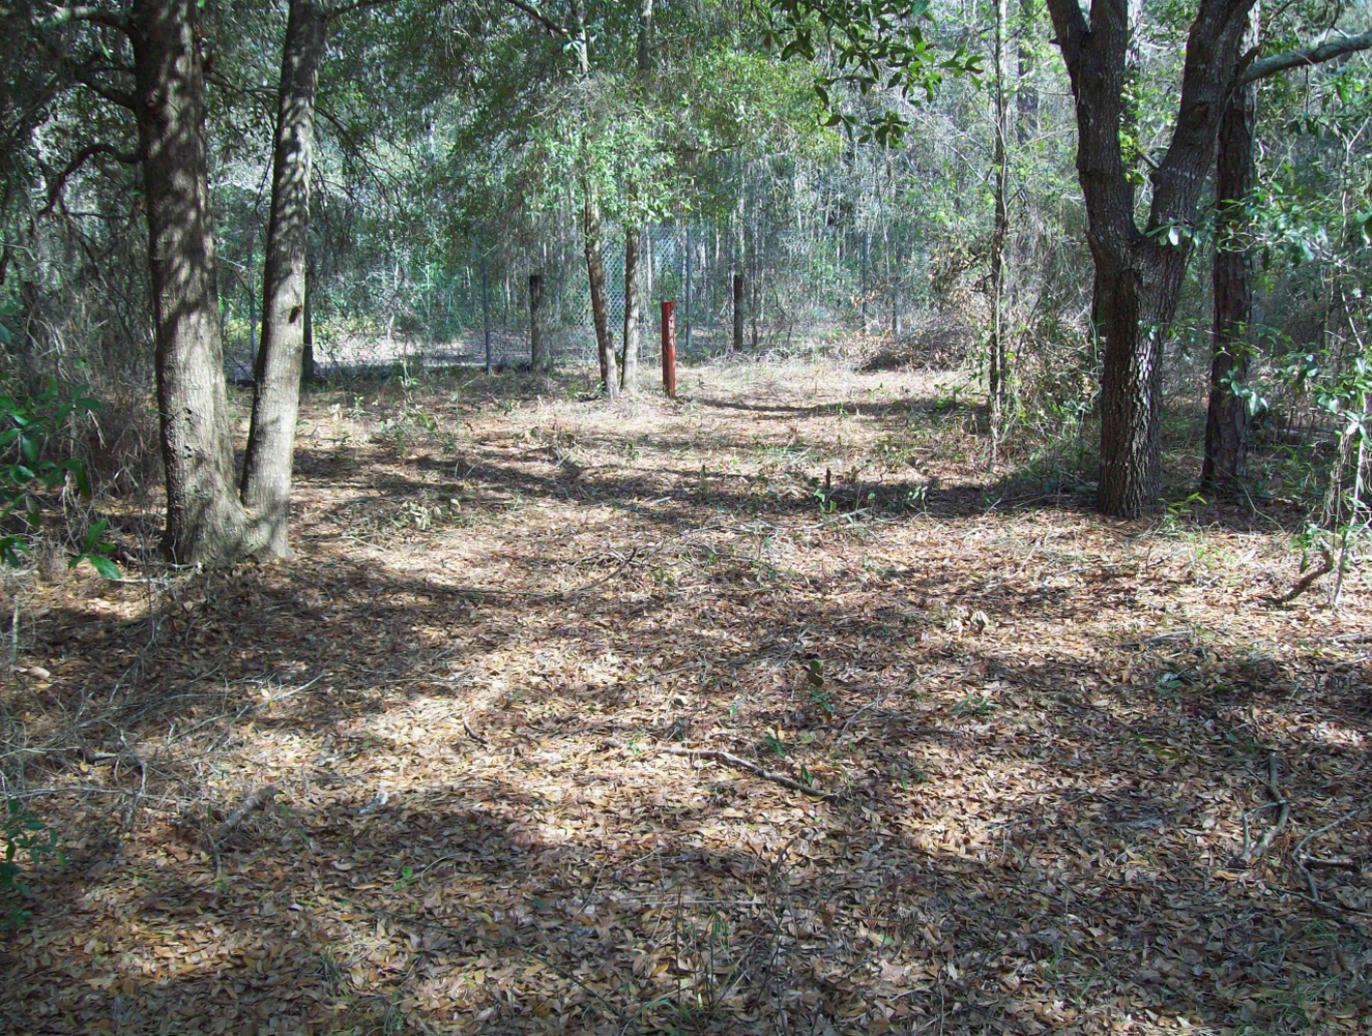
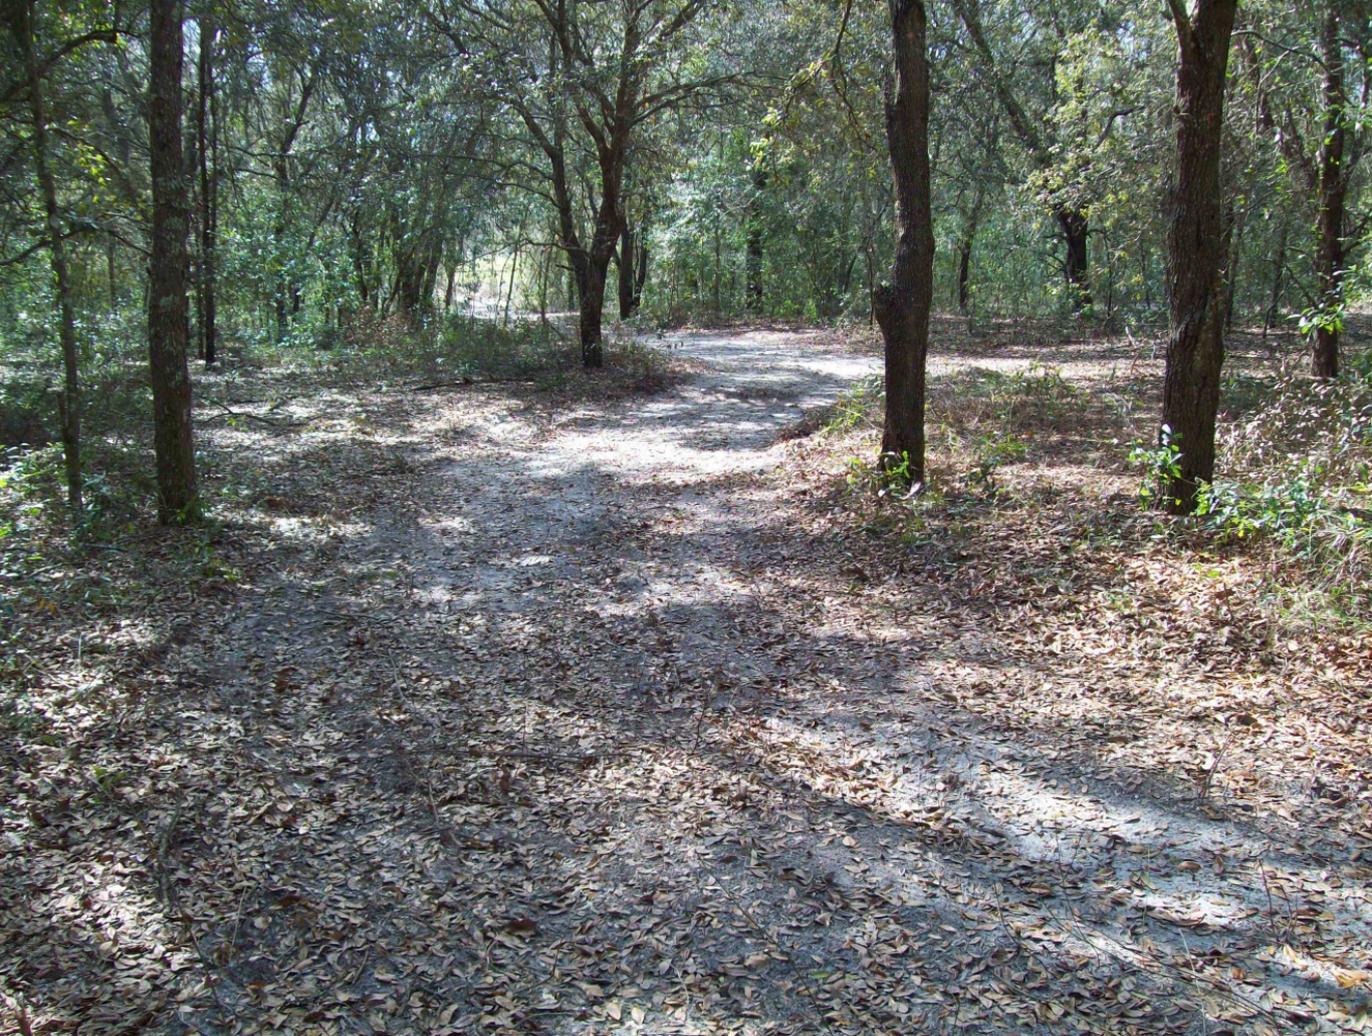
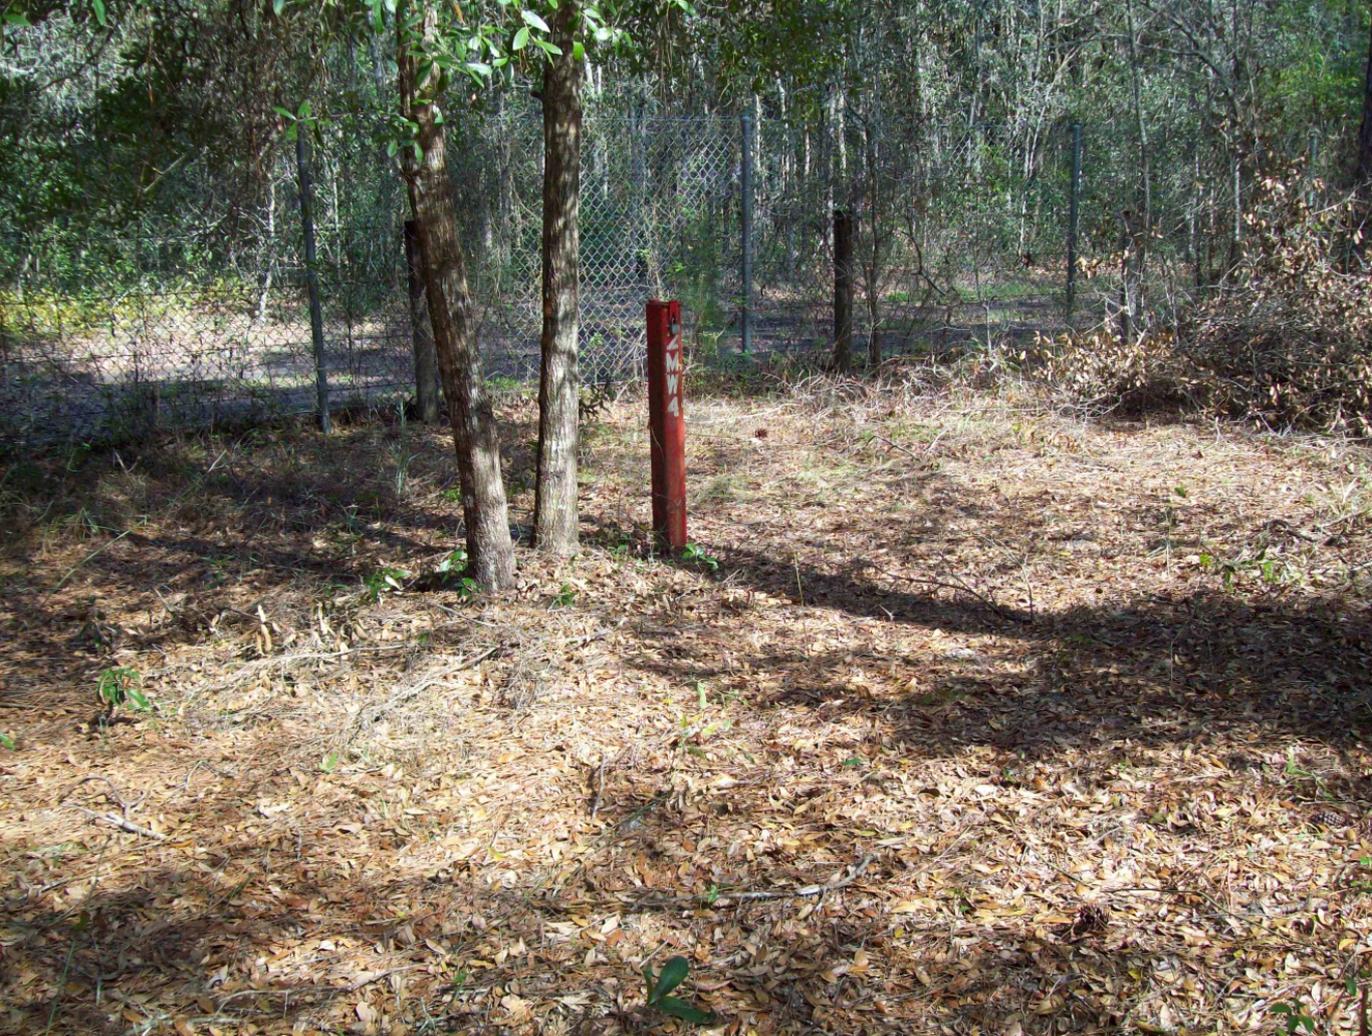
John
788 to 792 area between sw1 and sw2 where vegetation was removed,, 778 to 780 is cleared area to well on north fence,,776 and 777 is sw1 covered low area and flagging all covered and fixed,,

- (5.) The stormwater drain between SW Cells 1 and 2 had significant vegetation, blocking flow. See attached photograph. What is your timetable for clearing this out to restore flow? **The cleaning of the vegetation has been completed.**
- (6.) Exposed waste was noted on SW Cells 1 and 2. Mike explained that there are hogs that come out and root out waste; however, some of the waste appeared to have tracks from heavy machinery. See attached photographs. Can you send photos of the tops of both SW cells, as well as the South and East faces of SW Cell 1, and the North and East faces of SW Cell 2? Please also verify that all exposed waste on both cells has been appropriately covered. **It is apparent that the flagging was due to the tracking of the dozier and this was addressed the following day of the inspection.**
