Re: Tomoka Farms Road Landfill
SW Facility ID #27540
Volusia County

Florida Department of
Environmental Protection
Inspection Checklist

Facility Name: TOMOKA FARMS ROAD LANDFILL

On-Site Inspection Start Date: 06/04/2015

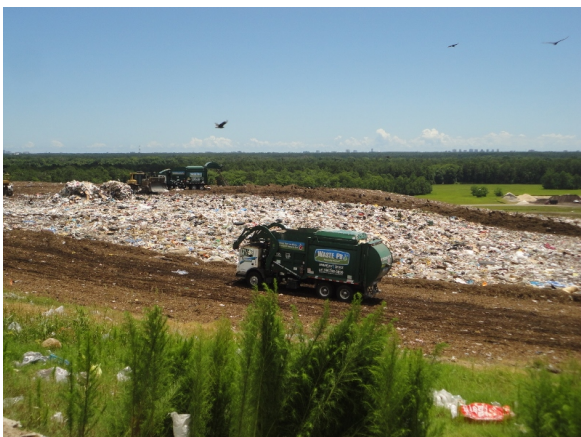
Disposal is located on the south side of Area 2 (North Cell, Phase II). Area 2 is approaching the elevation of the adjacent sections of the North cell. Jennifer Stirk said that approximately 20 feet of airspace remains until Area 2 is completed. Disposal will then shift to Area 3, currently under construction. At the time of inspection, new liner installation was near completion for this area.

Class I working face

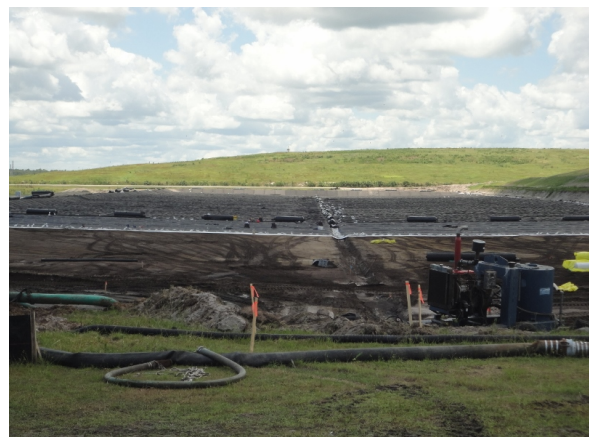
Area 3 (12.2 acres) is authorized by Permit Modification No.: 0078767-036-SO-MM.

Area 3 Liner installation

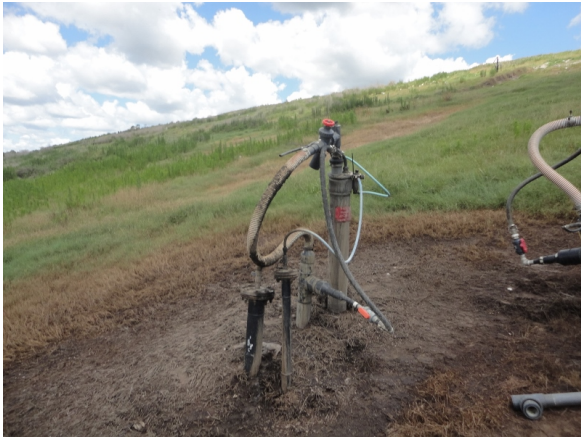
Leachate seepage was observed on the south side slopes in the area of horizontal gas collector 1B. Jennifer Stirk said that the collector lines in the area need to be dewatered periodically. She said that horizontal collector 1B will be pumped out and the seepage area will be covered. The seepage appeared to be contained and not running down the side slope at the time of inspection. On 6/15/2015, Jennifer Stirk submitted pictures to the Department showing that seepage has ceased and the seepage area has been covered and vegetated.

Horizontal Collector 1B

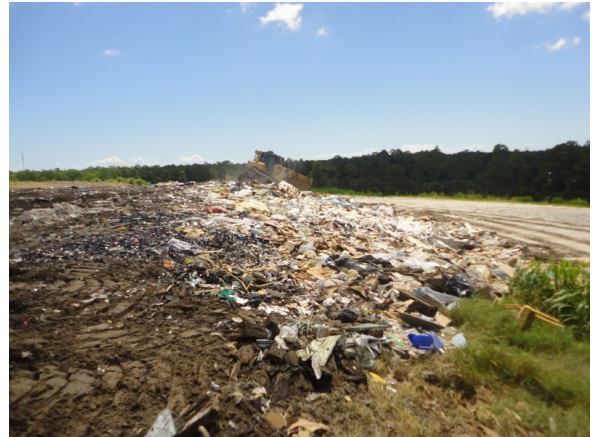
The class III working face is located on the upper side slope of the east side of the cell. The previous working face area was on the upper west side slope and had yet to be covered. Jennifer Stirk said the working face had just been moved the day prior to the inspection. Photographs of the covered area were submitted to the Department on 6/15/2015.

Class III Working Face
