Re: Citrus County Central Landfill - Permit No. 21375-018-SO/01

Leachate Storage Tank Inspections WACS I.D. # 39859 - Electronic Submittal

Citrus County, Florida Leachate Storage Tank(s) Inspection Report

Citrus County Central Landfill

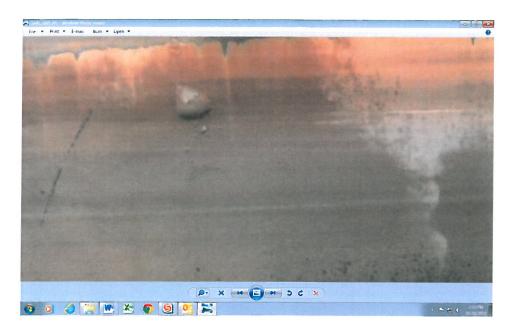
Figure 3 documents a sample of the interior wall with intact air bubble.

The Leachate storage tanks consists of two 125,000 gallon each cast-in-place concrete tanks constructed in 1996. During the county inspection of 2012 a series of bubbles was visibility noted on the interior of the leachate storage tanks.

A follow up inspection was completed by Tnemec products sales representative, Bill Langer with Florida Protective Coatings and he stated that the bubbles appearing in the epoxy material did not appear to compromise the integrity of the lining, but may require repair by patching areas in the future.

Interior: The bubbles on the walls as well as the floors were observed in both tanks and though there appears to be no significant change from the last inspection, the County intends on proceeding with either patching or completely removing and installing a new liner in both tanks. It is anticipated that the repairs / replacement of the liner will be completed by the spring of 2016 (weather permitting) and a follow up report will be submitted.

The Tnemec products sales representative, Bill Langer with Florida Protective Coatings has been contacted to make a further inspection of the current condition and provide recommendations.
