**Florida Department of
Environmental Protection
Inspection Checklist**

Facility Name: SOUTHEAST COUNTY SLF (PICNIC LF)

On-Site Inspection Start Date: 08/16/2017

Routine Operation Inspection for Landfill - Class I

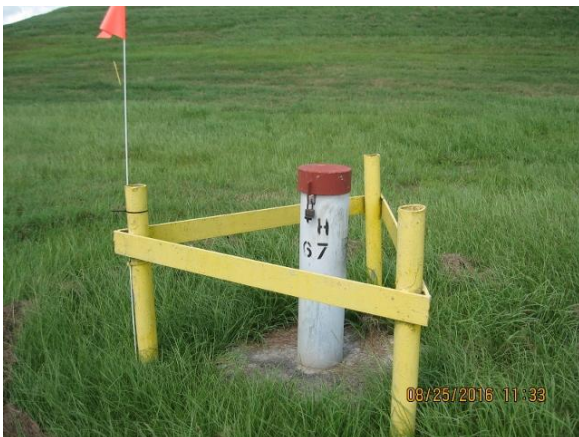
Explanation: As a result of the findings of the 1st Semi-Annual 2016 Water Quality Monitoring Report and subsequent confirmation sampling results, exceedances of groundwater standards were confirmed at TH-67. This well is located near the southeast corner of Phase II, extends to the surficial aquifer, and has been designated as a detection well. The parameters of interest are pH, total dissolved solids (TDS), chloride, and sodium.

Update for 2017 Inspection: The County continues to assess water quality impacts in the area surrounding TH-67. The County has installed additional monitoring locations (TH-79, 80, 81 and 82) and is conducting supplemental quarterly sampling at these plus existing locations to monitor impacts associated with elevated leachate levels within the Phases I-VI landfill in accordance with Paragraph 9.g of Consent Agreement OGC No. 17-0058. The most recent supplement event, sampled May 2017 indicates exceedances of a primary drinking water standard, Sodium at TH-67, TH-79, and TH-81, and of secondary drinking water standards, TDS and Chloride, at TH-67, TH-79, TH-81 and TDS at TH-80. TH-67 and TH-79 are detection wells located ~50 feet from the edge of waste. TH-80 and TH-81 are located at the edge of the zone of discharge (100' ZOD) for Phase I-VI.

Corrective Action: The County shall initiate evaluation monitoring in accordance with Rule 62-701.500(6)(a), F.A.C. at monitoring wells TH-67, TH-79, TH-80, and TH-81 upon receipt of this letter in addition to the requirements of Paragraph 10 of the Consent Agreement OGC No. 17-0058. Additionally, since contaminants which exceed Department water quality standards have been verified at the zone of discharge, the County shall also initiate corrective actions in accordance with Rule 62-701.500(6)(c), F.A.C. at affected locations.

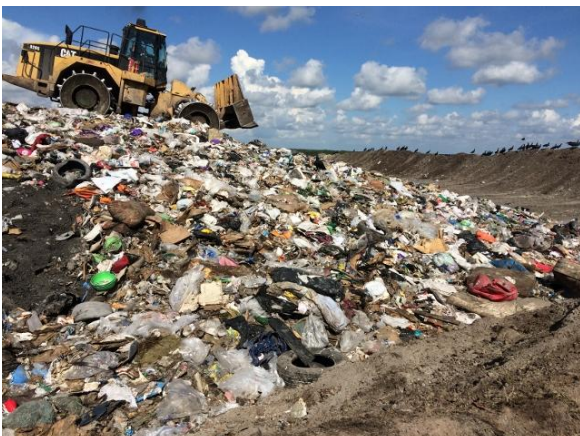
Working Face (Phase 3)

Item 2.6 - At least three whole waste tires were observed in the working face. The operator indicated that they likely came in with ash and would be removed.

Item 2.13 - The facility was filling in Phase IV, Lift 16A at time of inspection. A recent permit modification was issued to address a sequence of fill modification to avoid filling in Phase II (leachate accumulation) and potentially encourage settlement of LCS to restore flow from Phases I,II, III area to PPS-B.

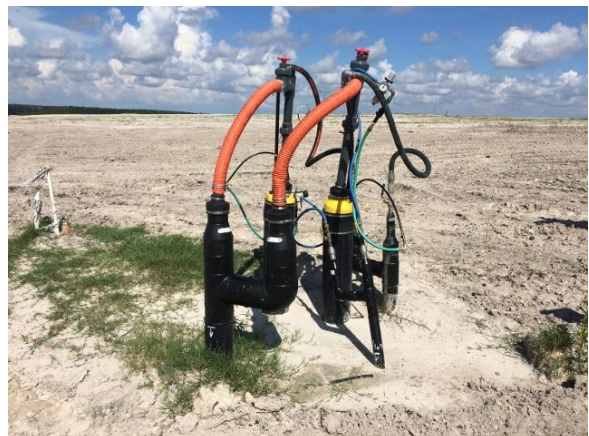
Phase 2 Leachate Extraction Pump

Item 2.22 - The Department and County recently executed a Consent Agreement (OGC No. 17-0058) to address elevated leachate levels in Phases I-VI and potential discharges from the system. The Department is in receipt of a Corrective Action Plan in accordance with Paragraph 9. Additional information to follow under separate cover.

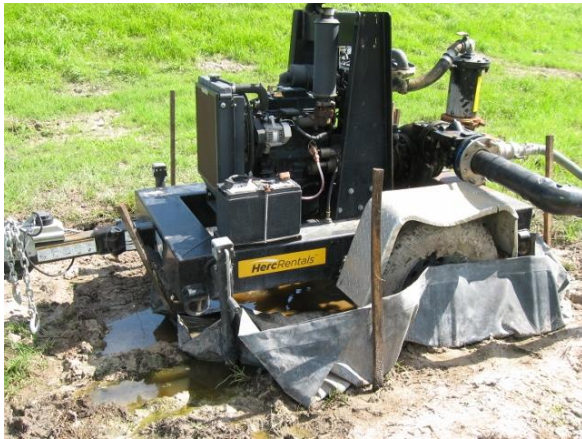
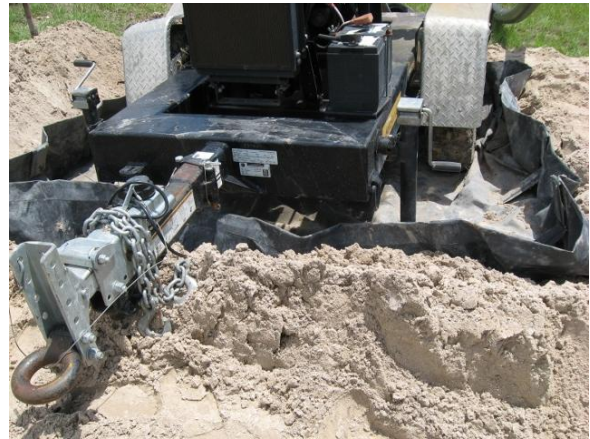
Phase 2 South Temp Pump (Before)

Item 2.28 - During the inspection, the temporary leachate pump located on the south side of Phase 2, TPS-2B, appeared to be discharging from an air release valve. A majority of the leachate was contained on top of a collapsing temporary containment liner on which the pump was located, however there appeared to be a small amount of leachate discharging onto the ground within the limits of the landfill. This discharge was cleaned up and a berm was erected around the pump during the time of the inspection. In addition, the temporary leachate pump located on the east side of Phase 2, PS-2, was observed to be discharging leachate onto the ground and into the adjacent stormwater ditch due to a leaky pipe fitting. Documentation that this discharge was cleaned up, the connection repaired, and a berm erected around the pump was provided to the Department prior to the end of the inspection day. The County indicated that new containment liners would be purchased with a plan to formalize containment structures if the locations are deemed permanent.

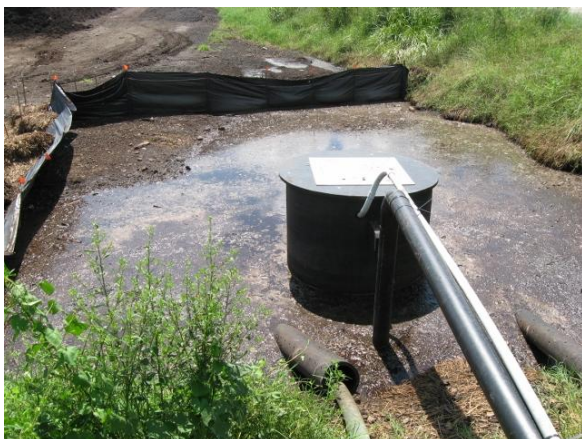
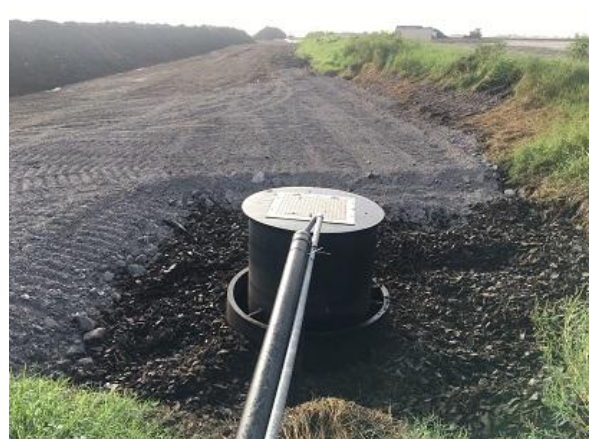
Compost Sump (Before)

During the inspection, the leachate sump for the compost pad on top of Sections 7, 8, and 9 was observed to have been clogged and ponded leachate was observed. This sump was cleaned on 8/23/17 and photos of the cleared sump were submitted to the Department. Leachate from the compost sump is also pumped from this sump and discharged into the Section 9 leachate forcemain for conveyance to the leachate treatment plant. This pump was not connected at the time of the inspection due to clogging of the intake. Specific Condition C.14 of Permit and the current Composting O&M Manual does not contemplate this method of leachate removal. Please work with Tallahassee permitting staff to ensure the current configuration for leachate management associated with the composting operation is authorized.
