Re: Requirement to Comply with Chapter 62-780, Florida Administrative Code &
Consent Agreement OGC No. 17-0058 Corrective Action Plan Comments
Hillsborough Southeast County Landfill
Facility ID No. 41193
Hillsborough County

**Florida Department of
Environmental Protection
Inspection Checklist**

Facility Name: SOUTHEAST COUNTY SLF (PICNIC LF)

On-Site Inspection Start Date: 08/16/2017

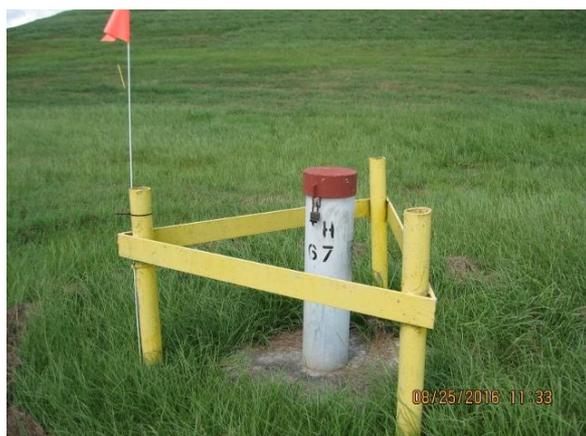
Explanation: As a result of the findings of the 1st Semi-Annual 2016 Water Quality Monitoring Report and subsequent confirmation sampling results, exceedances of groundwater standards were confirmed at TH-67. This well is located near the southeast corner of Phase II, extends to the surficial aquifer, and has been designated as a detection well. The parameters of interest are pH, total dissolved solids (TDS), chloride, and sodium.

Update for 2017 Inspection: The County continues to assess water quality impacts in the area surrounding TH-67. The County has installed additional monitoring locations (TH-79, 80, 81 and 82) and is conducting supplemental quarterly sampling at these plus existing locations to monitor impacts associated with elevated leachate levels within the Phases I-VI landfill in accordance with Paragraph 9.g of Consent Agreement OGC No. 17-0058. The most recent supplement event, sampled May 2017 indicates exceedances of a primary drinking water standard, Sodium at TH-67, TH-79, and TH-81, and of secondary drinking water standards, TDS and Chloride, at TH-67, TH-79, TH-81 and TDS at TH-80. TH-67 and TH-79 are detection wells located ~50 feet from the edge of waste. TH-80 and TH-81 are located at the edge of the zone of discharge (100' ZOD) for Phase I-VI.

Corrective Action: The County shall initiate evaluation monitoring in accordance with Rule 62-701.500(6)(a), F.A.C. at monitoring wells TH-67, TH-79, TH-80, and TH-81 upon receipt of this letter in addition to the requirements of Paragraph 10 of the Consent Agreement OGC No. 17-0058. Additionally, since contaminants which exceed Department water quality standards have been verified at the zone of discharge, the County shall also initiate corrective actions in accordance with Rule 62-701.500(6)(c), F.A.C. at affected locations.

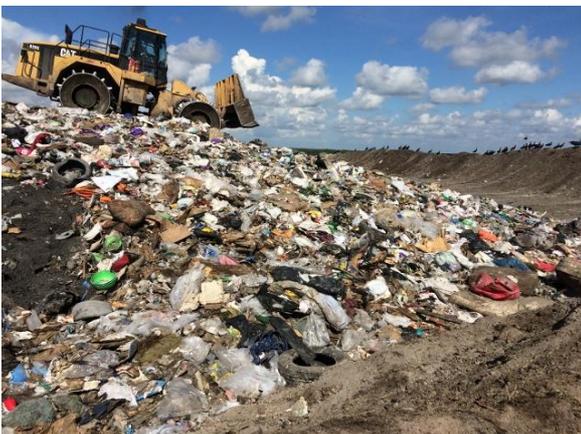
Working Face (Phase 3)

Item 2.6 - At least three whole waste tires were observed in the working face. The operator indicated that they likely came in with ash and would be removed.

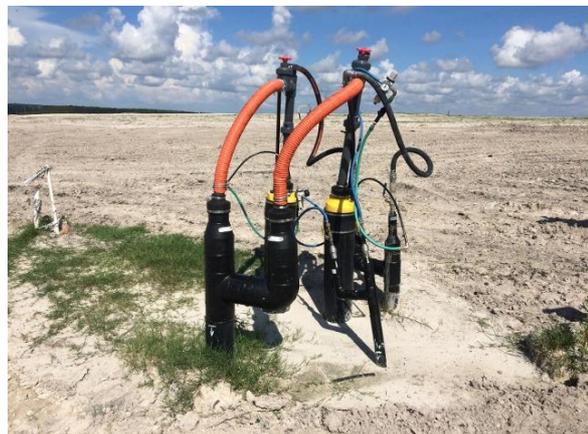
Phase 2 Leachate Extraction Pump

Item 2.22 - The Department and County recently executed a Consent Agreement (OGC No. 17-0058) to address elevated leachate levels in Phases I-VI and potential discharges from the system. The Department is in receipt of a Corrective Action Plan in accordance with Paragraph 9. Additional information to follow under separate cover.

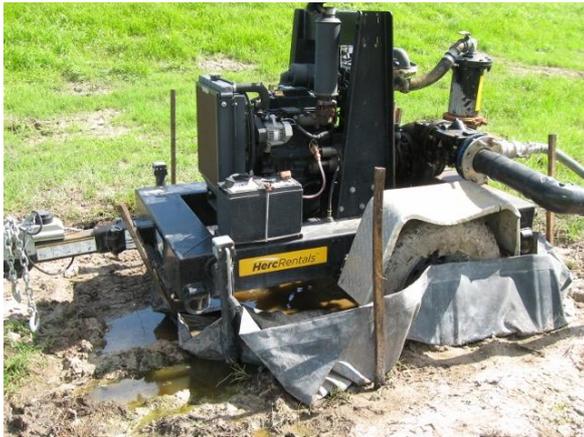
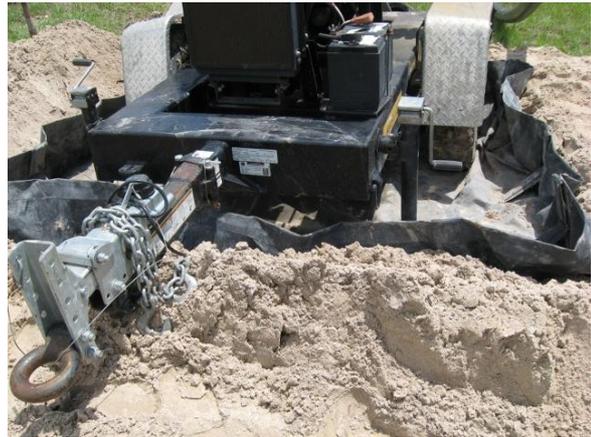
Phase 2 South Temp Pump (Before)

Item 2.28 - During the inspection, the temporary leachate pump located on the south side of Phase 2, TPS-2B, appeared to be discharging from an air release valve. A majority of the leachate was contained on top of a collapsing temporary containment liner on which the pump was located, however there appeared to be a small amount of leachate discharging onto the ground within the limits of the landfill. This discharge was cleaned up and a berm was erected around the pump during the time of the inspection. In addition, the temporary leachate pump located on the east side of Phase 2, PS-2, was observed to be discharging leachate onto the ground and into the adjacent stormwater ditch due to a leaky pipe fitting. Documentation that this discharge was cleaned up, the connection repaired, and a berm erected around the pump was provided to the Department prior to the end of the inspection day. The County indicated that new containment liners would be purchased with a plan to formalize containment structures if the locations are deemed permanent.

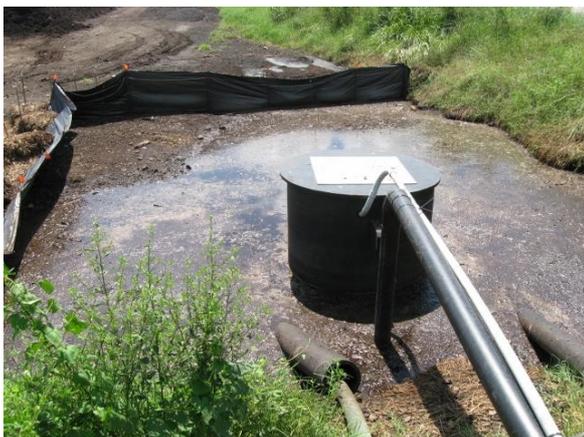
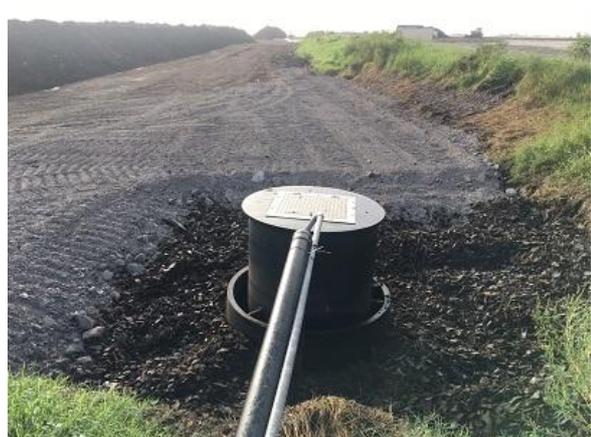
Compost Sump (Before)

During the inspection, the leachate sump for the compost pad on top of Sections 7, 8, and 9 was observed to have been clogged and ponded leachate was observed. This sump was cleaned on 8/23/17 and photos of the cleared sump were submitted to the Department. Leachate from the compost sump is also pumped from this sump and discharged into the Section 9 leachate forcemain for conveyance to the leachate treatment plant. This pump was not connected at the time of the inspection due to clogging of the intake. Specific Condition C.14 of Permit and the current Composting O&M Manual does not contemplate this method of leachate removal. Please work with Tallahassee permitting staff to ensure the current configuration for leachate management associated with the composting operation is authorized.
