**LIQUID ASSESSMENT MONITORING
MONTHLY PROGRESS REPORT
FOR FEBRUARY 2018**

**SOUTHEAST COUNTY LANDFILL
LITHIA, FLORIDA**

March 15, 2018
File No. 09215600.05

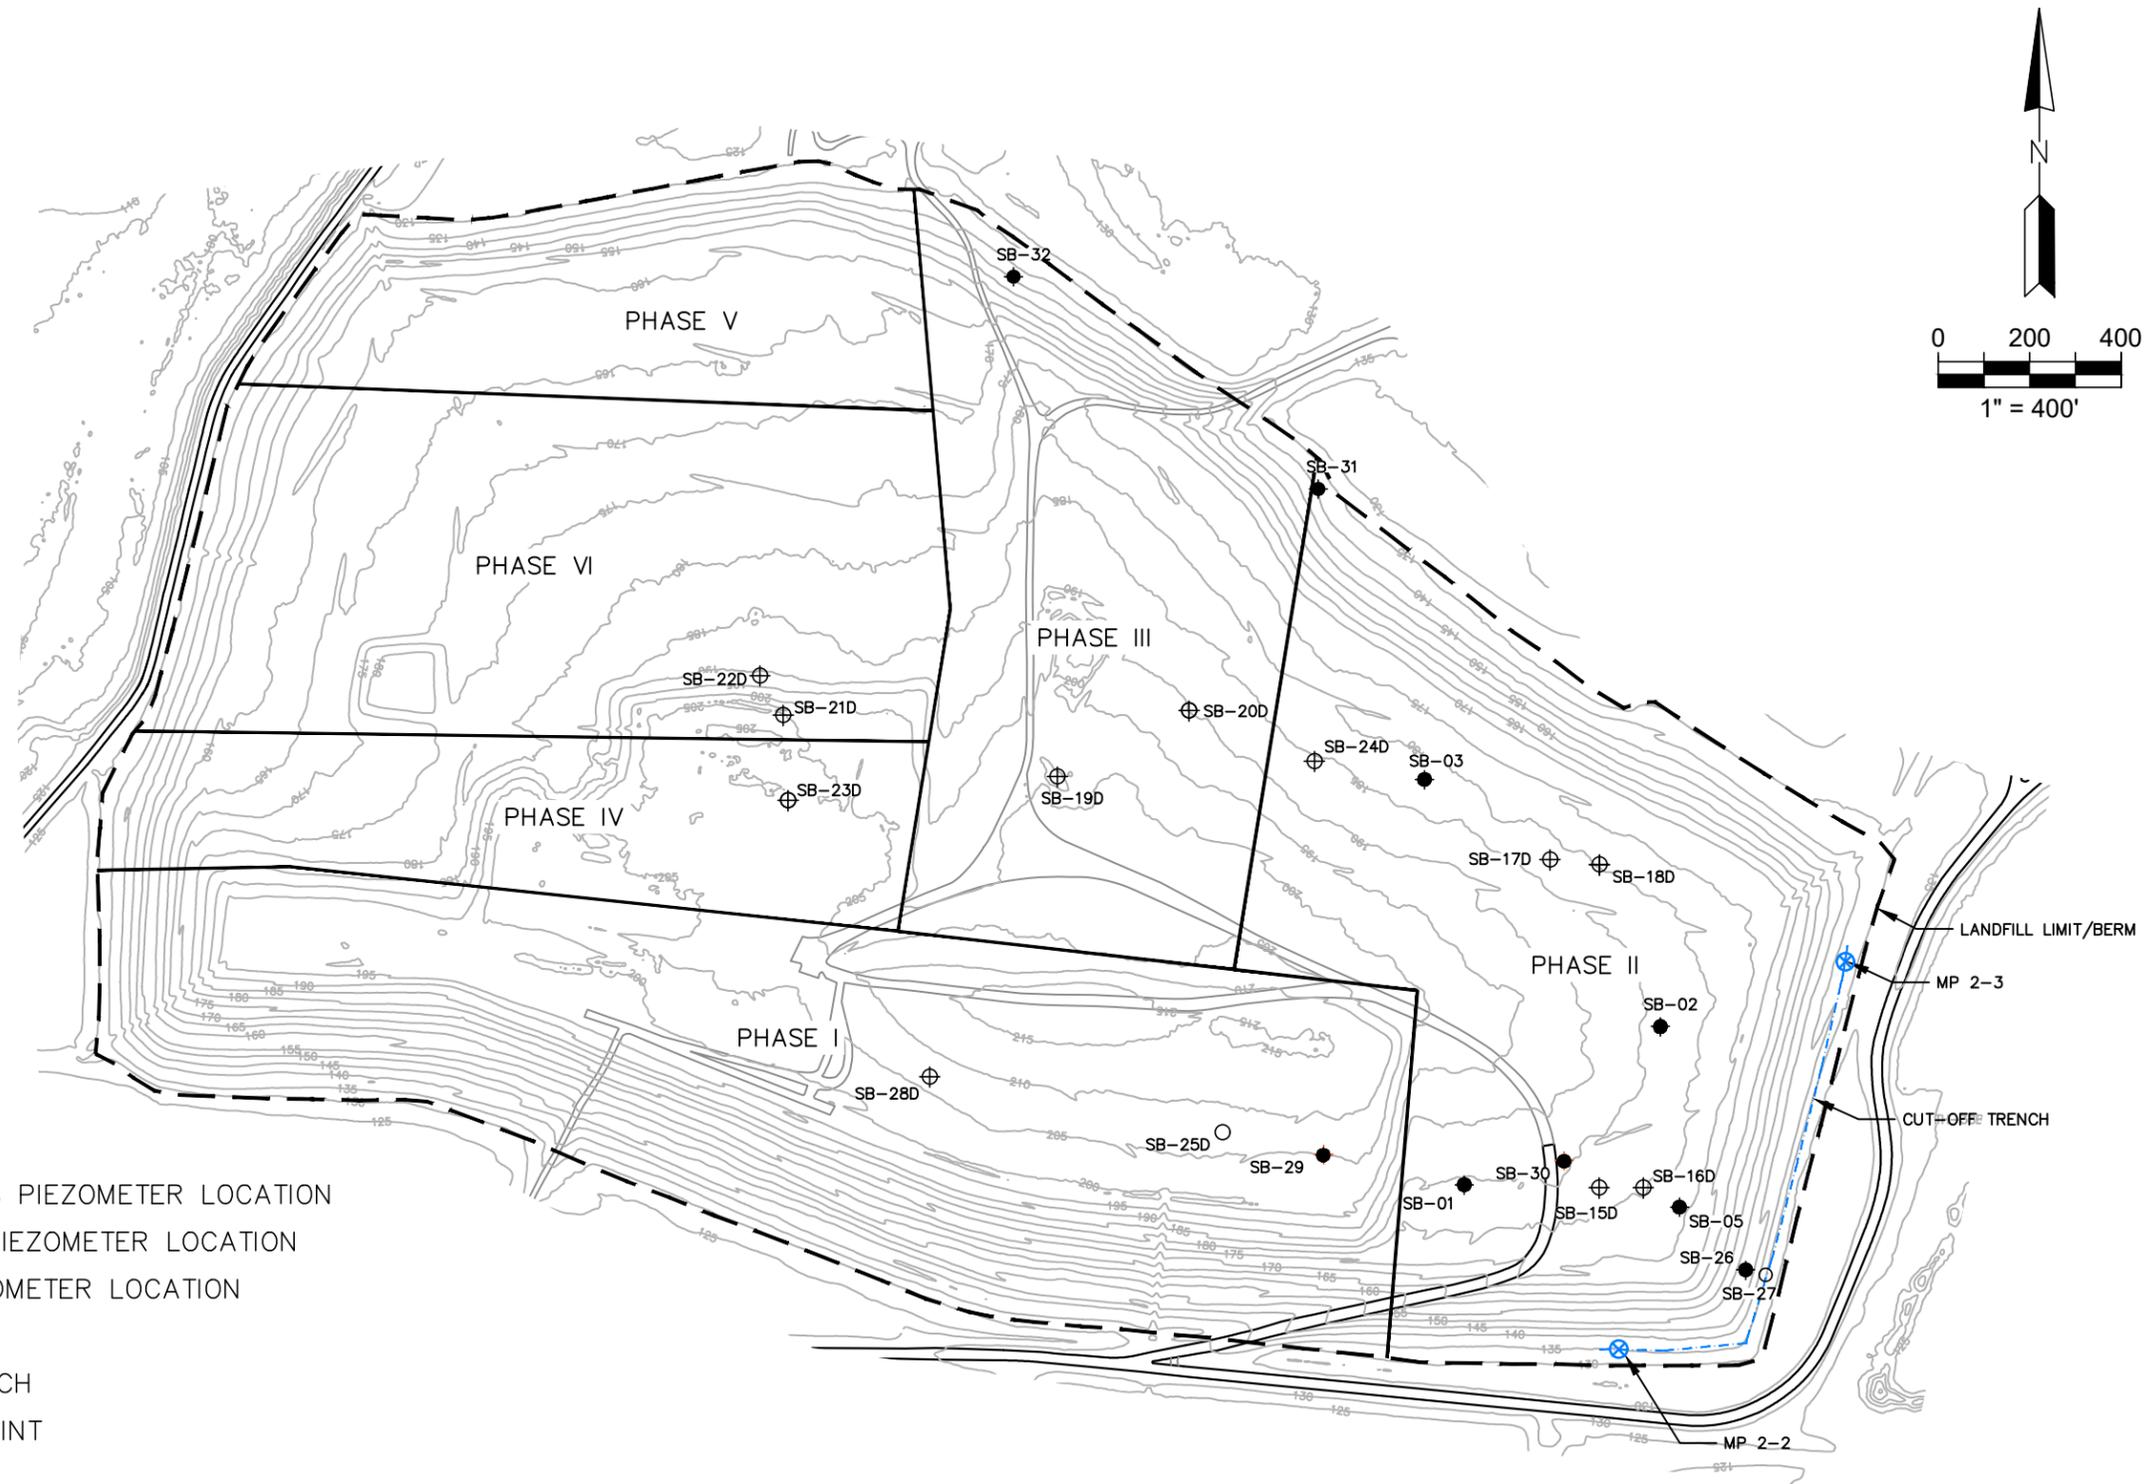
FIGURE 2. MAP OF PIEZOMETERS AND MONITORING POINTS
SOUTHEAST COUNTY LANDFILL
MARCH 2018

As part of the on-going investigation of liquid, the SWMD measures piezometer water levels once a week. Piezometers are differentiated by two construction types, Series-1 and Series-2. The Series-1 piezometers are screened in waste. They were originally intended to be temporary and do not prevent the downward migration of “perched liquids” intersected above the temporary piezometer screen (if any). Therefore, liquid levels in Series-1 piezometers may not be representative of true head over liner conditions at the SCLF. The Series-2 piezometers are screened in the drainage sand layer only. Installation of the Series-2 piezometers was completed to more accurately measure liquid levels. Locations of the current monitoring points are shown in **Figure 2**.

Monitoring and dewatering of the cut-off trench continues. The liquid levels in monitoring points MP 2-2 and MP 2-3 remained below 2 feet during February 2018. With the modifications to the cut-off trench completed in December 2017, the liquid elevations at MP 2-2 and MP 2-3 are approximately equal.
