**Florida Department of
Environmental Protection
Inspection Checklist**

Facility Name: VISTA LANDFILL, LLC (BUTTREY/KEENE RD SOUTH)
On-site Inspection Start Date: 11/19/2019
On-site Inspection End Date: 11/19/2019
WACS No.: 87081
Facility Street Address: 242 WEST KEENE RD
City: APOPKA
County Name: ORANGE
Zip: 32703

Routine Operation Inspection for Landfill - Class III

Routine Operation Inspection for WPF - Waste Tire Processing Facility

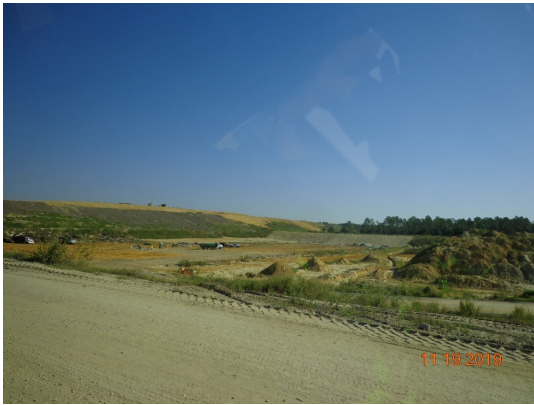
Cell 6 working face

Item 2.13 - Waste is currently being placed in Cell 6. Select waste is being used to fill the first lift of Cell 6 following construction of the Cell 6 liner. Metal and large pieces of wood are being removed from Cell 6 while filling with select waste.

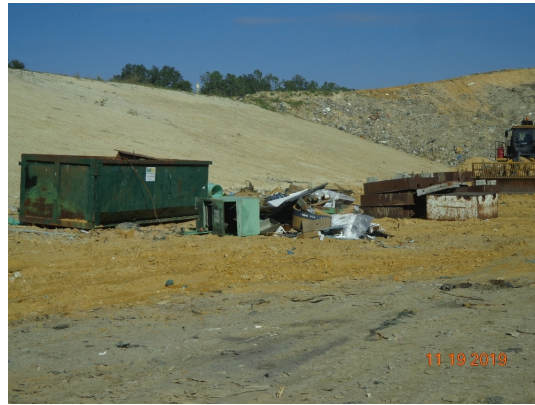
Removing metals for select waste
