**From:** Black, Alexis  
**Sent:** Friday, December 11, 2020 2:40 PM  
**To:** 'Henry C. Norris'; Madden, Melissa  
**Cc:** Randall S. Olney; Larry J. Brock; Joshua L. Younce  
**Subject:** RE: FDEP Inspection Response

**From:** Henry C. Norris <Henry.Norris@citrusbocc.com>  
**Sent:** Friday, December 11, 2020 1:30 PM  
**To:** Black, Alexis <Alexis.Black@FloridaDEP.gov>; Madden, Melissa <Melissa.Madden@FloridaDEP.gov>  
**Cc:** Randall S. Olney <Randall.Olney@citrusbocc.com>; Larry J. Brock <LARRY.BROCK@citrusbocc.com>; Joshua L. Younce <Joshua.Younce@citrusbocc.com>  
**Subject:** FW: FDEP Inspection Response

Good Afternoon, the attached document is in response to recent compliance inspection conducted on 12/4/2020. Most discrepancies have been corrected as shown in the pictures provided, we do ask for an additional week to address flagging in phase 3 and respond to finding, this request is due to mechanical problems associated with the landfill compactor and subsequent daily usage of bull dozer to manage working face? Let me know if you have any questions

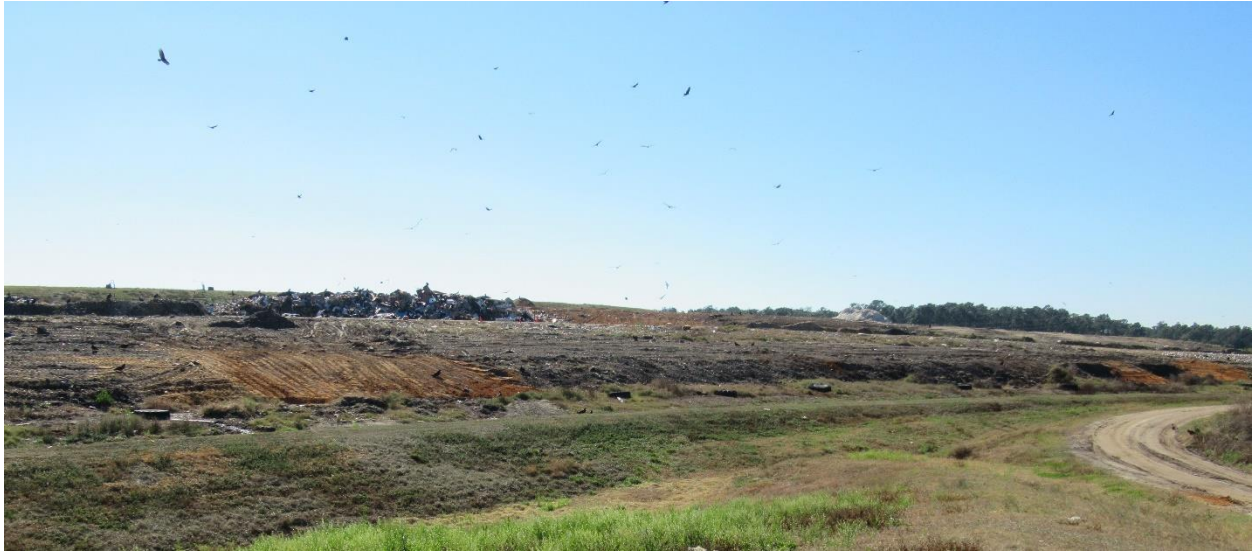
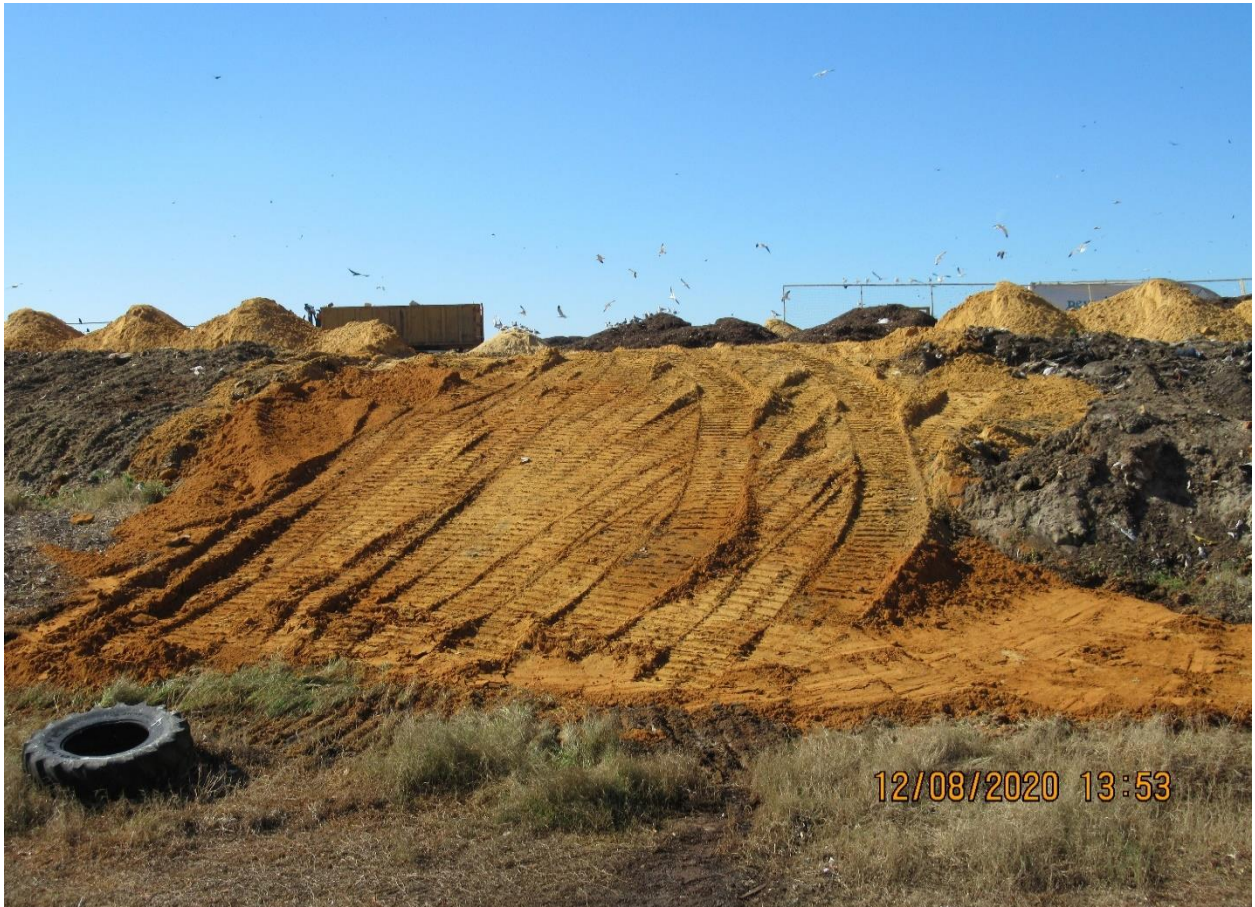
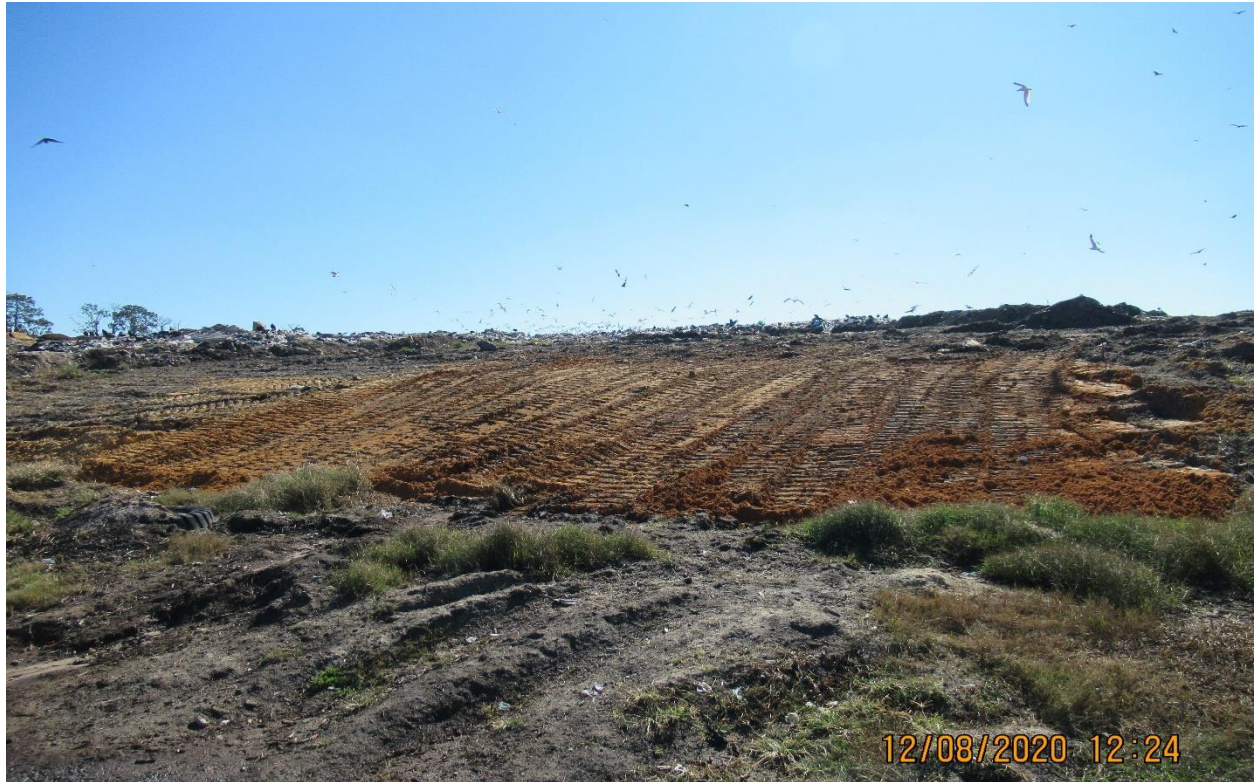
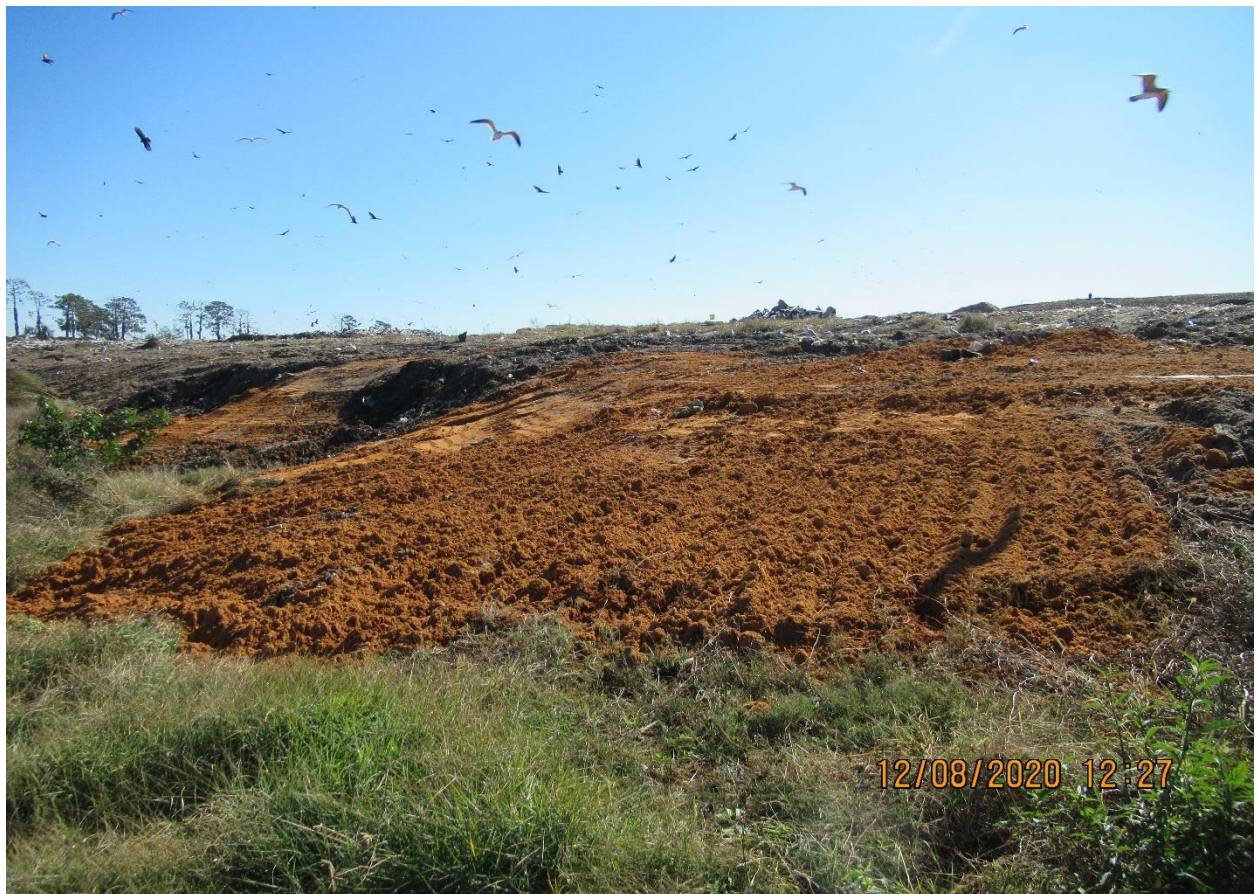
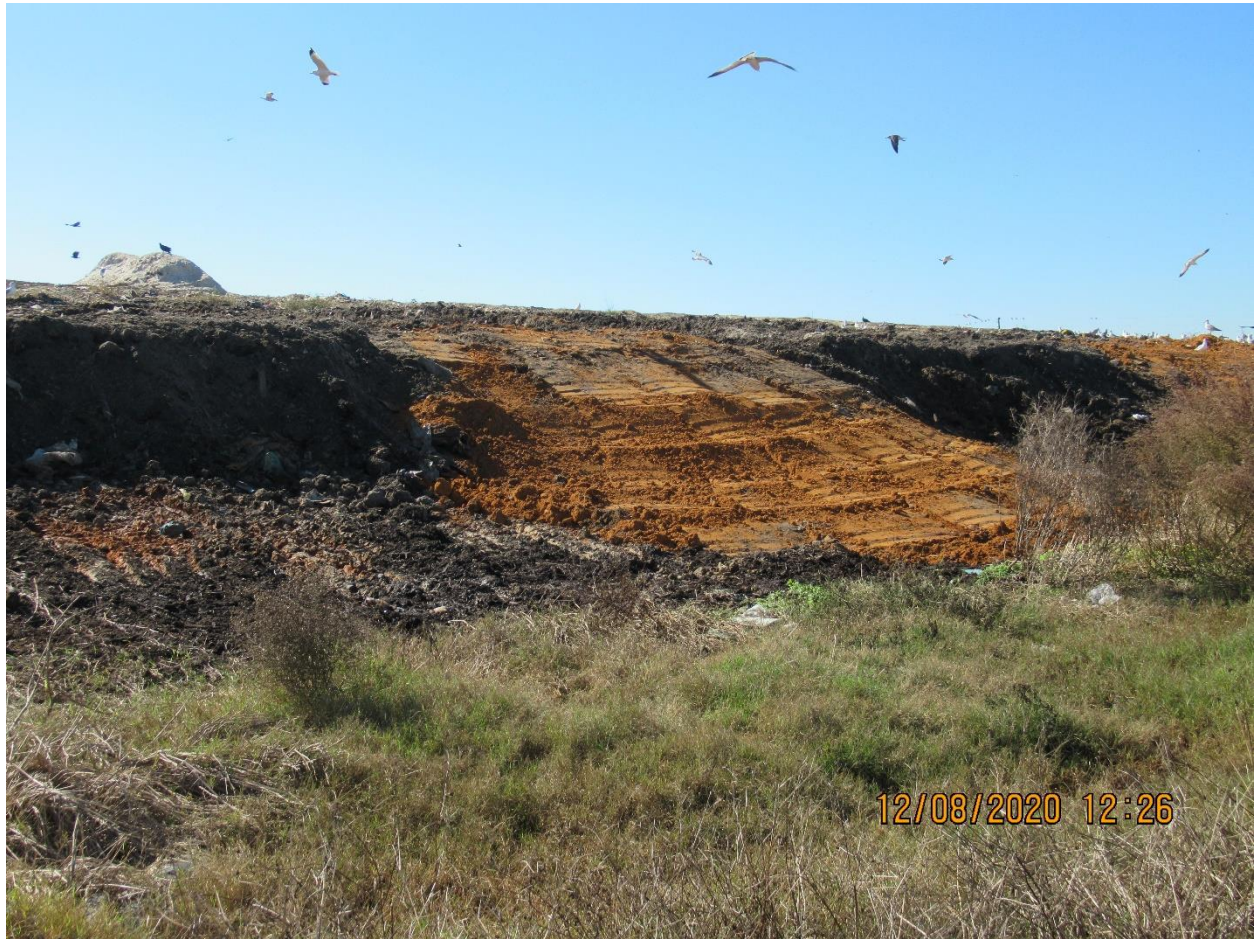
### Seeps (East, North-East North-West, West)

-Seep repairs have been completed on the all sides of Phase III. The landfill believes that the recent installation of laterals may have become a conduit that has been allowing water to pass through. We believe that this has in turn led to the increase in seep issues that we have constantly been repairing.

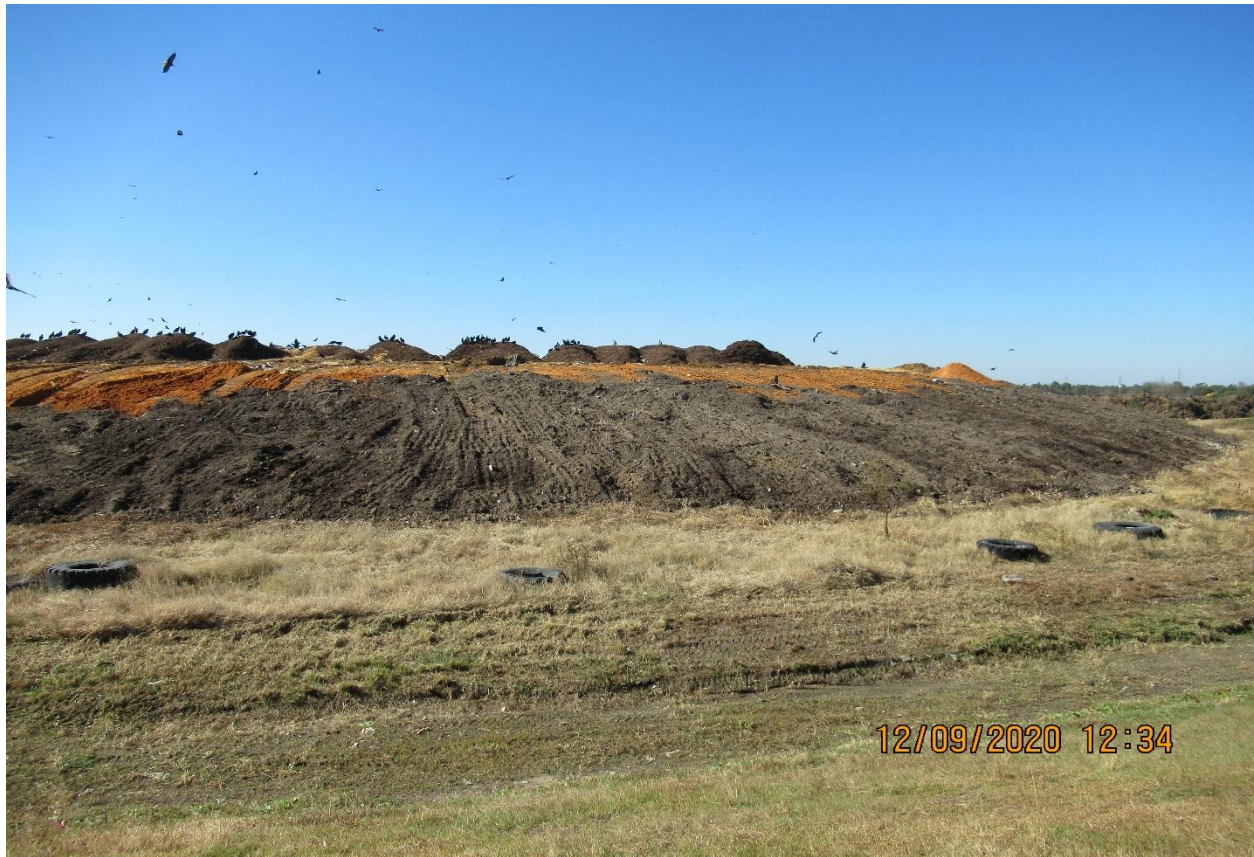
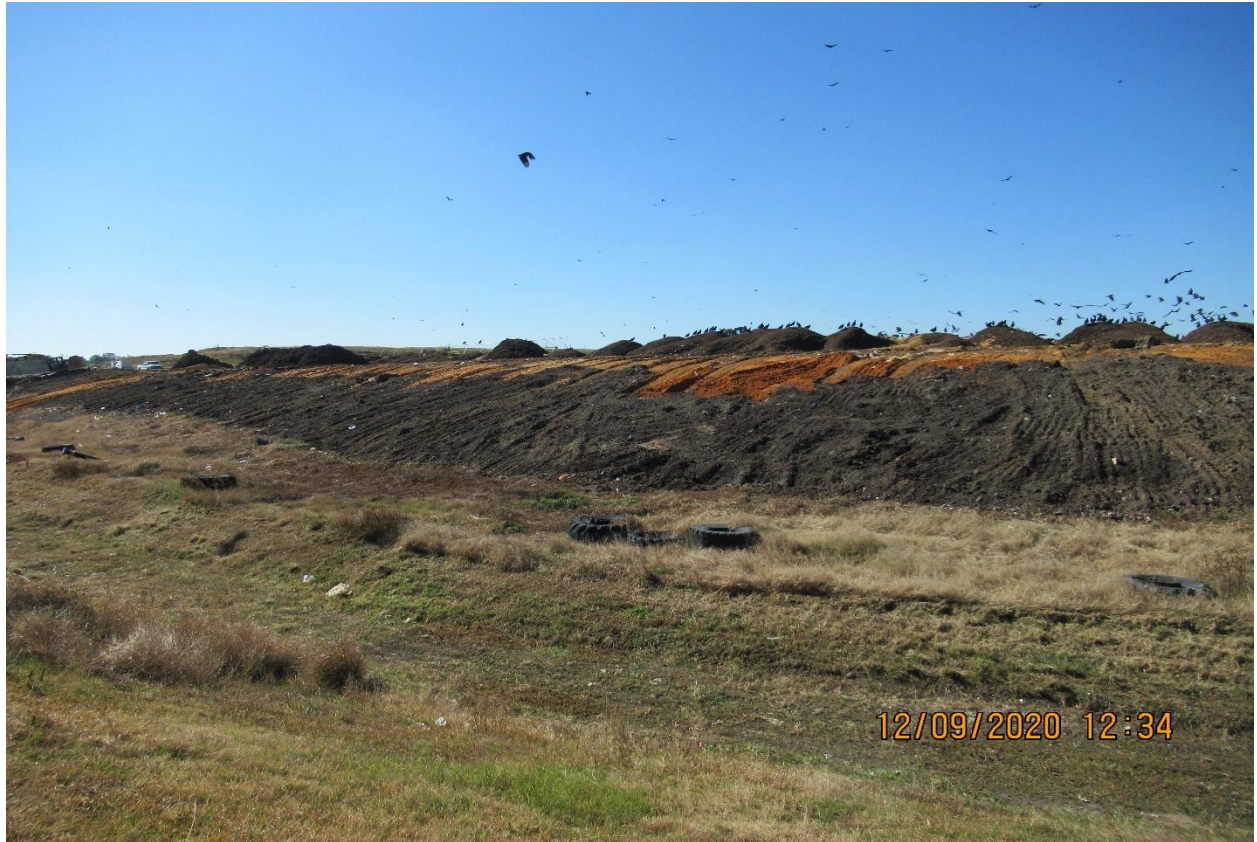
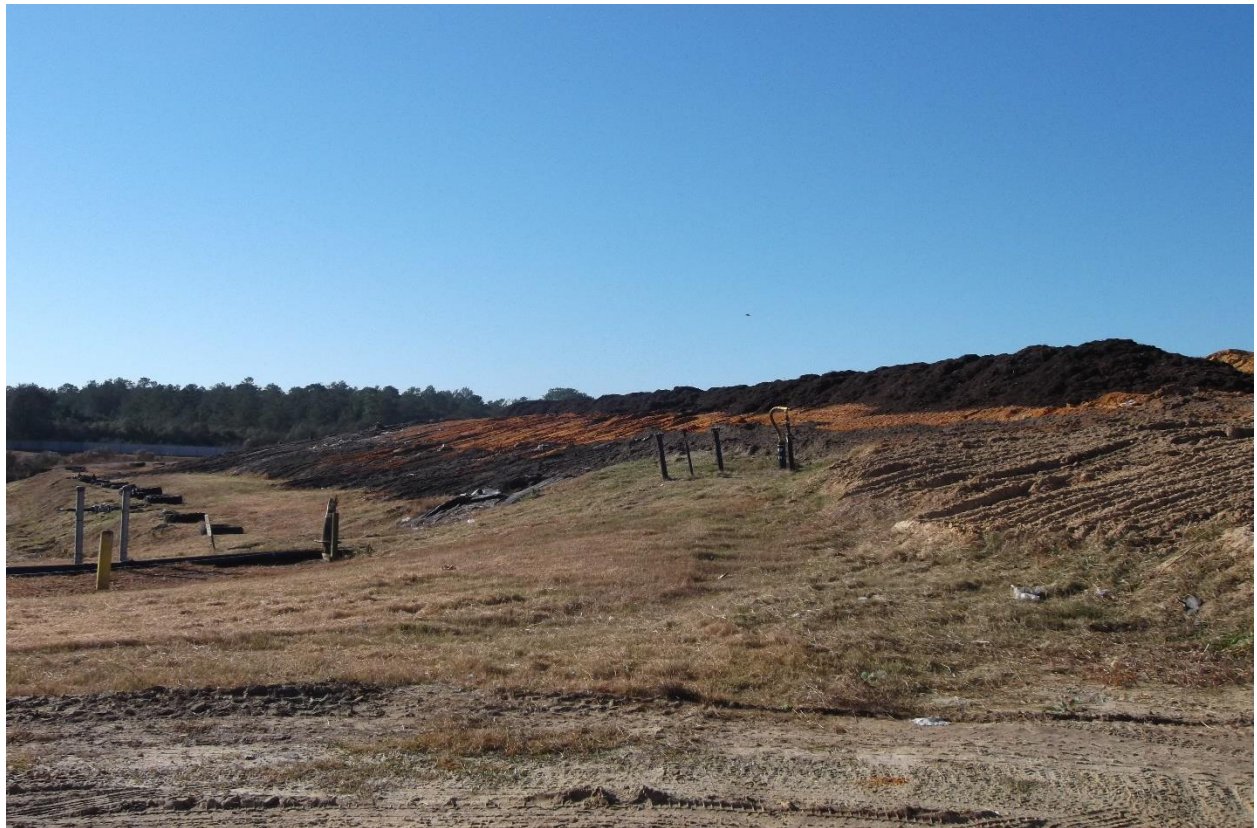
### South-East and North-East corners

-We are still currently working on remediation of the subject areas. Berms have been replaced and coverage is currently underway. Our landfill compactor has been down due to mechanical issues, Operations staff have been instructed that weekend compaction efforts will be required until all waste has been compacted properly. The landfill is currently working with the vendor to get the Compactor returned to service as soon as possible.

-Due to the mechanical issues that the landfill has been facing with our compactor, the Bulldozer has been constantly running in the cell and we have not had ample time to allow us to use it for other remediation purposes. We expect and hope that the compactor will be up and running once again on 12/11/2020. We would ask to request an additional week to finish resolving the flagging that has occurred on Phase III and to finish covering up any small remaining litter on the North-east and South-east corners.

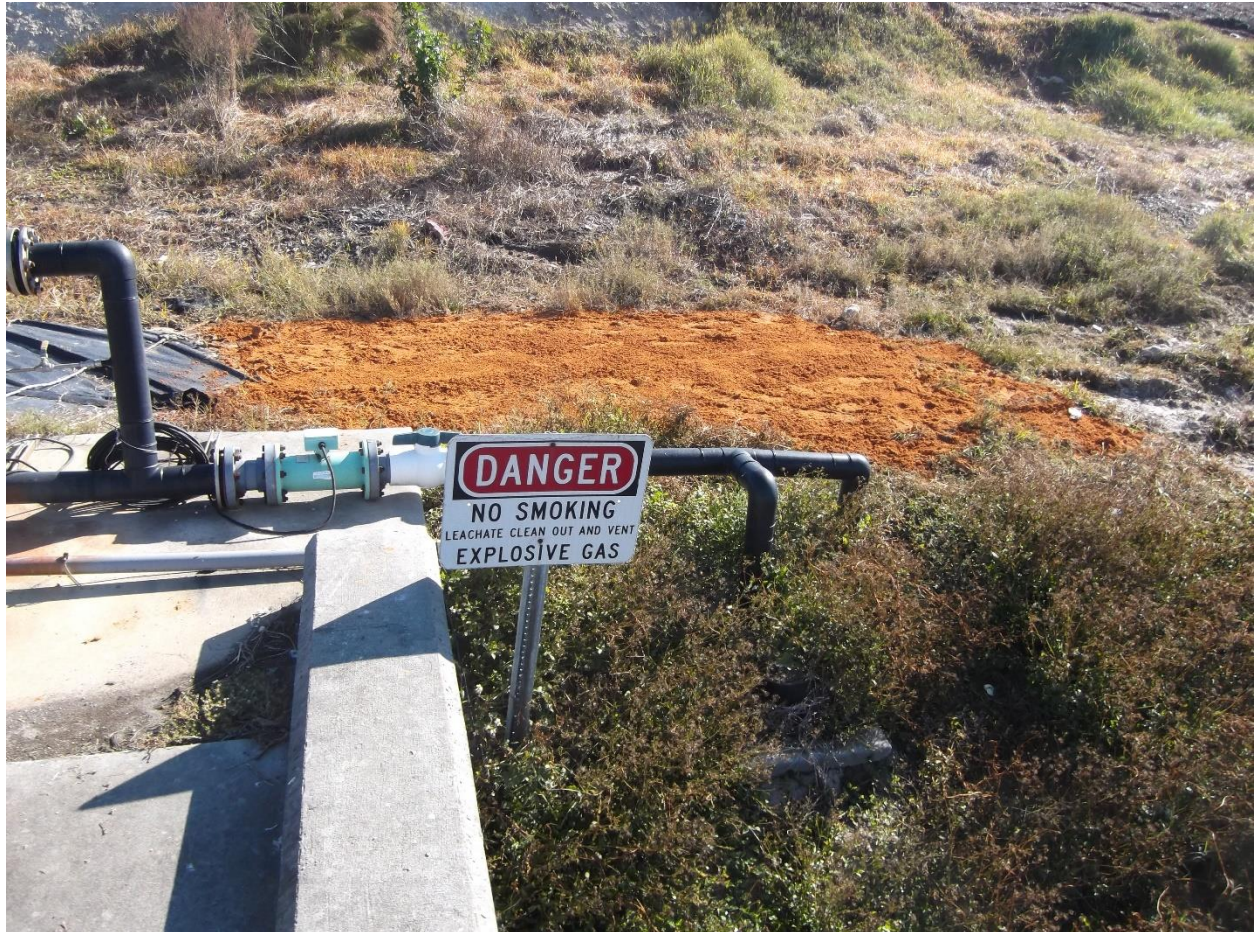
Liner webbing exposed

-The liner webbing exposure at the edge of waste near the West Phase III Leachate pumps has been covered with clay soil to prevent any further suspect release of methane gas.

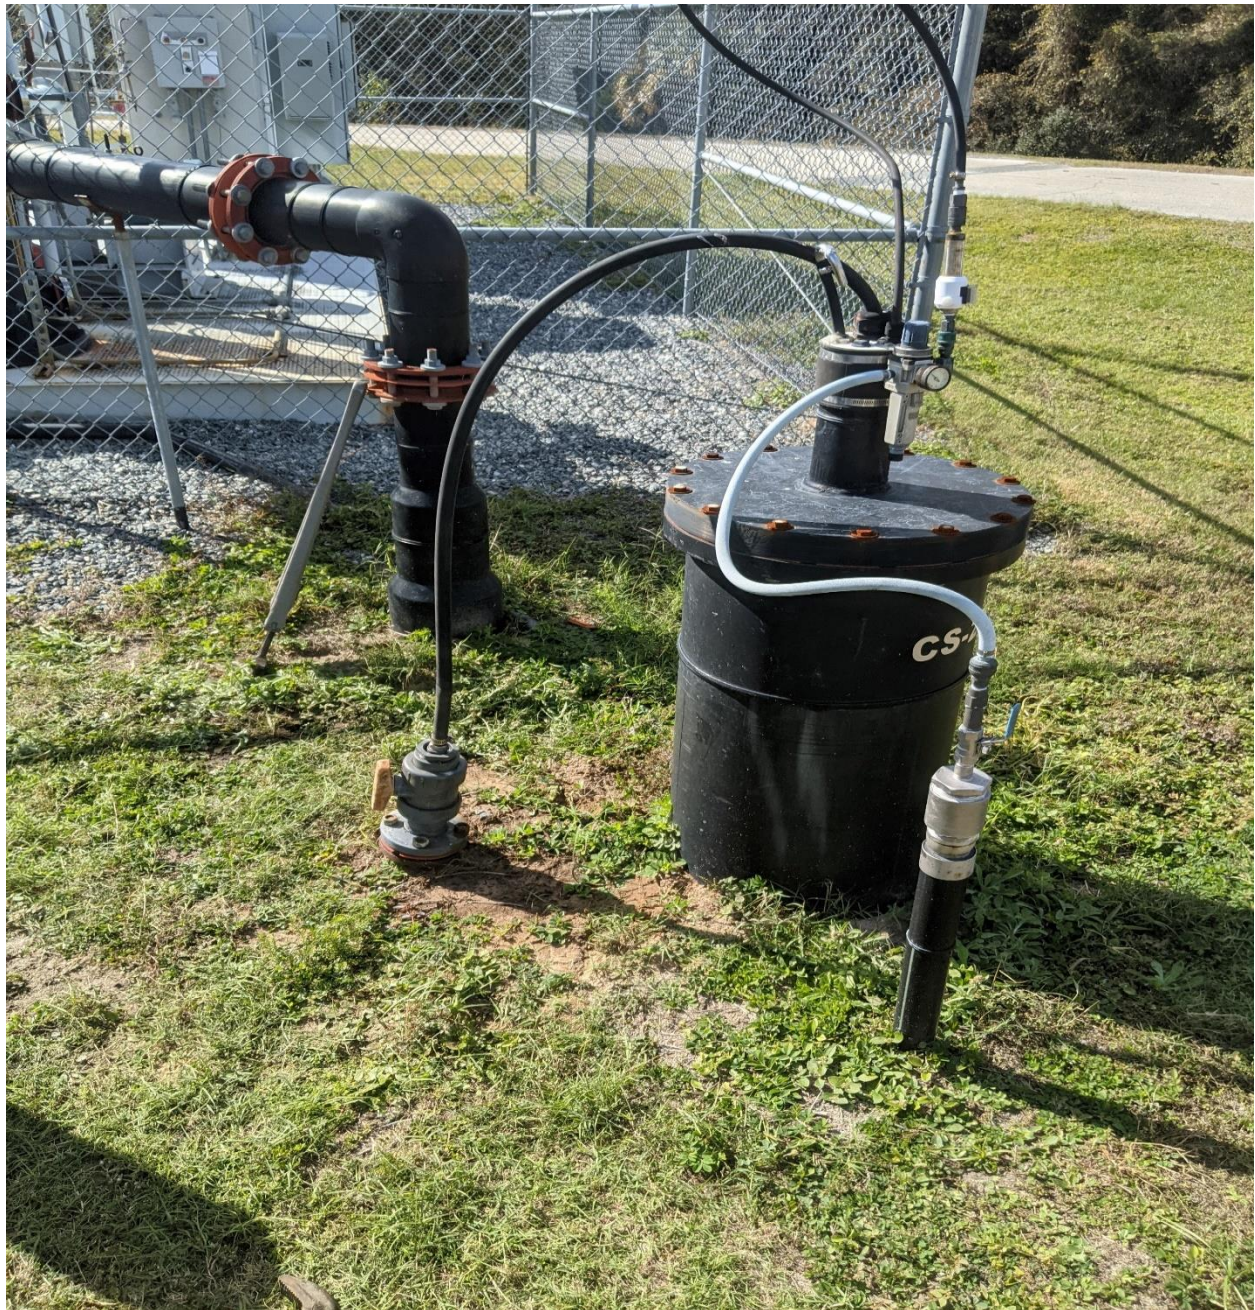
## Flare Condensate Flange

-Flange was inspected and determined that it needed replacement. Communication with vendor confirmed that there is a check valve in the condensate pump itself and that the corroded piece could be removed and bypassed temporarily until the new part arrives. We removed the flange and external check valve and ordered the part needed. Will send confirmation and new pictures after the part arrives and is installed.

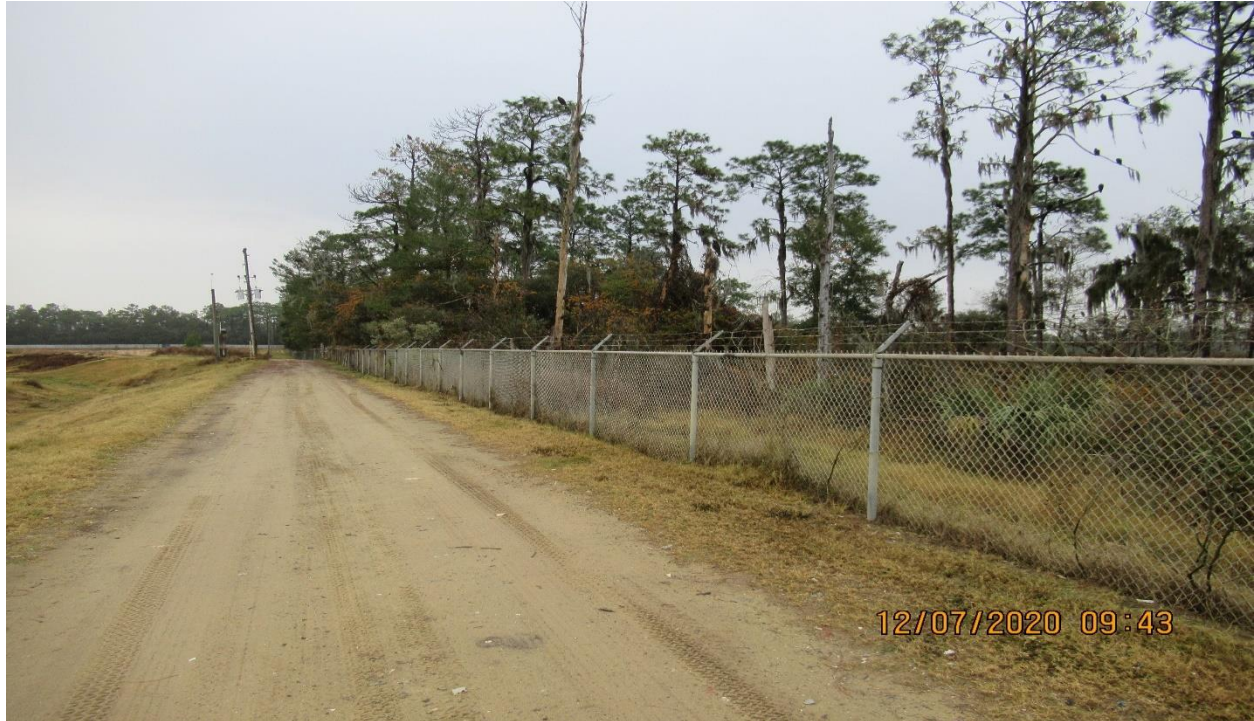
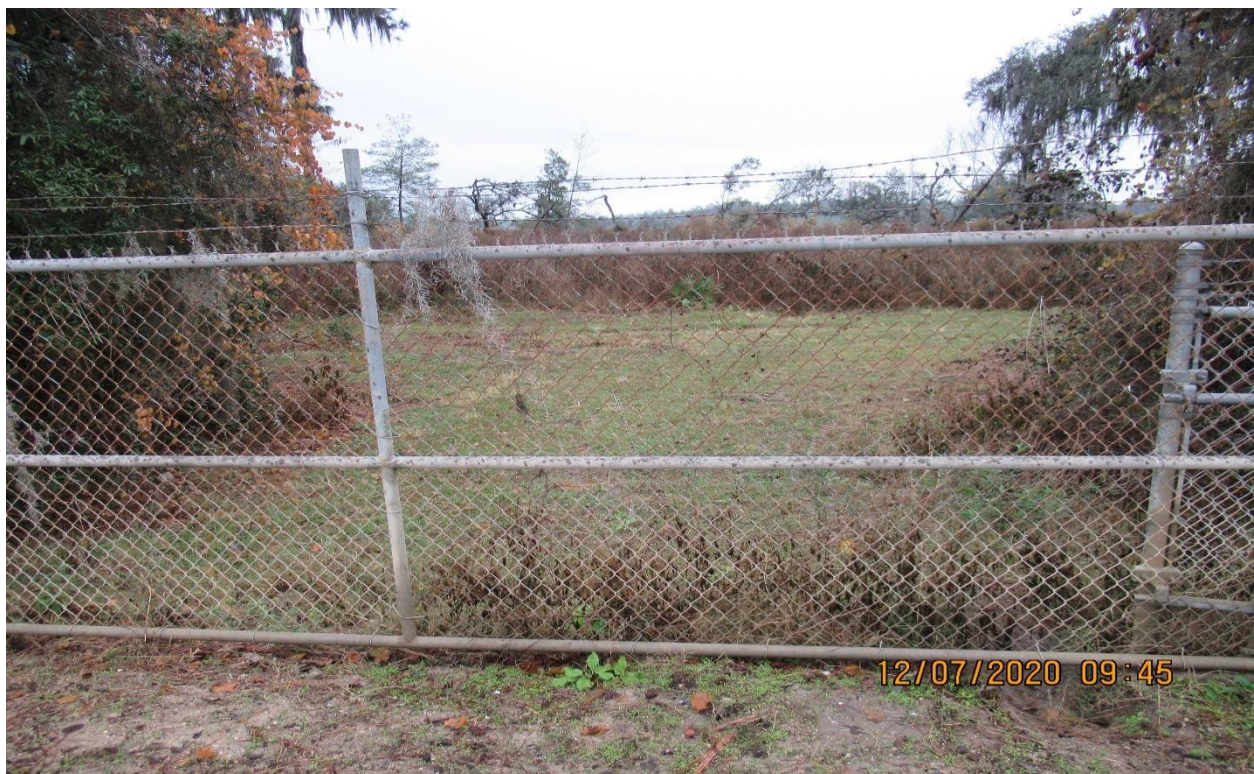
## Litter

-Litter has since been cleaned up and the landfill is in the process of acquiring (8) more litter fences for the surrounding workforce to combat the challenges we face as we continue to move up in elevation.
