**Florida Department of  
Environmental Protection  
Inspection Checklist**

**Facility Name:** SOUTHEAST COUNTY SLF (PICNIC LF)

**On-site Inspection Start Date:** 04/21/2021

Routine Operation Inspection for Landfill - Class I

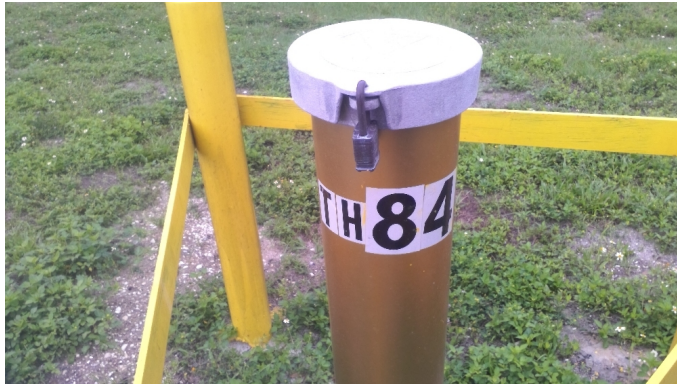
#### TH-84 Locked & Labeled

2) A newly installed compliance well (TH-84) located approximately 99 feet from the Phase II edge of liner, was installed on November 25, 2020. On December 21, 2020, the Permittee provided a memorandum documenting the TH-84 well installation alongside the corresponding Soil Boring Log, Well Construction Log, Well Construction Diagram, Field Screening Purge Logs, Calibration Logs, Field Screening Logs, and As-Built Survey.

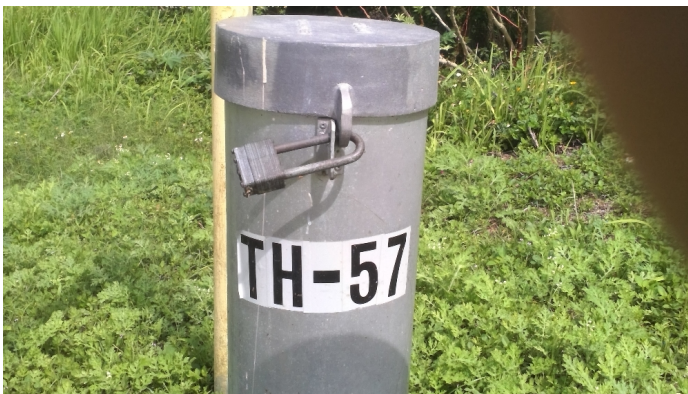
Item 2.37: All groundwater wells were not inspected during this inspection. All of the wells that were inspected were secured and labeled.

TH-57 Locked & Labeled

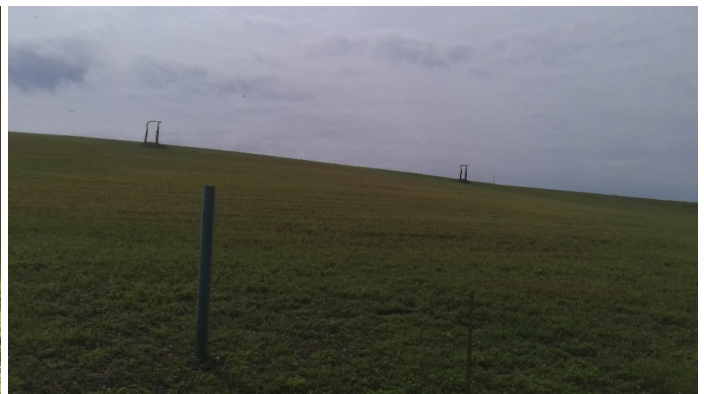
Prior Sinkhole Location

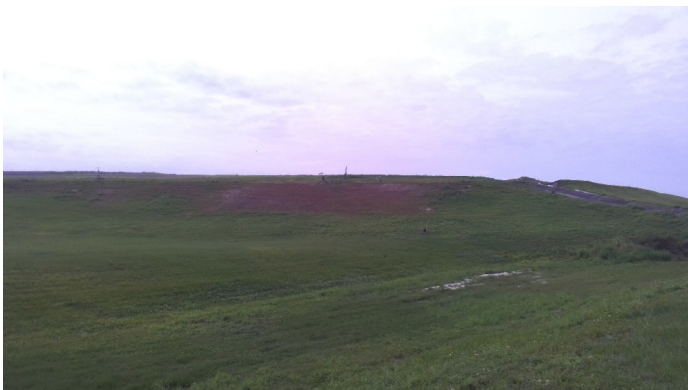
Item 2.19/2.21: During the inspection, Department staff observed a large area of sparse vegetation on the West side of Phase V. Per discussion with Mr. Weisman, this area was recently reseeded in March but has not yet reestablished itself due to a lack of rain. Please continue to monitor this area for erosion, and regrade and/or reseed as necessary.

Sparse Vegetation - Phase V

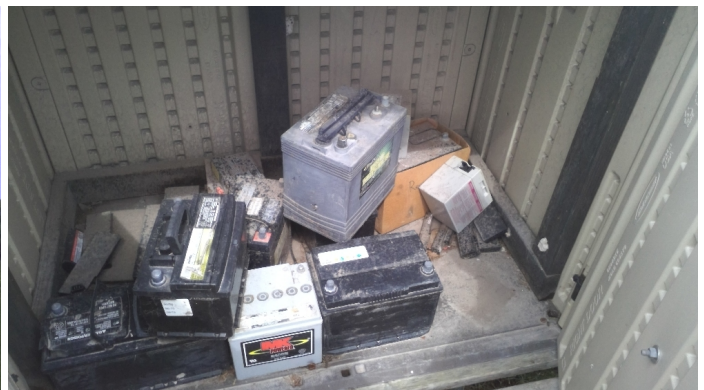
Battery Storage In Cabinet

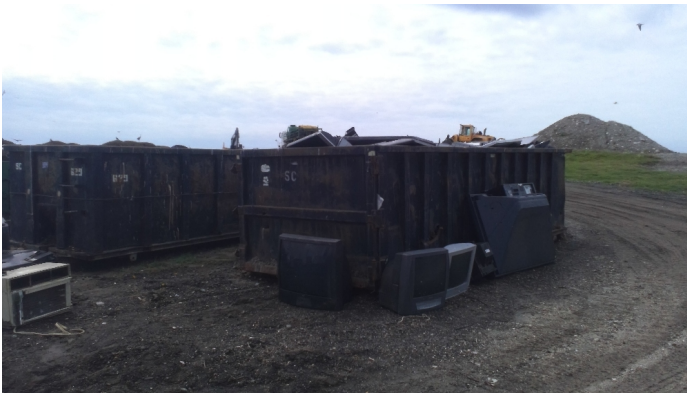
Item 2.38: During the inspection, the electronic scrap roll-off was noted to be full, consequently causing additional electronic waste to be stored on the ground. Following the Department's request, the facility provided photo documentation on April 26, 2021 demonstrating the roll-off had been removed and the additional e-waste removed from the ground. Please ensure that this roll-off is hauled off-site as needed so that waste is stored in accordance with permit requirements.

Electronic Waste Storage - During

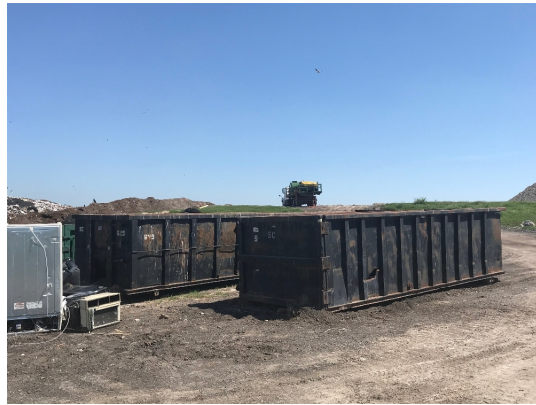
Electronic Waste Storage - Post

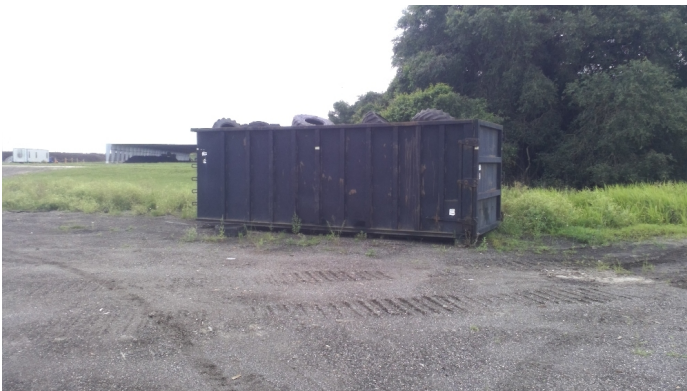
Item 2.1.1/9.1.1: At the time of inspection, Department staff noted a small pile as well a separate roll-off of unprocessed tires stored outside of the permitted Waste Tire Processing area. Photo documentation received on April 26, 2021 demonstrated that the roll-off and small pile of tires had been relocated inside of the permitted site plan. Moving forward, please ensure that waste tires are stored in accordance with the facility's approved site plan configuration.

Unprocessed Tires - During

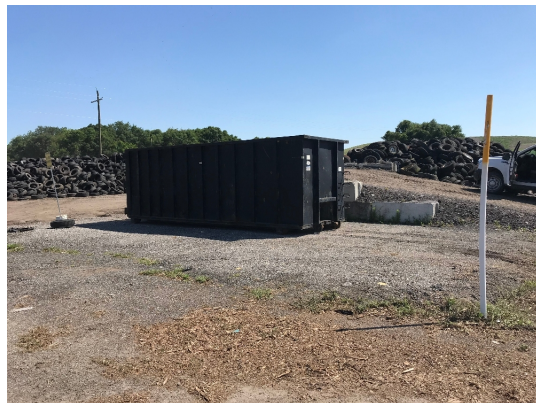
Unprocessed Tires - Post

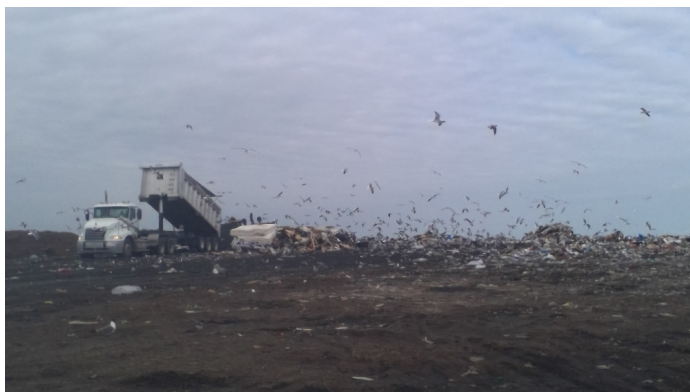
Item 2.13: The active working face at the time of inspection was Phase II, Lift 18A.

Working Face
