Re: Day & Night Tire, LLC
Facility ID: 95954
Polk County

**Florida Department of
Environmental Protection
Inspection Checklist**

Facility Name: DAY & NIGHT TIRE, LLC
On-site Inspection Start Date: 04/02/2021
On-site Inspection End Date: 04/02/2021
WACS No.: 95954
Facility Street Address: 3703 VENTURA DR W
City: LAKELAND
County Name: POLK
Zip: 33811

Routine Operation Inspection for WPF - Waste Tire Processing Facility

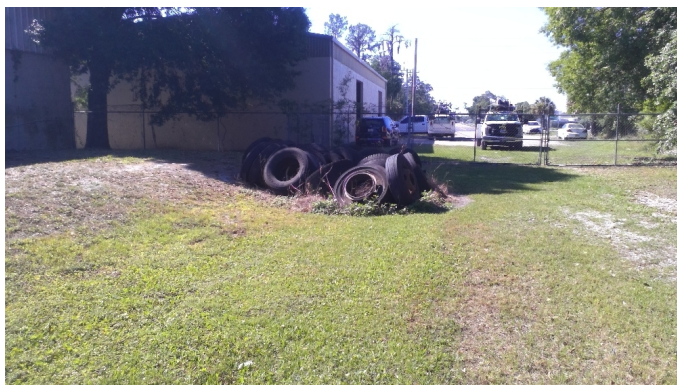
Unauthorized Tire Storage

Explanation: (1) During the inspection, Department staff noted a pile of unauthorized waste tires that were located behind the designated storage building. These waste tires did not appear to be actively utilized for the facility's operation. Based on a review of the 02/20/2020 inspection report issued to the facility on 03/05/2020, the facility was previously requested to remove this pile and dispose of the waste tires at a permitted solid waste management facility. Failure to store or dispose of solid waste in accordance with the facility's permit is considered a violation of Rule 62-701.300(1)(a), Florida Administrative Code (F.A.C).

Corrective Action: (1) Within 15 days of receiving this inspection report, please process or dispose of these tires at an approved solid waste management facility. Moving forward, please ensure this area is kept free of grass, underbrush, and other flammable vegetation. Following the removal of the tires and mowing of this area, please provide the Department with receipts and photo documentation of the cleared area.

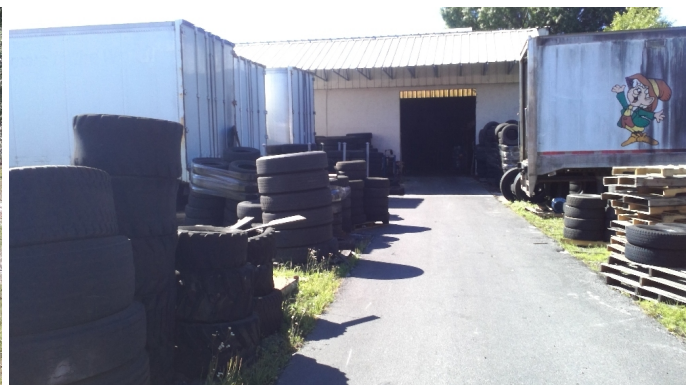
Trailer Storage Area

(2) Following the inspection, Department staff noted that the tires located in front of the tire storage trailers, between the facility processing building and the storage building, do not appear to be stored in accordance with the facility's approved site plan. Failure to store solid waste in accordance with the facility's approved site plan is considered a violation of Rule 62-701.300(1)(a), Florida Administrative Code (F.A.C).

(2) Please relocate the waste tires located outside of the storage trailers to a permitted storage area within the facility (i.e. within the permitted waste tire storage trailers) . Within 15 days of receiving this report, please provide the Department with photo documentation demonstrating this action has been completed.

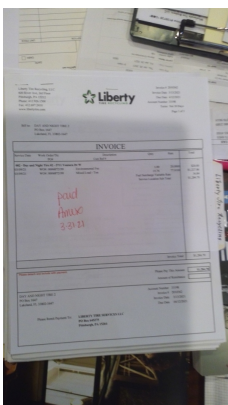
Liberty Tire Disposal Receipts

Item 9.12/9.13/9.14: The following documentation was reviewed at the time of the inspection: Emergency Preparedness Manual (last revised July 2018), 2021 Waste Tire Collector Decal, Operation's Plan Description, March 2021 Incoming Waste Tires and January - March 2021 Waste Tire Disposal Receipts (via Liberty Tire Recycling; WACS ID: 70963).
