Re: Warning Letter #WL22-77SW09SWD
Citrus County Class I Central Landfill
Facility ID: 39859
Citrus County

**Florida Department of
Environmental Protection
Inspection Checklist**

Facility Name: CITRUS CENTRAL SLF
On-site Inspection Start Date: 04/28/2022
On-site Inspection End Date: 04/28/2022
WACS No.: 39859
Facility Street Address: 230 W GULF TO LAKE HWY
City: LECANTO
County Name: CITRUS
Zip: 34461

Routine Operation Inspection for Landfill - Class I

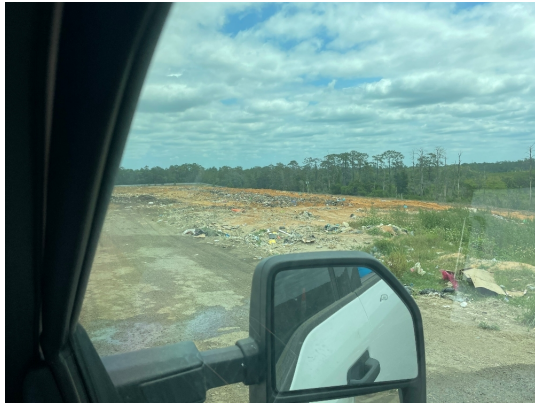
Regraded area

Area: Phase III

Explanation: This is the third consecutive year this violation has been observed. Two leachate seeps were observed: one on the eastern side of the landfill, and one on the northeast corner. Other than the seeps, intermediate cover seems to be improved.

Corrective Action: Please ensure adequate intermediate cover is applied to prevent seeps. Photo documentation was provided on May 4, 2022 showing the eastern seep was repaired. Within 30 calendar days of the date listed on the attached letter, please provide the Department with photo documentation demonstrating that the north eastern seep has been repaired.

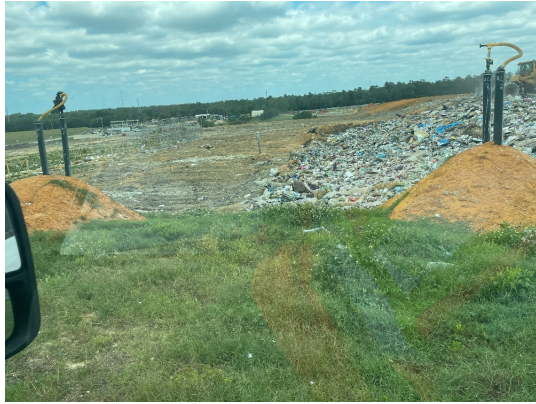
Litter over berm

B) Department staff observed that waste had been pushed over the berm surrounding the working face.

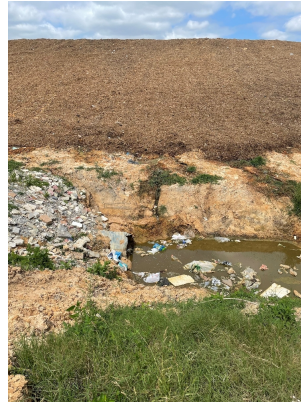
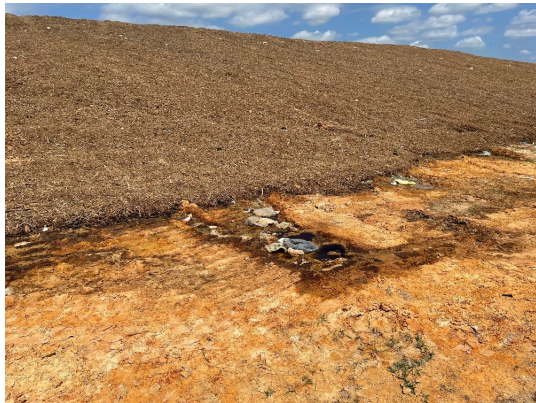
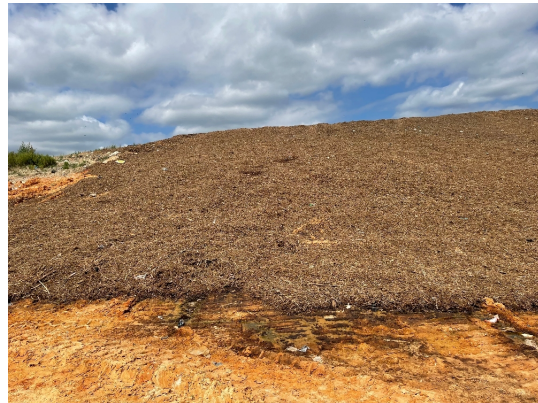
Eastern seep

A) See 2.19. Two leachate seeps in total were observed: one on the eastern side, and one on the northeastern side of the landfill. The eastern seep appeared to drain into the eastern stormwater swale, which also contained litter. The northeastern corner seep was observed to be pooling in the stormwater swale and the edge of disposal.

Corrective Action: A) Photo documentation was provided on May 4, 2022 indicating that the eastern seep was repaired. Please provide photo documentation showing the northeastern seep has been repaired. Please continue to monitor and mitigate seeps.

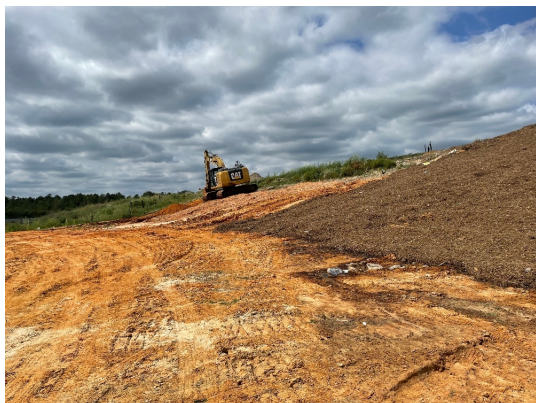
Eastern seep being mitigated 4/28

Facility staff were observed making efforts to mitigate the leachate seeps: the eastern seep was being covered with red clay, and the northeastern corner seep appeared to be already covered, but leachate was still coming through. Additionally, Facility staff were observed clearing litter out of the eastern stormwater swale (see 2.20 for image).

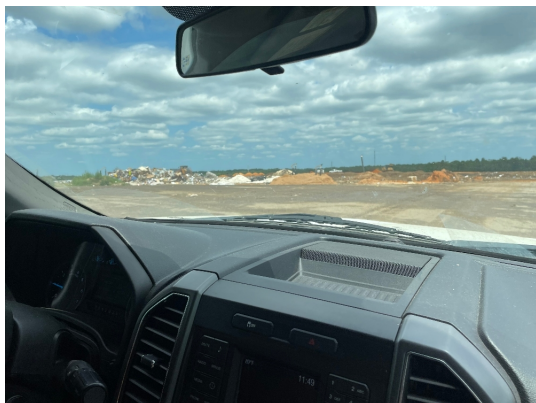
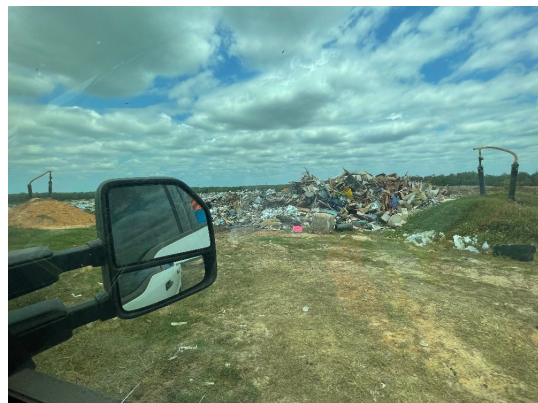
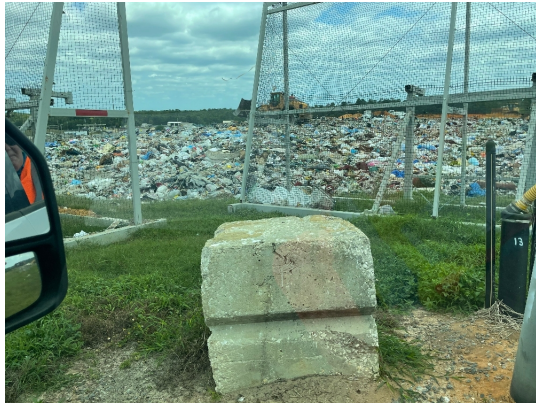
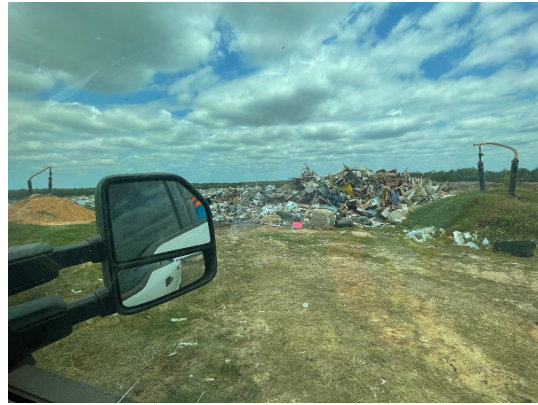
Explanation: The working face was observed to be large, which may be contributing to the amount of litter found in stormwater swales and elsewhere on and off the property. According to the Daily Operator Log, the working face should be <50'x75'. The working face appeared to exceed these dimensions during the inspection. Additionally, wastes had been placed outside of the stormwater berm at the working face.

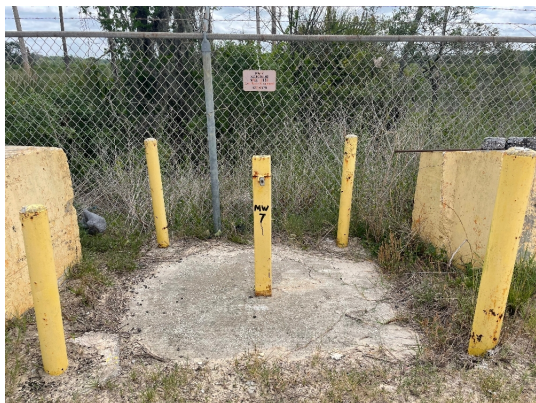
MW-7 Cracked Pad

Explanation: Department staff observed MW-7 to be unlocked. Additionally, the concrete pad of MW-7 was cracked.

Corrective Action: Please provide photo documentation showing this well secured with a new lock and the crack in the concrete pad filled. Please ensure all wells are maintained and secured to prevent tampering and accurate reporting.

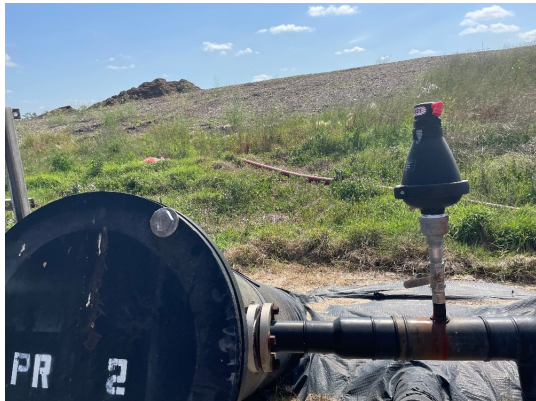
Transmission Line in background

Explanation: On 8/13/2021, Department staff conducted a site visit and observed a roughly 650ft long toe drain with a sump and leachate transmission line that was not included in the operation plan. On 4/28/2022, Department staff conducted an inspection and the toe drain assembly was still present.

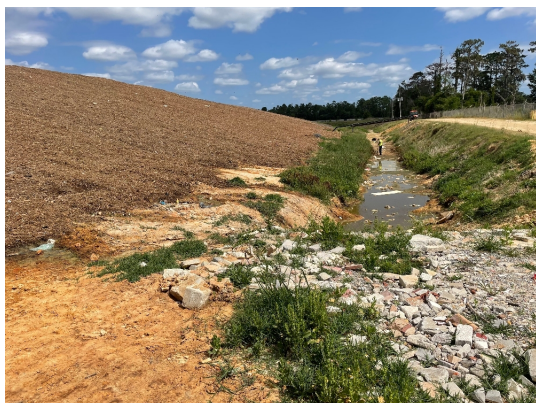
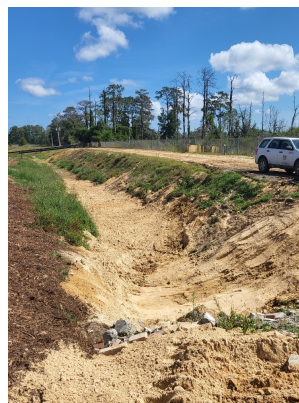
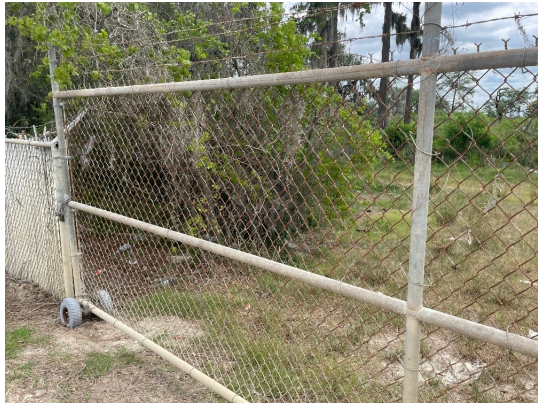
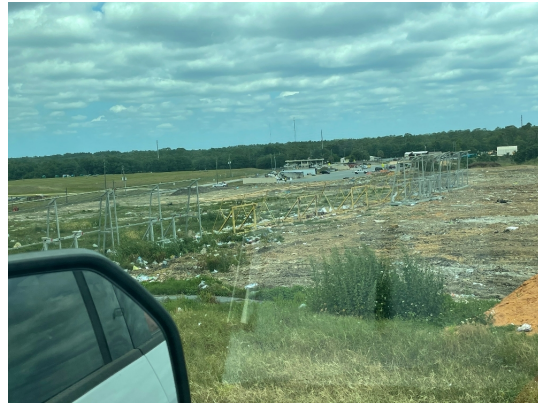
Explanation: This is the second consecutive inspection during which litter was observed on site outside of the working face, in stormwater swales, and areas beyond the fence on the east side of the landfill. Litter fences were in use at the working face. Facility staff were observed already picking up the litter during the time of inspection. Decreasing the area of the working face should make litter control more manageable. Photo documentation was provided to the Department via email on April 28, 2022, showing that litter was removed from the east stormwater swale.

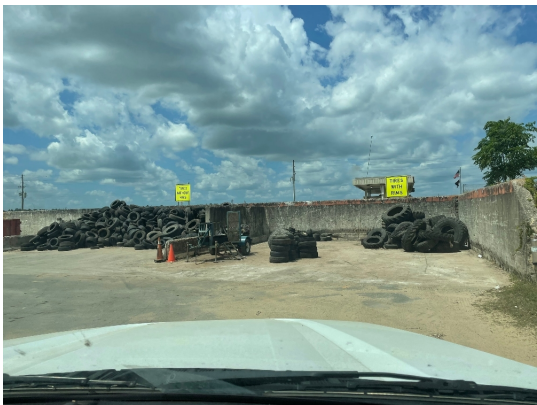
Waste Tire Storage

Item No. 2.6: Two waste tires were observed at the working face: one had been removed from the working face and placed to the side for proper disposal, and one was amid the waste. Please ensure that no unauthorized wastes are allowed to be disposed of at the working face.
