RE: Warning Letter No. WL22-278
Advanced Tire Recycling, Inc.
Facility ID No. 101060
Gilchrist County – Solid Waste Enforcement

**Florida Department of
Environmental Protection
Inspection Checklist**

Routine Operation Inspection for WPF - Waste Tire Processing Facility

Follow-up Operation Inspection for WPF - Waste Tire Processing Facility

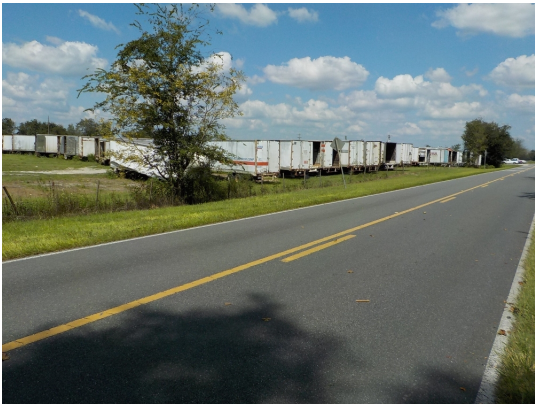
East Property Boundary

Explanation: Department staff counted approximately 165.5 trailers in the yard (approximation due to combination of several partial trailers combined for a full trailer estimate) and an estimated 10 trailers of tires in the warehouse for a total of 175.5 trailers or about 210,600 tires on site. Specific Condition Section 2 C.4 of Permit No.: 321853-003-WT provides "The maximum amount of waste tires at the Facility shall be less than 125,000 tires." The 125,000 tires is the equivalent of 104 trailers as specified in the permit. The facility is currently over the maximum amount of tires authorized, representing unauthorized storage of approximately 85,600 waste tires.

Corrective Action: The facility shall reduce the amount of waste tires on site to below 125,000 tires within 30 days of the inspection. Report corrective action to the Department via phone or email immediately upon completion to arrange for a confirming inspection.
