SUBJECT: Short Form Consent Order
Proposed Settlement of International Paper Company
OGC File No.: 06-1180-17-HW

WARNING LETTER

HAZARDOUS WASTE INSPECTION REPORT

FACILITY NAME: International Paper, Inc. **DEP/EPA ID #:** FLD 008 166 639

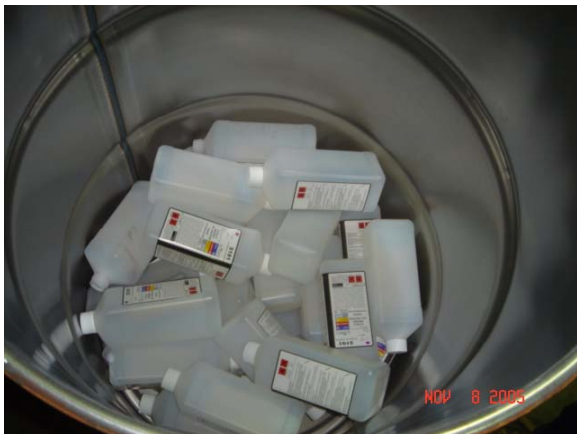
picture A

There are three process lines in the converting area on which Xerox paper is cut to size, printed with a code and packaged in pre-printed paper. James Eiland, Benco Operator, demonstrated that printing is accomplished by “mod” printers using disposable cartridges which contain MEK. The cartridges are removed from the printers when empty and replaced. Cartridges (usually empty) are placed in a Satellite Accumulation Area (SAA) drum, see picture A. The SAA drum was labeled “Hazardous Waste” and covered, see picture B. Solvent containing MEK used for cleaning purposes is caught in a container attached to a funnel, see picture C. When the container is full it is placed in the SAA drum along with the empty cartridges.

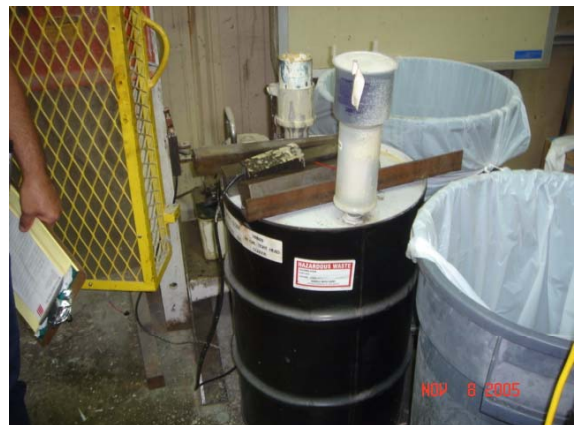
picture D

There was one SAA in the Converting Area Maintenance Shop for collecting residue from punctured cans, see picture D. The punctured cans are collected in a dedicated trashcan and handled as scrap metal. Rags used in this area are disposed of with the regular trash. A review of manifests subsequently submitted by IP for aerosol cans observed in this area suggests that none contain any constituents listed for any reason other than ignitability (F003).

- (2) Training should include management of spent aerosol cans. Employees should be familiar with the proper way to manage un-punctured and punctured cans. The puncturing of aerosol cans is considered hazardous waste treatment requiring a hazardous waste permit unless the punctured cans are managed as scrap metal which causes the puncturing operation to be exempt from RCRA regulation.

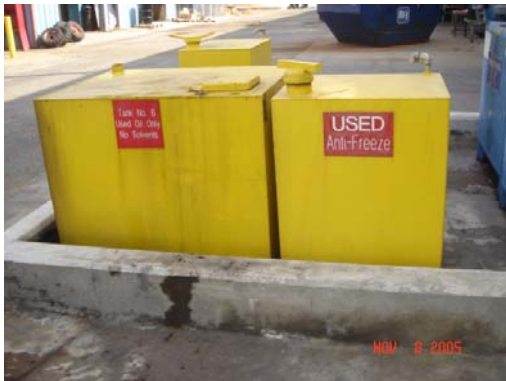
picture E

Used oil, used antifreeze and waste gas generated in the vehicle maintenance area are collected in separate tanks located within secondary containment just outside the shop area, see pictures E and F. The tanks were appropriately labeled and in good condition. Gasoline collected in the tank labeled "Waste Gas and Water Mixture" is picked up to be used as a fuel and is therefore exempt from the definition of "solid waste" and not regulated under RCRA. The secondary containment was compromised by an open valve which Mr. Dail closed upon discovery, see picture G. Used Oil Filters are crushed and placed in a drum labeled "Drained Used Oil Filters, see picture H." Aerosol cans are punctured in this area and residue is collected in a closed container labeled "Hazardous Waste". Punctured and un-punctured aerosol cans and fuel filters were found mixed in with the regular trash, see picture I and J.

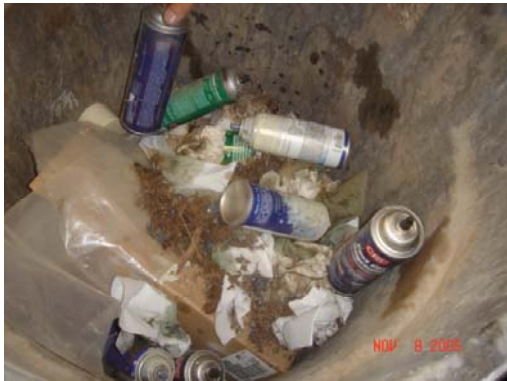
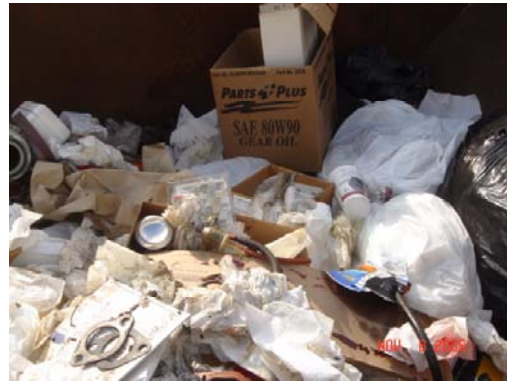
picture I

Waste fuel filters were found in the regular trash. Fuel filters generally are characteristically hazardous (D001/D039) when disposed of. Fluorescent tubes were found abandoned and broken in the wood yard area and generally are characteristically hazardous (D008). The dip tank solution located behind the machine shop will be characteristic hazardous waste (D002) when spent and no determination has been made on whether heavy metals or other contaminants may become entrained as a result of its use. The hose connected to the bottom of the tank appeared to be there for the purpose of draining the dip tank onto the road and no other explanation was offered.

- (1) Training should include management of used fuel filters. Used fuel filters may be managed with used oil filters if accepted by your hauler and destination facility. The containers should be labeled "Used Oil and Fuel Filters" and managed per used oil filter requirements. If the filters are disposed of with the regular trash, they are solid waste and most likely hazardous waste.

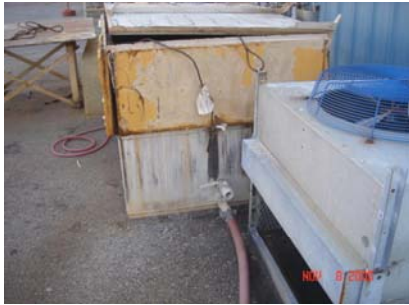
There is a System One parts washer and agitating parts washer in this area. Both units use non-hazardous solvent and are serviced monthly by Safety Kleen. Aerosol cans generated in this area are taken to the vehicle maintenance shop to be punctured and rags are disposed of with the regular trash. There was a covered dip tank located just outside the machine shop. A hose was attached to the bottom of the tank and extended out to the end of the building, see picture K - N. The inspectors asked about the use of the hose and how the dip tank solution is normally disposed of when spent. Mr. Dail said that he did not know why the hose had been attached and that it should not be there. He called someone to have the hose removed. He also said that the spent dip tank solution is normally recovered for its caustic value by pumping it into the sodium hydroxide solution (white liquor) used to break down wood chips in the pulping process. There were several rusty drums in the same area. We asked Ken Borne, machinist, what the drums contained. He said that they contained detergent that is diluted and used in the dip tank. There were no waste drums in this area. On 11/14/05 Nicole McDonald and Melissa Woehle tested the pH of the dip tank solution using wide and short range pH paper with the following results:

- c) IP should perform a hazardous waste determination for the caustic dip tank solution when spent per 40 CFR 262.11. If the waste is excluded or exempted under 261.2-6, then a one-time notice describing such generation, subsequent exclusion or exemption and the disposition of the waste should be placed in IP's on-site files, as required in 268.7(a)(7).

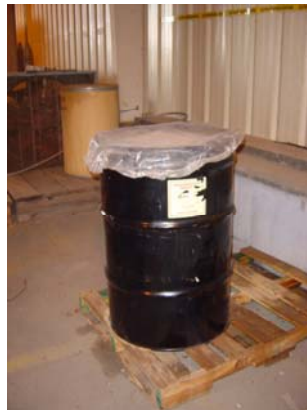
picture P

In the less than 180-day hazardous waste accumulation area, there was one 55-gallon drum labeled Hazardous Waste / solid paint waste F003/D001 dated 11/3/05. The drum was in good physical condition and closed. There were three drums labeled Non-Hazardous / fuel oil dirt from dikes and “oily material tested for halogens & flashpoint.” There were several over-pack drums, spill control kits and absorbents staged in this area for use by IP’s Emergency Response Team (ERT). See pictures O – Q.

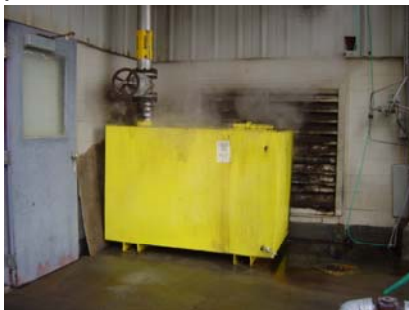
picture R

Ten used oil accumulation areas located throughout the mill were visually inspected including the bleach plant, wood yard, digester area, paper machine area, power boiler area, and the recovery boiler area. All used oil containers were in good condition, closed and labeled; however, they were not located within secondary containment, see pictures R - V.

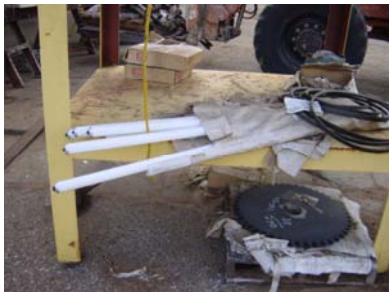
picture W

There is a maintenance shop located in the wood yard area. Aerosol cans are punctured in this area and used oil and universal waste is generated. A weathered box of improperly stored fluorescent tubes was observed, see picture W. Two of the tubes were broken.

- (3) Training should include management of universal waste from generation through to proper containment and labeling. Each container of universal waste lamps should be labeled as specified in 40 CFR 273.14.

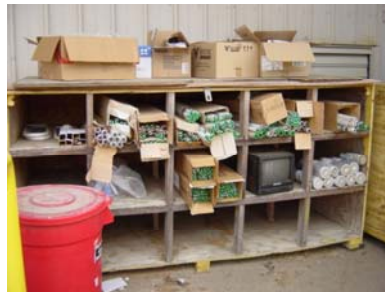
picture X

Waste fluorescent tubes, batteries and ballast are collected throughout the mill and aggregated for management in the universal waste storage area. The battery container was properly labeled "Used Batteries" and closed; however, the lamp containers were not labeled or closed.

The boxes containing used lamps were not labeled or closed.
