**Florida Department of
Environmental Protection
Hazardous Waste Inspection Report**

Facility Name: FPL Area Office West

On-Site Inspection Start Date: 06/07/2016

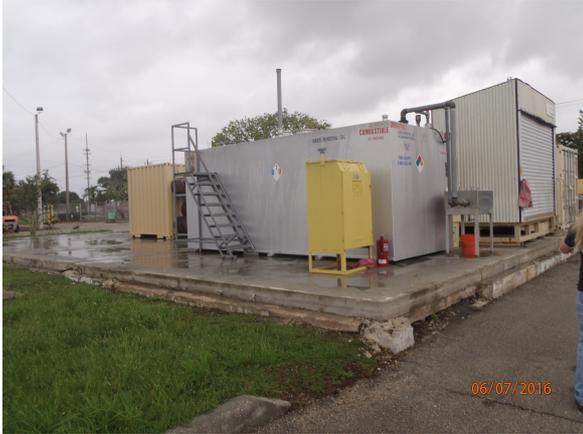
Non-PCB used mineral oil is picked up from eight other FPL service centers in the immediate area using a single transfer truck. At the time of the inspection, the truck was not at the facility. Ms. Shoosmith indicated the truck has a volume capacity of 1500 gallons. Used oil is off loaded into a 6000-gallon, double-walled, above ground storage tank the same day the used oil is picked up. Ms. Shoosmith indicated that used oil is never stored in the truck for >24 hours. The storage tank is labeled with the words 'used mineral oil', 'used oil', 'no smoking' and 'combustible'. The tank is registered ID# 9814811.

At the time of the inspection, an open, orange 5-gallon bucket was noted beneath what appeared to be the fill port for the storage tank. The bucket contained oily waste. It was discussed with Ms. Shoosmith that the bucket should be maintained closed when not actively adding/removing oily waste and labeled with words identifying its contents. Various equipment and spill response equipment is maintained in storage areas adjacent to the storage tank. It was indicated by Mr. Daugherty that FPL utilizes a computerized compliance tracker to ensure tasks, inspections and work activities are conducted timely.

used mineral oil storage tank

The open, orange 5-gallon bucket managing oily waste adjacent to the used oil storage tank should be maintained closed when not actively adding/removing oily waste and labeled with words identifying its contents.

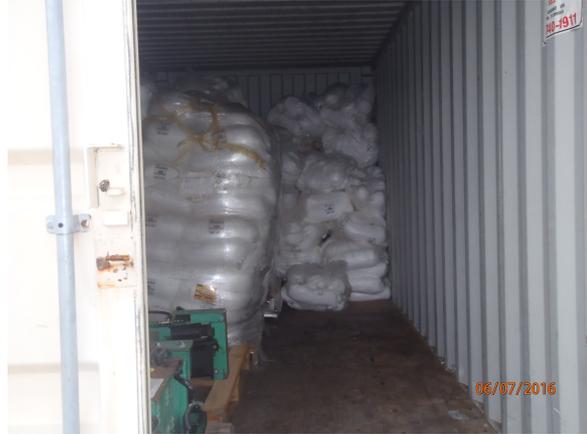
spill control equipment
