**Florida Department of
Environmental Protection
Hazardous Waste Inspection Report**

Facility Name: Ring Power Corp

Routine Inspection for Used Oil Transporter facility

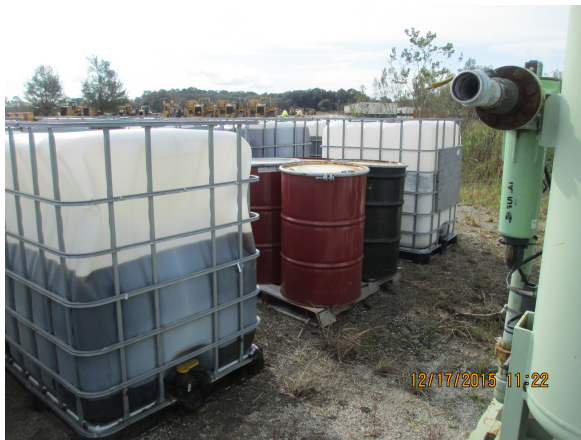
Used Oil Drums

The facility stores vehicles and equipment both for facility use and rental in an outside storage yard. Four 55-gallon drums of used oil were observed in the area where air compressors for customer rental are stored. The drums were not labeled [40 CFR 279.22(c)(1)], were not on an oil impervious surface, and did not have adequate secondary containment [62-710.401(6), FAC]. The facility added the drums to the facility's used oil during the inspection.

Type:	Violation
Rule:	279.22(c)(1)
Explanation:	Four 55-gallon drums of used oil were not labeled with the word "Used Oil."

Explanation: Four 55-gallon drums of used oil were not located in secondary containment.

Corrective Action: No further action is required. The facility returned to compliance at the time of the inspection.

Corrective Action: No further action is required. The facility returned to compliance during the inspection.
