**Florida Department of
Environmental Protection
Hazardous Waste Inspection Report**

Facility Name: Triumvirate Environmental Florida Inc
On-Site Inspection Start Date: 01/18/2017 **On-Site Inspection End Date:** 01/18/2017
ME ID#: 50649 **EPA ID#:** FLD981018773
Facility Street Address: 3670 SW 47th Ave #109, Davie, FL 33314
Contact Mailing Address: 3670 SW 47th Ave #109, Davie, FL 33314-2830
County Name: BROWARD **Contact Phone:** (954) 583-3795

Routine Inspection for Hazardous Waste Transfer Facility facility
Routine Inspection for Hazardous Waste Transporter facility
Routine Inspection for Universal Waste Transporter facility
Routine Inspection for Used Oil Transporter facility
Routine Inspection for Used Oil Generator facility
Routine Inspection for CESQG (<100 kg/month) facility
Routine Inspection for Used Oil Transfer Facility facility
Routine Inspection for Used Oil Processor facility

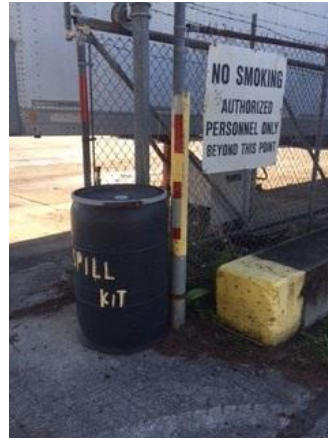
The facility had fire extinguishers stationed at regular intervals, a safety shower in the hazardous waste storage building, spill kits stationed in logical areas throughout the facility, and several portable eye wash stations. The eye wash station in the hazardous waste storage building was expired per the stamp on the container. The inspectors brought hard hats, hard toed shoes, safety glass and ear protection. For the facility tour, TEF required everything but the ear protection.

spill kits

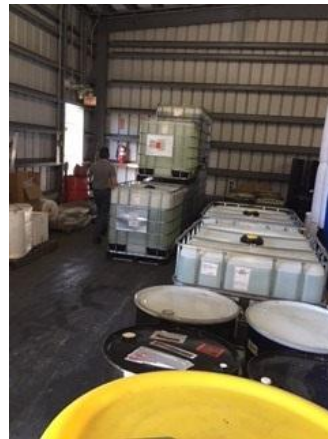
On the other side of the building, there were four distinct storage zones. There was the Hazardous Waste Transfer facility, the liquid non-regulated waste area, the solid non-regulated waste area and the Universal Waste storage area. This area was empty at the time except for some e-scrap because TEF had a shipment of universal waste the day before the inspection.

HW storage area building
