Re: Compliance Assistance Offer
Howco Environmental Services – Fort Myers
HW Facility ID No. FL0001000611
Lee County

**Florida Department of
Environmental Protection
Hazardous Waste Inspection Report**

Facility Name: Howco Environmental Services

On-Site Inspection Start Date: 08/10/2017

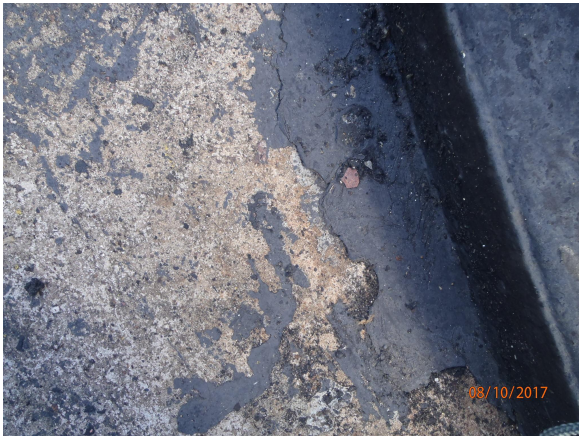
Type:	Violation
Rule:	279.45(e)(2)
Explanation:	Existing aboveground tanks used to store used oil at transfer stations must be equipped with a secondary containment system. The entire containment system, including walls and floors, must be sufficiently impervious to used oil to prevent any used oil released into the containment system from migrating out of the system to the soil, groundwater, or surface water.
	The black coating/sealant on the concrete floor of the containment structure is wearing away and cracking in areas.

The entire containment system, including walls and floors, must be sufficiently impervious to used oil to prevent any used oil released into the containment system from migrating out of the system to the soil, groundwater, or surface water

Black coating/sealant worn off in containment structure

Corrective Action: The entire containment structure needs to be resealed with an impervious sealant.

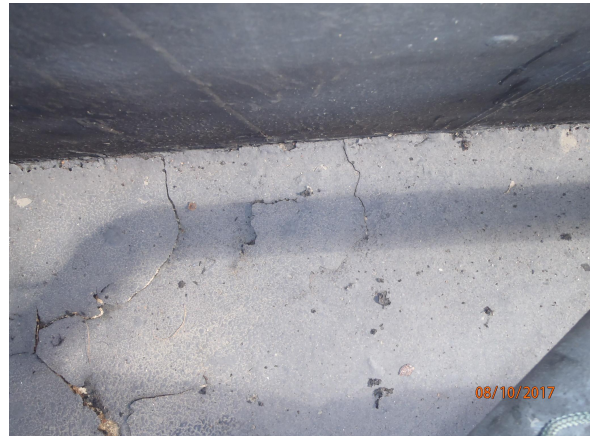
Black coating/sealant cracking in containment structure

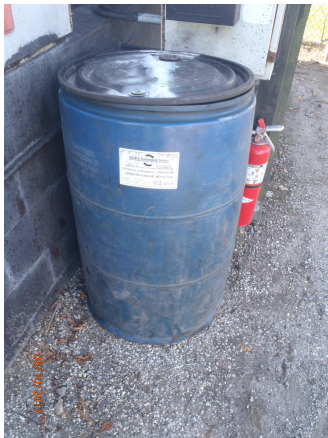
A closed, blue 55-gallon drum labeled 'Fort Myers yard waste' was noted outside the containment structure and approximately 1/3-full of used absorbent pads and trash (see photos). According to Mr. Bradley, absorbent pads are used to cleaning hands, trailer, etc. and for managing drips. Drums of used absorbent are transported to the Howco St Petersburg facility for disposal.

Blue drum labeled 'Ft Myers yard waste'

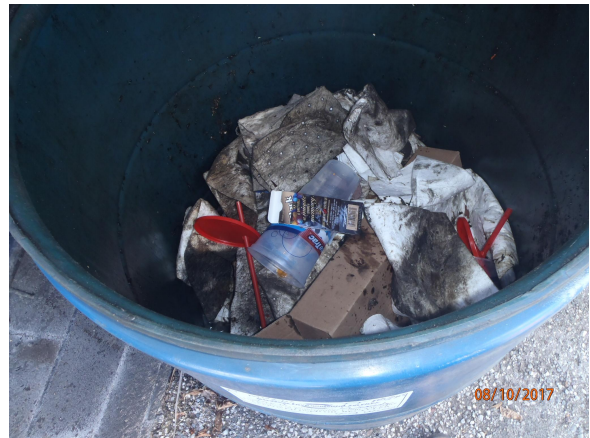
Blue 55-gallon 'Ft Myers yard waste' drum

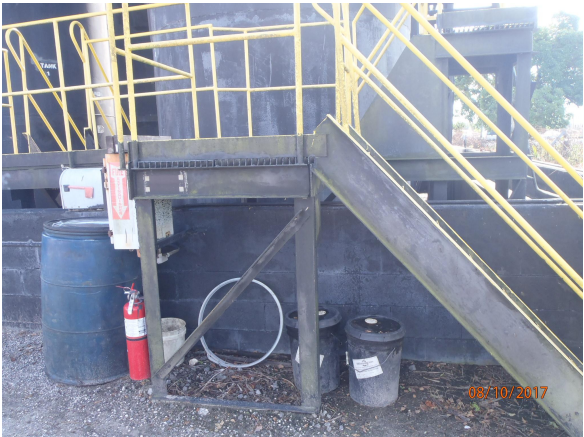
Also noted outside the containment structure was one approximate 200-gallon aboveground storage tank labeled 'empty' and a closed 55-gallon drum labeled 'new abs for yard use' (see photos). The storage tank appeared empty. Two empty closed 5-gallon buckets and an open two-gallon bucket approximately 1/4-full of what appeared to be rainwater was noted beneath the staircase leading into the containment structure (see photos).

Containers beneath staircase

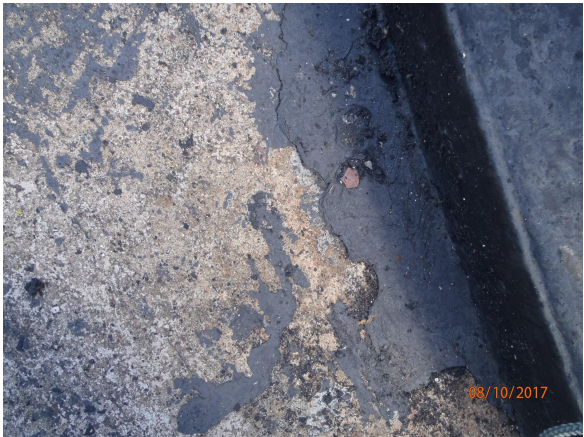
Black coating/sealant wearing off

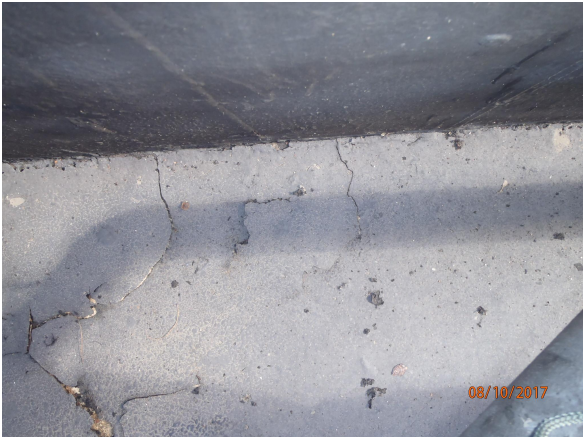
black coating/sealant cracking

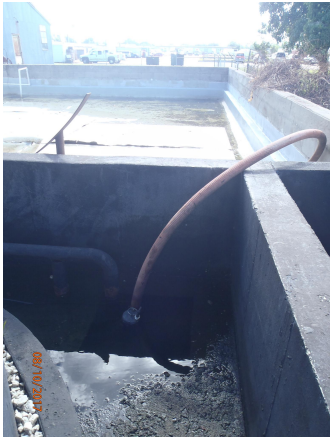
part of a larger containment unit that includes fuel tanks owned/operated by Ryan Petroleum. According to Mr. Bradley, the containment structure for the four tanks is capable of containing 110% of the largest storage tank. A sump pump is situated at the southeast corner of the containment structure. According to Mr. Bradley, rainwater that collects in the containment structure is either pumped into the PPW storage tank or vacuumed up and placed in the truck and transported to St. Petersburg. The secondary containment structure was inspected. It appeared that a black coating/sealant has worn away and cracking in areas (see photos). According to a record review, it appears the facility most recently applied an impervious sealant in the secondary containment structure 2013. Following the inspection, Mr. Bradley was provided photos of the worn away and cracking sealant in the containment structure and indicated he would review with other Howco representatives and initiate a work order to address the issue.

sump pump

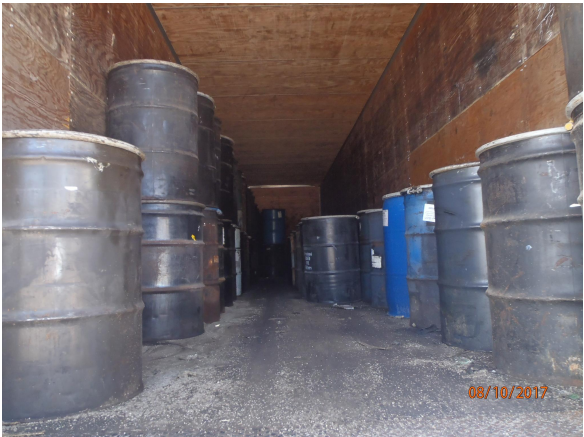
55-gallon drums of used oil filters are stored inside a 53-foot trailer parked over broken/cracked concrete surface. According to Mr. Bradley, the trailer is swapped out when full. The trailer was not inspected however it appeared that all drums were closed and labeled. What appeared to be granular absorbent covered the floor of the trailer around the drums. According to Mr. Bradley, the drums are on a wood surface situated on top of the metal base of the trailer; and that the wood floor of all used oil filter storage trailers are coated with an impervious sealant. There were no discharges or discolored areas noted beneath the trailer. A closed 55-gallon drum labeled 'new abs' was observed behind the trailer.

Used oil filter storage trailer

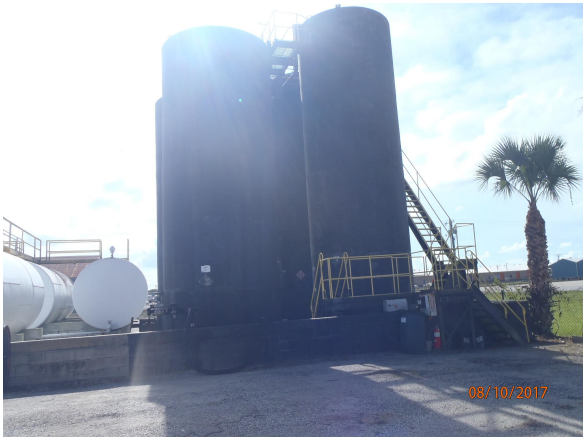
Each storage tank is a vertical aboveground, single-walled tank that is 20,000-gallons in capacity. The tanks are labeled according to the contents and numbered 1-4. Tanks 1 and 2 are labeled 'used oil'; tank 3 is labeled 'PPW' and tank 4 is labeled 'A/F' (see photos). According to Mr. Bradley, tank 3 contains petroleum, product and water (oily water), and tank 4 contains used antifreeze. It was discussed following the inspection that the tanks should be labeled with words identifying the contents. According to Mr. Bradley, waste fluids are transported weekly from this facility to the Howco St. Petersburg facility where the used oil is recycled and sold as burner fuel, used antifreeze is recycled, and oily water is separated, treated and either discharged to the city or burned. Mr. Bradley estimated that bulk loads are transported to the St. Petersburg facility anywhere from once every 10 days to three times a week depending on driver availability.

storage tanks

It is recommended to label tank 3 and tank 4 with words identifying their contents, 'petroleum product water' and 'used antifreeze'.

Please verify if the four storage tanks are equipped with a functioning tank monitoring/sensor system.

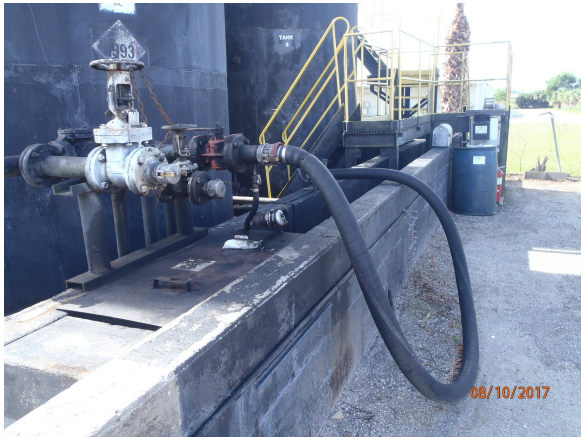
At the time of the inspection, the truck and driver were not at the facility. According to Mr. Bradley, the truck is off-loaded every day and pumped into the specified tanks. The driver offloads waste fluids by connecting a hose to a valve header which is situated within the containment structure. According to Mr. Bradley, the driver places a bucket beneath the hose to catch any drips outside the containment structure. What appeared to be staining was noted on the outside of the containment structure wall directly beneath the valve header (see photo). Beneath the valve header is a metal box to collect drips, etc. from the hoses. Drivers open the lid when loading/off-loading fuel. At the time of the inspection the lid was on the box which prevents rainwater from collecting and was not inspected. Fluids that collect in the box are removed and managed.

hose and valve header

Regarding the staining noted on the outside of the containment structure directly beneath the valve header, drivers should be cautious when loading/off-loading fluids to prevent spills from occurring.

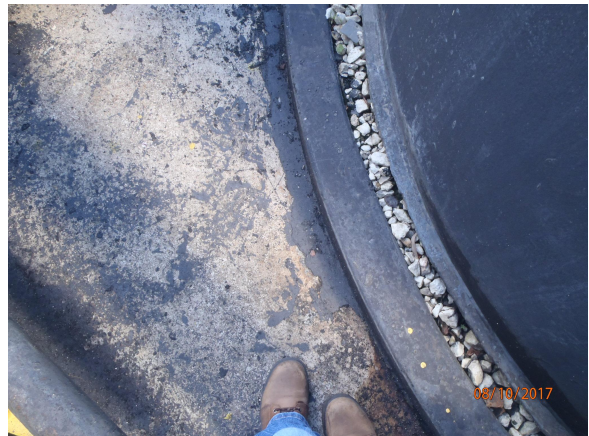
Black coating/sealant worn off in containment structure
