**Florida Department of  
Environmental Protection  
Hazardous Waste Inspection Report**

**Facility Name:** CEMEX Miami Cement Plant & SCL Quarry

**On-Site Inspection Start Date:** 11/08/2017

Routine Inspection for CESQG (<100 kg/month) facility

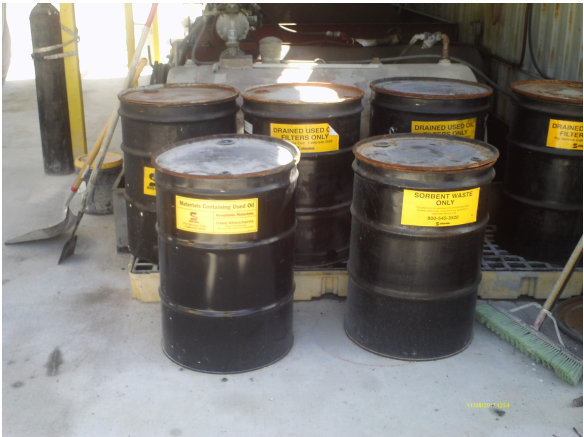
SCL Quarry Shop

The SQL Quarry provides crushed limestone to Cemex and is covered under Cemex's EPA Identification Number FLD981758485. This Quarry Shop had a canopy covered work area; the used oil storage area has been provided with a metal roof. The inspectors observed the some oily rain water had accumulated in the secondary containment area of the 500-gallon used oil tank. Containers of used oil filters and oily rags were protected from the elements, properly labeled and stored on containment pallets. No hazardous waste is generated at this shop. Spill kits and fire extinguishers were observed during the inspection.

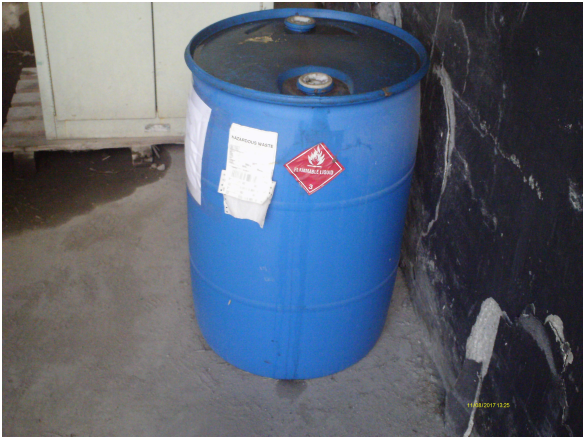
1 - 55 gallon drum of hazardous waste

Located near to the New Oil Drum Storage and Equipment Wash Area, the inspectors observed one closed and labeled (1)- 55 gallon drum of waste glycerol, ethanol and barium chloride.

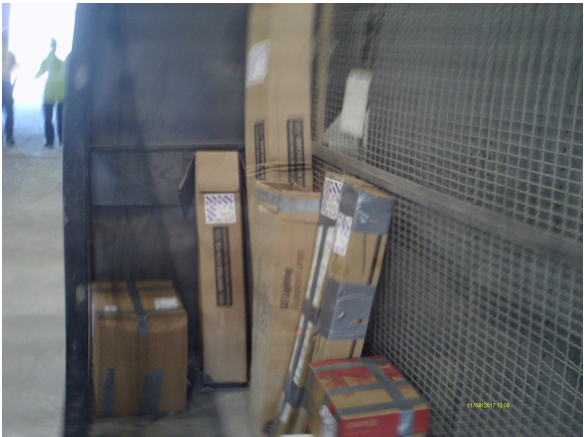
Universal wastes

Lead-acid batteries were being stored in this area on a pallet. The batteries are managed under the Universal Waste regulation and were marked as universal waste batteries. Also, the inspectors observed nine (9) boxes of universal wastes- spent mercury lamps- properly closed, labeled and dated.

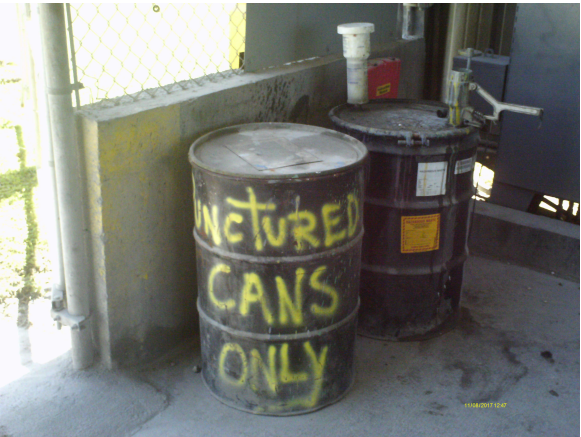
Aersolv recycling system

This area had one closed, labeled 55-gallon drum of used oil filters, two (2) closed 55-gallon drum of empty aerosol cans, one closed/labeled ( 1) 55-gallon drum of hazardous waste (Aerosolv puncture system), eleven (11)- 55 gallon drum of oily rags; four of them were open but were closed during the inspection. This area also has an equipment wash bay. Oily water from this bay is removed by CBI. A used oil filter crusher is also located in this area.

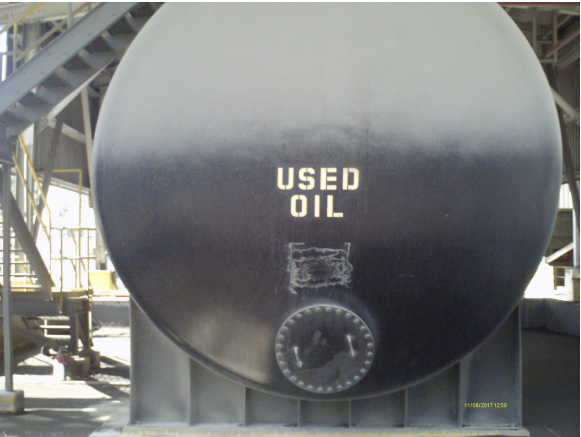
Used oil tanks

This area consists of two 600,000-gallon aboveground used oil storage tanks, a tanker truck unloading station, and six 25,000-gallon aboveground oily water storage tanks that are inactive. All tanks were labeled "Used Oil". Used oil is unloaded from trucks and transferred via pumps to the tanks. Used oil pump filter residue is mixed with the contaminated soil for processing. Oily water from the truck unloading containment area is removed by Cliff Berry, Inc. (CBI). Near to this area, the facility has spill kits and fire extinguishers up to date.

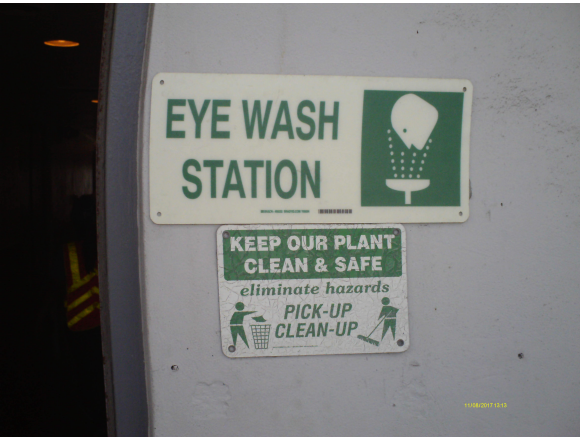
Eye wash station

All emergency and safety equipment observed during the inspection, such as eye wash stations, fire extinguishers, etc., appeared satisfactory.

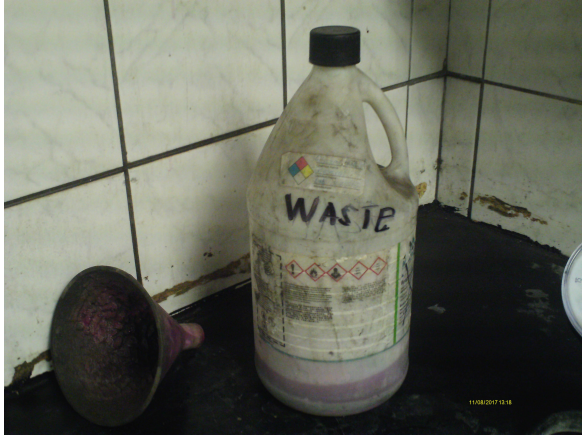
SAA - QC Laboratory

At this area, CEMEX conducts quality control sampling for their materials and generates hazardous wastes at this point. Acidified sample waste from the atomic absorption (AA) analyzer is collected in small containers. The AA waste is primarily nitric acid and mercuric chloride. One 2-gallon collection container was observed connected to the AA analyzer via tubing. One, full, 5-gallon container of AA waste acid was also observed in the lab. The containers are transferred from the lab to the hazardous waste storage area and placed in a metal cabinet. A glycerol, ethanol, and barium chloride waste is also generated by the lab and managed as a hazardous waste. The amount generated is about one 55-gallon drum every 12 to 18 months based on the volume of cement production. This waste is also transferred to the hazardous waste storage area and placed in 55-gallon drums. A record of the hazardous waste transferred to this area is kept in the metal storage cabinet. All containers observed in the lab were being properly managed.

The inspectors observed three (3) closed- 2 gallon containers of waste glycerol designated as satellite accumulation area (SAA's). All containers were labeled.
