**Florida Department of
Environmental Protection
Hazardous Waste Inspection Report**

Facility Name: Universal Environmental Services LLC
On-Site Inspection Start Date: 02/13/2018 **On-Site Inspection End Date:** 02/13/2018
ME ID#: 127125 **EPA ID#:** FLR000225029
Facility Street Address: 6940B Mission Ln, Fort Myers, FL 33916-4862
Contact Mailing Address: 411 Dividend Dr, Peachtree City, GA 30269-1940
County Name: Lee **Contact Phone:** (678) 544-2915

Routine Inspection for Used Oil Transfer Facility facility
Routine Inspection for Used Oil Transporter facility

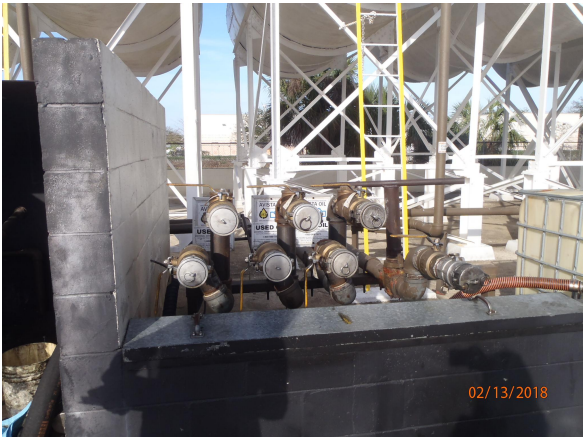
Photo 1 - tank fill/drain ports

Each storage tank has a designated fill port and drain port (see photo1). The ports are labeled with the associated tank number and 'in' and 'out' (see photo 2). Directly beneath the ports is a grated containment tray and metal cover. The tray is situated within the tank containment structure. The cover is moved when off/on-loading used oil to collect any incidental drips, spills, etc. in the tray. At the time of the inspection, the tray appeared to contain several inches of used oil (see photo 3). Used oil is pumped out of the tray as needed into a 250-gallon closed/labeled storage tote situated within the tank containment structure (see photo 4).

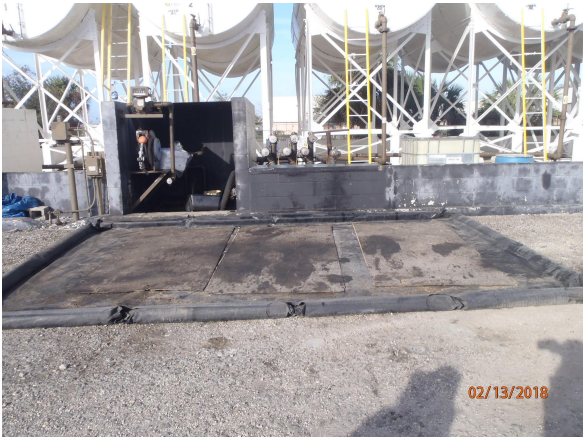
Photo 5 - bermed visqueen

Bermed visqueen is maintained outside the containment structure where the truck parks to off/on-load used oil (see photo 5). What appeared to be petroleum staining was evident on plywood situated on the visqueen (see photo 6). It was discussed that at some point, the bermed visqueen will accumulate rain and the oily water will need to be properly managed and disposed. It was also discussed that all trucks should be properly maintained to prevent oil drips; and any spills or releases occurring from off/on-loading used oil outside of the containment area should be addressed immediately. A spill kit containing absorbent, gloves, etc. is maintained in the containment area (see photo 7). Oily absorbent pads are collected in a closed container labeled used oil filters only. The container is transported to the UES Ocala facility via the Ft. Lauderdale UES facility's box truck.

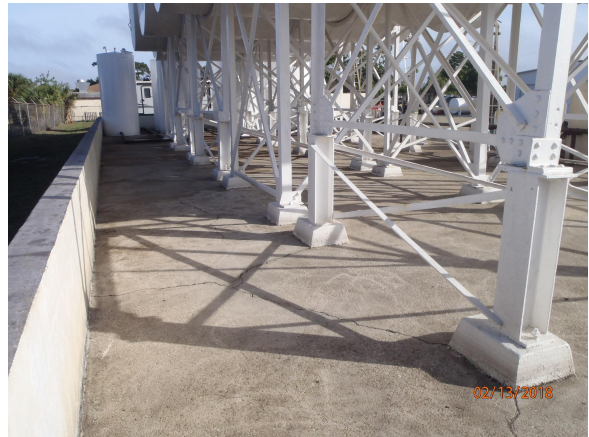
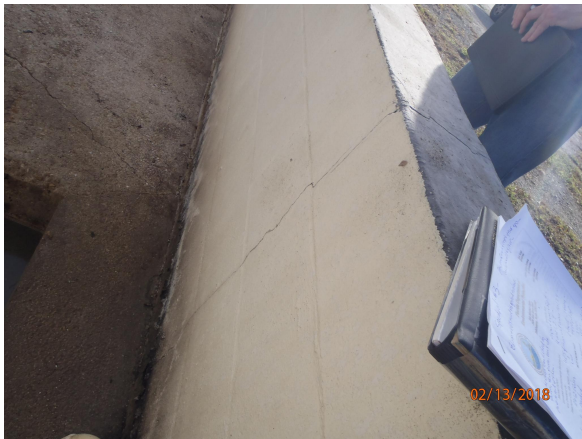
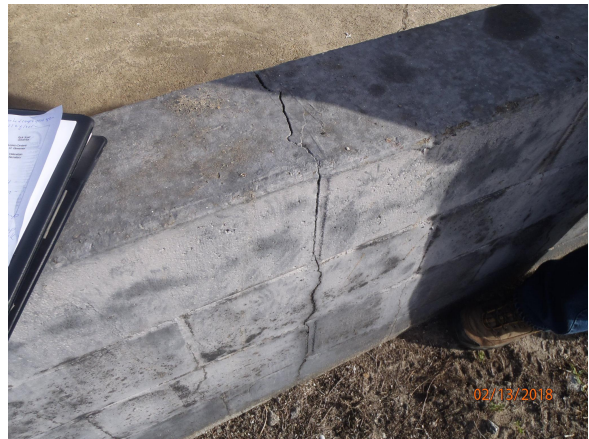
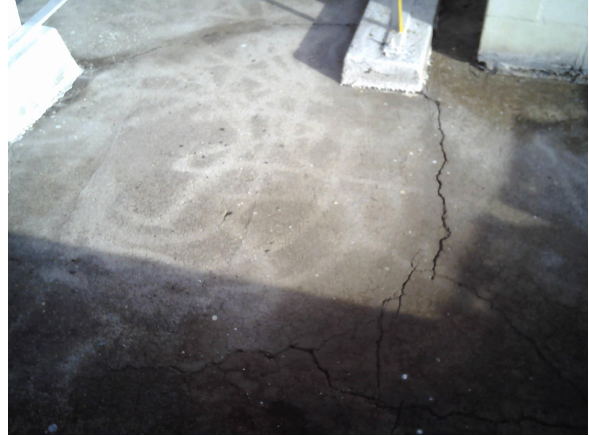
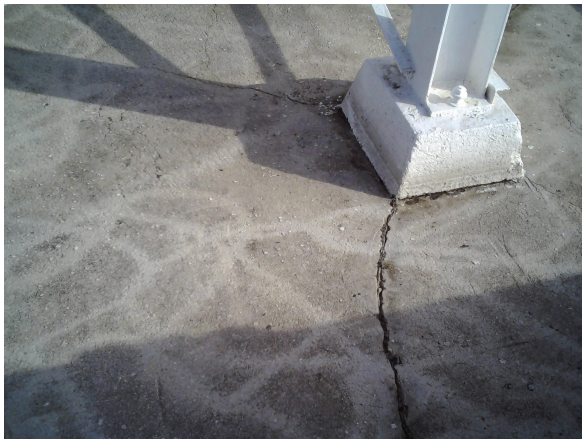
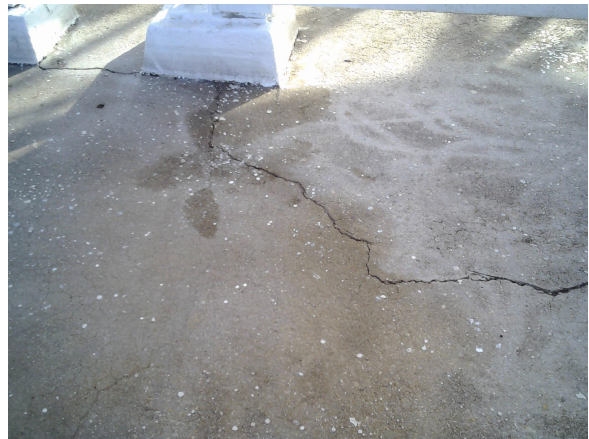
The tanks are situated within a concrete block secondary containment structure. Cracks were noted in the floor and walls of the containment structure (see photos 8-10, 14-16)). It also appeared that the sealant has worn off the floor and walls of the structure. Mr. McCaig indicated that the containment structure was recently pressured washed. Rainwater that collects in the containment structure is discharged via a drain sump located in the southwest corner of the containment structure (see photo 11). The drain port/valve is maintained closed and is located outside the containment structure (see photo 12). If the rainwater has a sheen, absorbent pads are used to remove the sheen prior to discharging. It was not discussed during the inspection however it is recommended to routinely inspect/ensure the drain port/valve is in the closed position

Type:	Violation
Rule:	279.45(e)(2)
Explanation:	The entire containment system, including walls and floors, must be sufficiently impervious to use oil to prevent any used oil released into the containment system from migrating out of the system to the soil, groundwater, or surface water.
	The coating/sealant on the concrete floor and walls of the storage tank containment structure has worn off; and there are cracks in the floor and walls.
Corrective Action:	The cracks and entire containment structure needs to be resealed with an impervious sealant. See photos 8-10 and 14-16.
	Subsequent to the inspection, Mr. McCaig provided specs for the sealant/primer to be used to re-seal the containment structure; and will be completing the corrective actions.

Photo 8 - cracks in containment floor

Photo 9 - crack in containment wall

Photo 10 - crack in containment wall

Photo 14 - cracks in containment floor

Photo 15 - cracks in containment floor

Photo 16 - cracks in containment floor

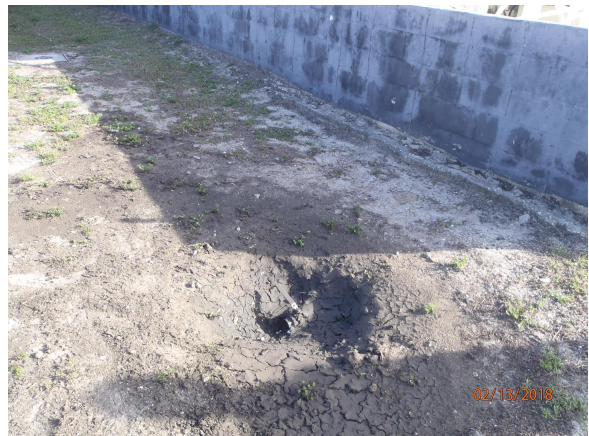
Photo 12 - drain port/valve

when not discharging rainwater and to maintain a lock on the drain port/valve to ensure it remains closed.

It is recommended to routinely inspect/ensure the drain valve is in the closed position when not discharging rainwater and to maintain a lock on the drain valve to ensure it remains closed.

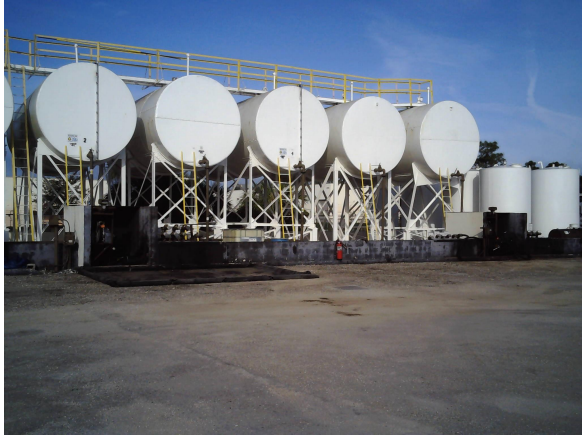
Photo 13 - storage tanks

Each storage tank is an aboveground, horizontal mounted, single-walled tank that is 15,000-gallon in capacity (see photo 13). The tanks and piping are labeled used oil, UES and numbered. Each tank is equipped with a gauge to visually determine the tank volume.

The current tank registration reflects the three leased tanks #1,2 and 4 contain 'new/lube oil'. EOC should revise their tank registration to accurately reflect the contents of the storage tanks [including tank #3].
