**Florida Department of
Environmental Protection
Hazardous Waste Inspection Report**

Facility Name: Safety-Kleen Systems Inc

On-Site Inspection Start Date: 05/07/2019

Routine Inspection for Used Oil Processor facility

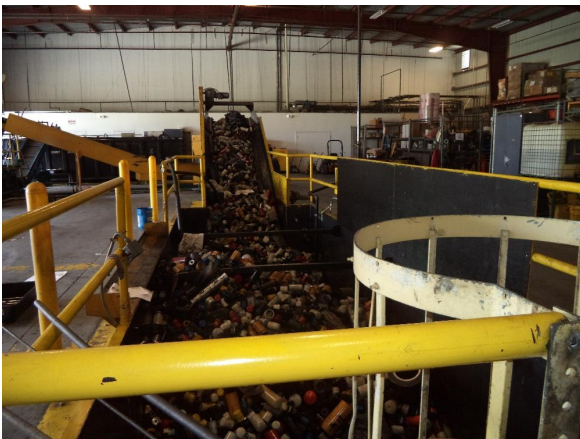
1. Oil Filter Processing

The used oil filter processing area is located within the southern half of the warehouse. Used oil, used oil filters, and used absorbent containers are stored in this section of the warehouse. The used oil filter processing operation consists of a used oil filter receiving pit, conveyor, and storing/crushing unit (Figure 1). Under normal conditions used oil filters are processed in the crusher. The metal filters accumulate in a roll-off container stored within the warehouse (Figure 2). Used oil is directed into the storage tanks and the plastic and soft filter waste is transferred to the solid waste processing/solidification area. The filter crusher was not operational at the time of this inspection. Used oil filters were being diverted directly to the solid waste processing area until the equipment could be repaired and returned to service.

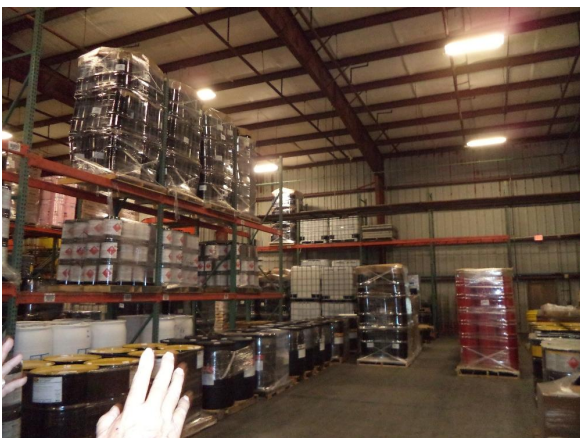
3. Distribution Warehouse

The northern half of the warehouse is used as a distribution center. Products for sale are stored in bulk in the former processing plant area (Figure 3). No wastes are stored in this area.
