Re: Cummins Inc. Compliance Assistance Offer
Facility ID # FLR000233452
Palm Beach County

**Florida Department of
Environmental Protection
Hazardous Waste Inspection Report**

Facility Name: Cummins Inc
On-Site Inspection Start Date: 11/05/2020 **On-Site Inspection End Date:** 11/05/2020
ME ID#: 108437 **EPA ID#:** FLR000233452
Facility Street Address: 3754 Interstate Park Rd N, Riviera Beach, Florida 33404-5908
Contact Mailing Address: 5515 Frontage Rd, Forest Park, Georgia 30297-2531
County Name: Palm Beach **Contact Phone:** (404) 763-0151

Inspection Date: 11/05/2020

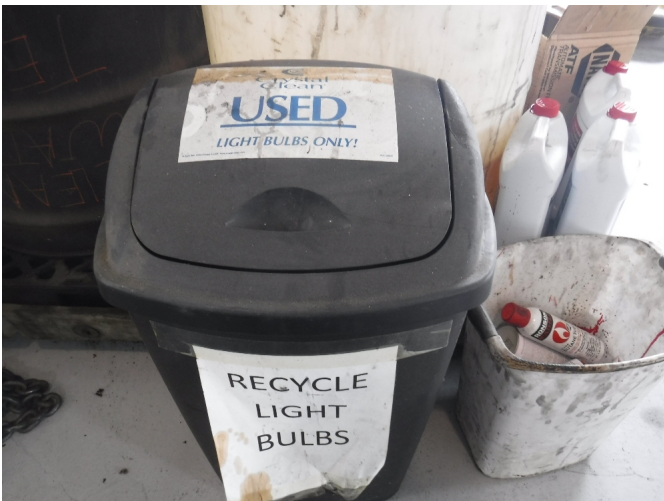
>One closed six-gallon poly container for spent mercury lamps not properly labeled. Per 40 CFR 273.14(e) spent mercury lamps shall be specifically labeled as "universal waste-mercury-containing lamps", "waste mercury-containing lamps" or "used mercury-containing lamps". The facility was required to submit a picture of the container properly labeled. On 11/20/2020 the facility submitted a picture of a spent mercury lamps container properly labeled.

Type:	Violation
Rule:	273.14(e)
Explanation:	One five-gallon container for spent mercury lamps was observed not properly labeled at the time of inspection.
Corrective Action:	Spent mercury lamps containers shall be specifically labeled "universal waste-mercury-containing lamps", "waste mercury-containing lamps" or "used mercury-containing lamps". The facility was requested to properly label the spent mercury lamps container and submit to the Department as corrective action.

Spent mercury lamps container not properly labeled

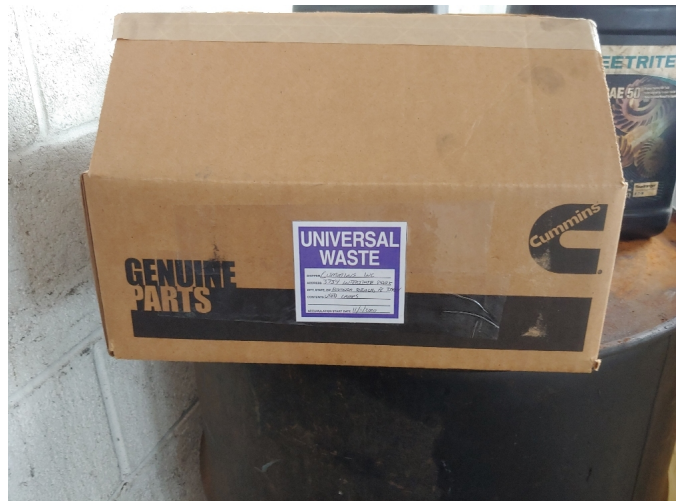
Spent mercury lamps container properly labeled

This violation was resolved via submittal to the Department on 11/20/2020.

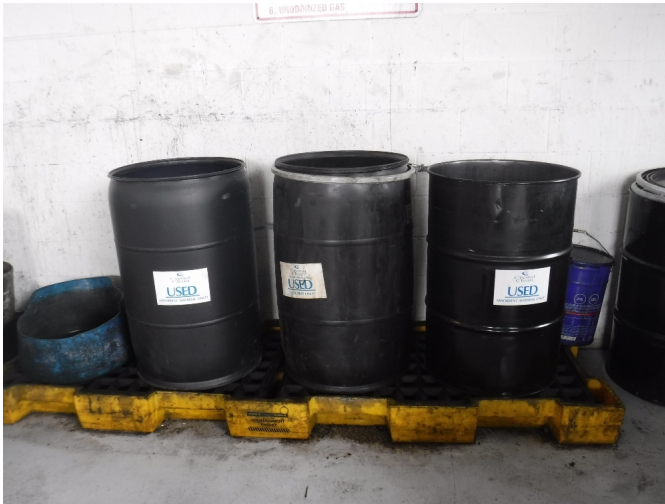
>Three open 55-gallon poly drums, one for used oil filters and the other two for oily absorbent materials over a secondary containment. Per 62-710.850(5)(a) FAC used oil filter containers shall be kept closed, the facility was requested to close the used oil container as a corrective action.

Used oil filters and oily absorbent drums open

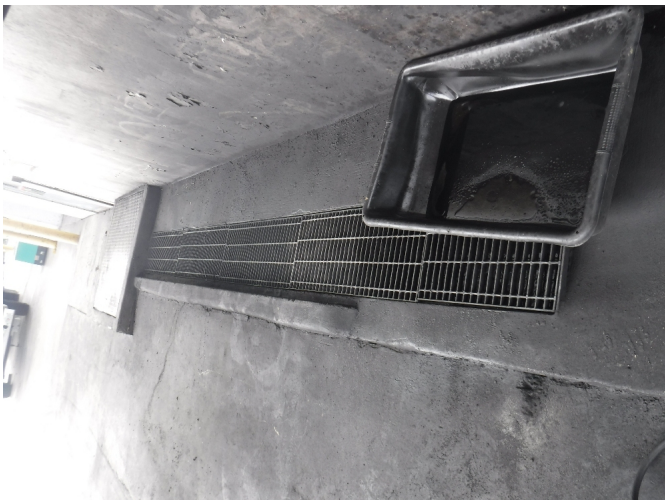
Outside the tanks area there is the pressure washer area, where a drainage system was observed. The oily water is drained and connected the oily water to the separator system.

Drainage system for used oil and water

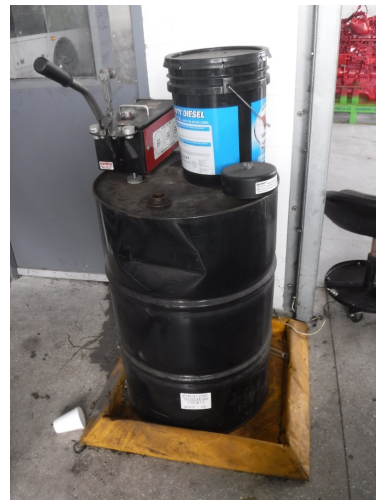
>One 55-gallon metal drum attached to a can puncturer system. This drum collects and stores the spent aerosol can contents, which according to the facility are generated in small quantities and are disposed as hazardous waste.

Aerosol can puncturer system
