**SUBJECT: Department of Environmental Protection v. San Jose Collision, Inc.**  
**OGC File No. 20-1095**  
**EPA/DEP ID: FLR 000 165 969**  
**Duval County**

**RE: Warning Letter WL20-167 (Significant Non-Complier)**  
**San Jose Collision, Inc.**  
**EPA/DEP ID: FLR 000 165 969**  
**Duval County – Hazardous Waste**

**Florida Department of  
Environmental Protection  
Hazardous Waste Inspection Report**

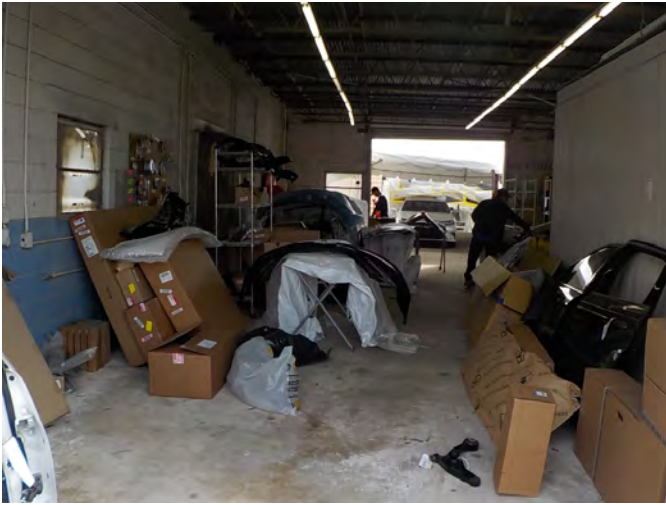
Photo 1

Vehicle parts are stored in the Parts Garage (Photo 1). No hazardous waste or used oil is generated in this area.

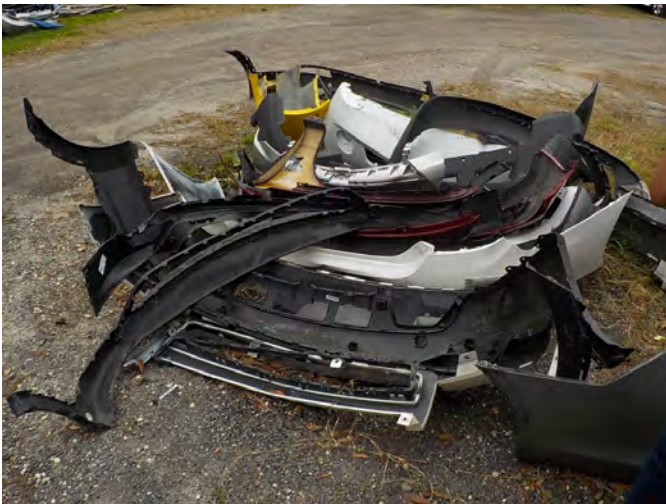
Photo 3

Irreparably damaged car parts are placed in this area and the metal pieces are separated out and sent off-site for recycling (Photo 3). There was one shed in the area that is used for the storage of tools and several containers of paint. The facility is reminded that once this paint is determined to be a waste, or is no longer usable, the facility should make a hazardous waste determination on it and manage the waste paint appropriately.

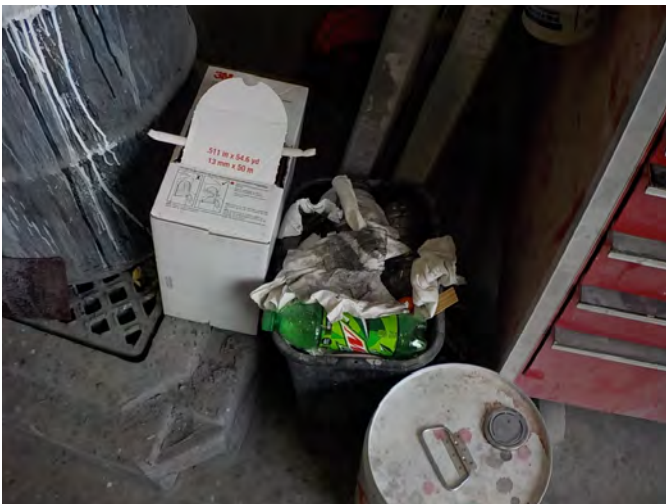
Photo 5

The first step in preparing the vehicles for painting is cleaning the exterior to remove dirt and debris. Technicians use Vietek Premium Wash Thinner (Wash Thinner) (30-50% methanol, 30-50% toluene, 10-20% acetone; flashpoint -4°F) with a lint-free disposable wipe to spot-clean the vehicle. Spent Wash Thinner liquid is a D001/F003/F005 hazardous waste. Wipes used with Wash Thinner are an F005 hazardous waste. Facility personnel stated that these wipes are managed as solid waste and are thrown into the trash [40 CFR 262.20(a)]. Inspectors observed wipes in several trash cans throughout the Paint Shop (Photo 5).

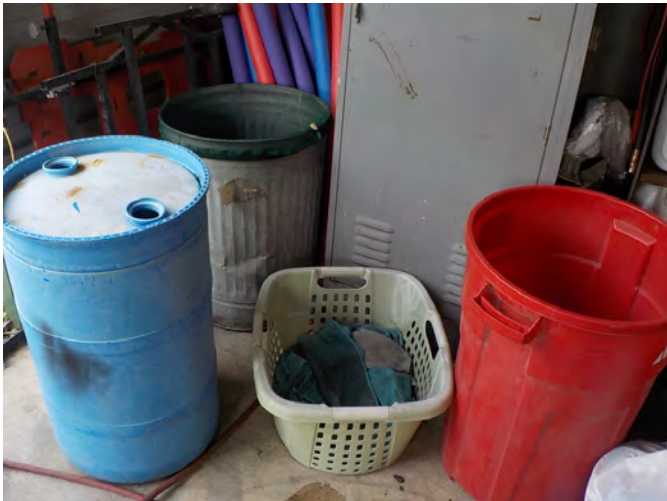
Photo 7

All Purpose Cleaner (1-5% 2-butoxyethanol, 1-5% mixed alkyl sulfates, 1-5% sodium metasilicate; flashpoint 200°F) is used with launderable wipes for cleaning car interiors. This generates a non-hazardous wipe. Launderable wipes are placed into a 30-gallon metal container that was located in this area (Photo 7). The wipes are laundered weekly by Unifirst.

Launderable wipes from the Body Shop that are used with GAC are also added to the 30-gallon metal wipes container in this area. It appears that the facility is managing the wipes from the Detail Area and the Body Shop as Excluded Solvent-Contaminated Wipes by having them laundered. However, because the wipes are not being managed in accordance with the solvent-contaminated wipe exclusion in 40 CFR 261.4(a)(26), the waste wipes container is considered a hazardous waste satellite container that was not closed [40 CFR 262.15(a)(4)] and was not properly labeled [40 CFR 262.15(a)(5)].

Type:	Violation 3
Rule:	262.15(a)(4)
Explanation:	The following hazardous waste satellite containers were not kept closed: <u>Detail Area</u> - One 30-gallon container of solvent-contaminated wipes; <u>HWAA</u> - One 30-gallon container of hazardous waste still bottoms.
Corrective Action:	In order to return to compliance, within one day of receipt of this report, the facility should close these containers and keep closed, except when adding or removing waste.

Type:	Violation 4
Rule:	262.15(a)(5)
Explanation:	The following hazardous waste satellite containers were not properly labeled: <u>Detail Area</u> - One 30-gallon container of solvent-contaminated wipes; <u>HWAA</u> - One 30-gallon container of hazardous waste still bottoms.
Corrective Action:	In order to return to compliance, within one day of receipt of this report, the facility should: <u>Detail Area</u> - Manage solvent-contaminated launderable wipes as Excluded Solvent-Contaminated Wipes in accordance with the solvent-contaminated wipe exclusion in 40 CFR 261.4(a)(26) and place the wipes into a closed, non-leaking container, and properly label the container as "Excluded Solvent-Contaminated Wipes."  <u>HWAA</u> - Label the container with the words "Hazardous Waste" and with an indication of the hazards of the contents.

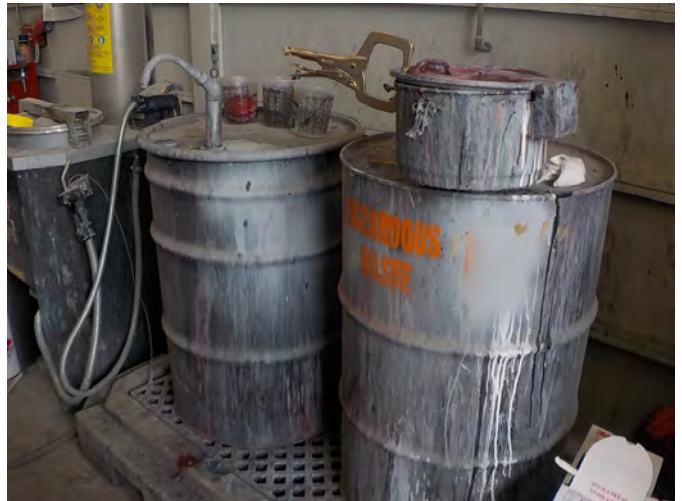
Photo 8

The HWAA is located on the east side of the Paint Shop. There was one 55-gallon drum of hazardous waste paint and thinner waste accumulating (Photo 8). The drum was properly labeled, but was not marked with an indication of the hazards of the contents [40 CFR 262.16(b)(6)(i)(B)] or with the accumulation start date [40 CFR 262.16(b)(6)(i)(C)]. The drum was not completely sealed closed due to the buildup of waste paint on the funnel lid (Photo 9) [40 CFR 262.16(b)(2)(iii)(A)].

Explanation:	In the HWAA, one 55-gallon accumulation drum of hazardous waste paint and thinner was open.
Corrective Action:	In order to return to compliance, within five days of receipt of this report, the facility should replace the funnel with a threaded funnel that is attached to the bung hole and has a lockable latch that can be sealed closed. The funnel should remain closed and latched, except when adding or removing waste.
Type:	Violation 6
Rule:	262.16(b)(2)(iv)
Explanation:	The facility did not did not perform weekly inspections of the HWAA.
Corrective Action:	In order to return to compliance, within one day of receipt of this report, the facility should begin conducting and documenting weekly inspections of the HWAA.
Type:	Violation 7
Rule:	262.16(b)(6)(i)(B)
Explanation:	In the HWAA, one 55-gallon accumulation drum of hazardous waste paint and thinner was not marked with an indication of the hazards of the contents.

Corrective Action:	In order to return to compliance, within one day of receipt of this report, the facility should mark or label the container with an indication of the hazards of the contents.
Type:	Violation 8
Rule:	262.16(b)(6)(i)(C)
Explanation:	In the HWAA, one 55-gallon accumulation drum of hazardous waste paint and thinner was not marked with the start date of accumulation.
Corrective Action:	In order to return to compliance, within one day of receipt of this report, the facility should mark or label the container with the start date of accumulation.
Type:	Violation 9
Rule:	262.16(b)(8)(ii)(C)
Explanation:	The HWAA did not have the required equipment including an eyewash and spill kit.
Corrective Action:	In order to return to compliance, within ten days of receipt of this report, the facility should install an eyewash and spill kit in this area.
Type:	Violation 10
Rule:	262.16(b)(8)(vi)(A)
Explanation:	The facility had not made emergency arrangements with local authorities.

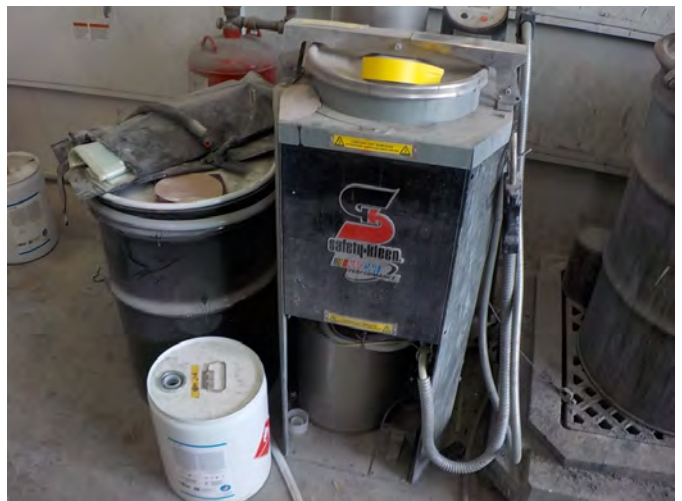
Photo 10

Some of the spent paint/thinner is distilled in a 5-gallon capacity solvent recovery still located in this area (Photo 10). Technicians stated that the solvent still is used daily to recycle approximately five gallons of waste paint/thinner. Still bottoms from the solvent still are collected in a 30-gallon satellite drum adjacent to the still (See Photo 10). The drum was not closed [40 CFR 262.15(a)(4)], was not properly labeled with the words "Hazardous Waste" and was not labeled with an indication of the hazards of the contents [40 CFR 262.15(a)(5)]. The area was equipped with a fire extinguisher but did not have an eyewash or spill kit [40 CFR 262.16(b)(8)(ii)(C)]. Inspectors observed employees smoking near containers of ignitable wastes and also observed cigarette packages in this area (Photo 11). This is an Area of Concern. SJC should ensure that the facility is maintained and operated in a manner to minimize the possibility of a fire or explosion that could result in a release of hazardous waste constituents to the air or soil which could threaten human health or the environment.
