Re: Return to Compliance Letter – Cummins Inc.  
EPA ID # FLR000233452  
Palm Beach County

**Florida Department of  
Environmental Protection  
Hazardous Waste Inspection Report**

## Cummins Inc Inspection Report

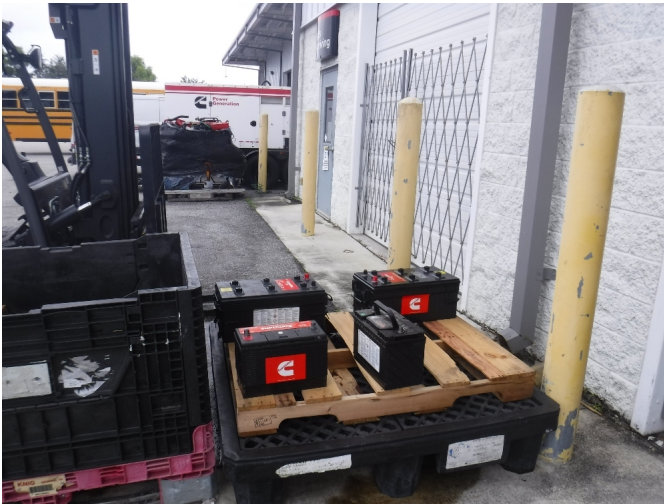
>Six spent lead acid batteries stored over an impervious surface, but not covered nor protected from the elements. Per 40 CFR 273.13(a), universal waste spent batteries shall be stored in a way to prevent release.

Type:	Violation
Rule:	273.13(a)
Explanation:	For spent lead acid batteries were observed stored outside, not protected from the weather at the time of inspection.
Corrective Action:	SQH of universal waste shall manage waste batteries in a way to prevent release. The facility was requested to store the spent lead acid batteries under a covered area, protected from the elements.

Six spent lead acid batteries not protected from the elements

The facility was requested to provide a corrective action picture of the spent batteries protected from the elements. On 11/20/2020, the facility submitted a picture of an improper universal waste batteries storage; thus,

The Department received a submittal on 11/20/2020; however it was incomplete and the violation remains open.

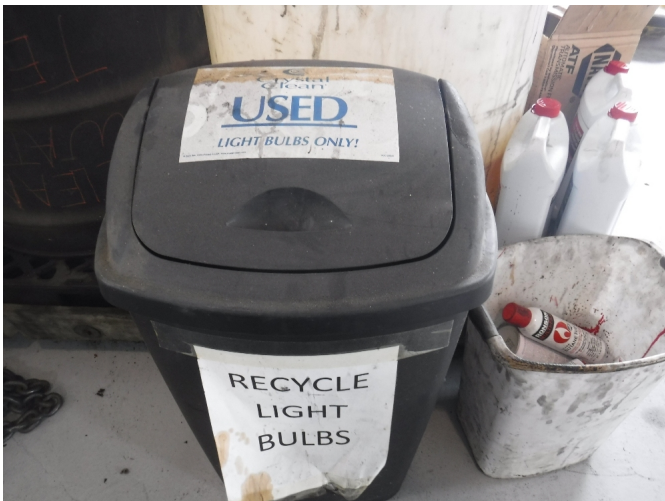
>One closed six-gallon poly container for spent mercury lamps not properly labeled. Per 40 CFR 273.14(e) spent mercury lamps shall be specifically labeled as "universal waste-mercury-containing lamps", "waste mercury-containing lamps" or "used mercury-containing lamps". The facility was required to submit a picture of the container properly labeled. On 11/20/2020 the facility submitted a picture of a spent mercury lamps container properly labeled.

Type:	Violation
Rule:	273.14(e)
Explanation:	One five-gallon container for spent mercury lamps was observed not properly labeled at the time of inspection.
Corrective Action:	Spent mercury lamps containers shall be specifically labeled "universal waste-mercury-containing lamps", "waste mercury-containing lamps" or "used mercury-containing lamps". The facility was requested to properly label the spent mercury lamps container and submit to the Department as corrective action.

Spent mercury lamps container not properly labeled

This violation was resolved via submittal to the Department on 11/20/2020.

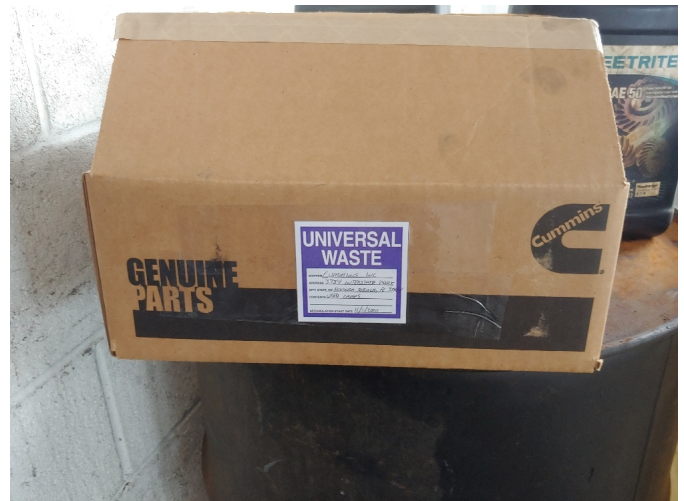
Spent mercury lamps container properly labeled

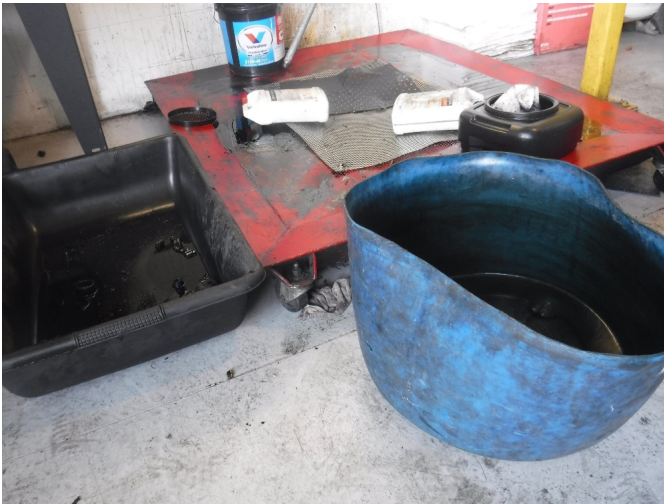
Next to the drums there was a pail used oil used for used oil collection, not properly labeled. Per 40 CFR 279(c)(1) used oil containers shall be labeled as "used oil", the facility was requested to and to label the used oil pail as a corrective action.

Used oil pail not properly labeled

This violation was resolved via submittal to the Department on 11/20/2020.

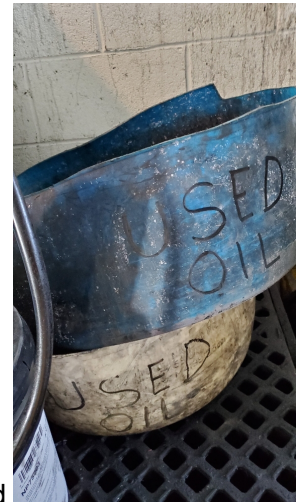
Used oil pail properly labeled

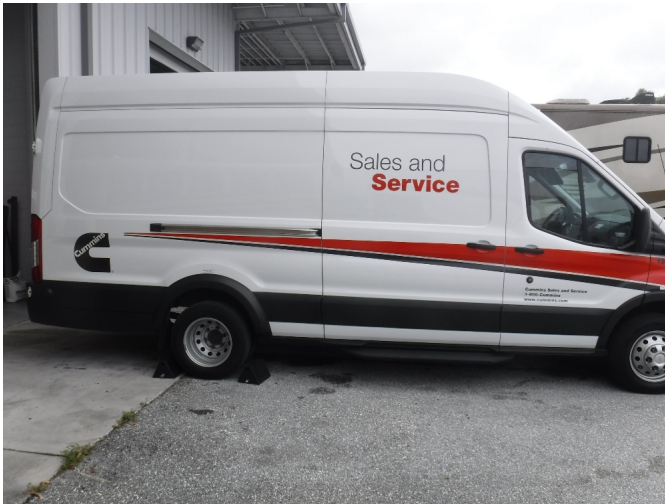
Outside the warehouse shop is the parking lot where the fleet is located. There are six service vans used for maintenances and repairs at the client's site. In the vehicle was observed a spill kit and a fire-extinguisher. No Department of Transportation (DOT) number was observed posted on the vehicles. Per 40 CFR 279.43(b) vehicles used for used oil transportation shall comply with the DOT requirements by demonstrating placards and carrying documentation, such as, UOT notification, liability insurance and contingency plan in the vehicle. The facility was requested to provide corrective action pictures of the vehicles with DOT numbers posted and with the compliant documentation.

Service van not compliant with DOT requirements

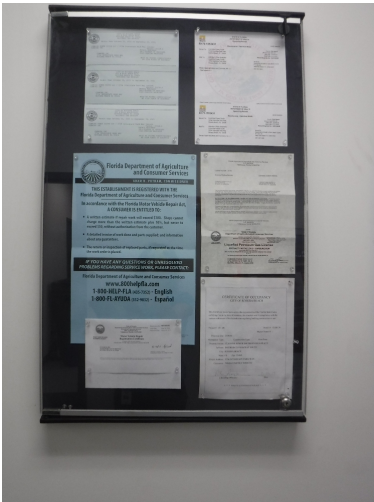
Type: Violation  
Rule: 62-710.500(4)  
Explanation: The UOT registration from the facility was not observed posted at a prominent place at the facility.  
Corrective Action: Each registered person shall display the validated registration form and identification number in a prominent place at each facility location. The facility was requested to post the UOT registration at a prominent place as corrective action.

Missing UOT notification and number posted

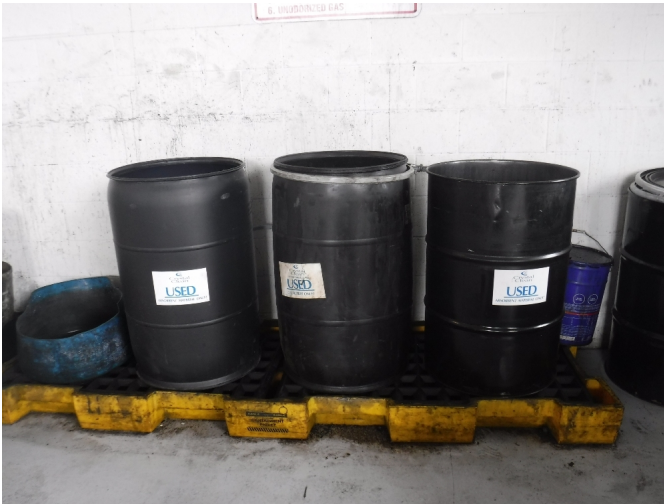
>Three open 55-gallon poly drums, one for used oil filters and the other two for oily absorbent materials over a secondary containment. Per 62-710.850(5)(a) FAC used oil filter containers shall be kept closed, the facility was requested to close the used oil container as a corrective action.

Type:	Violation
Rule:	62-710.850(5)(a)
Question Number:	5.25
Question:	Are the used oil filter containers closed or otherwise protected from weather? 62-710.850(5)(a)
Explanation:	One open 55-gallon used oil container was observed at the shop during the inspection.
Corrective Action:	Used oil containers shall be sealed or otherwise protected from weather and stored on an oil-impermeable surface. The facility was requested to close the container as corrective action.

Used oil filters and oily absorbent drums open

This violation was resolved via submittal to the Department on 11/20/2020.

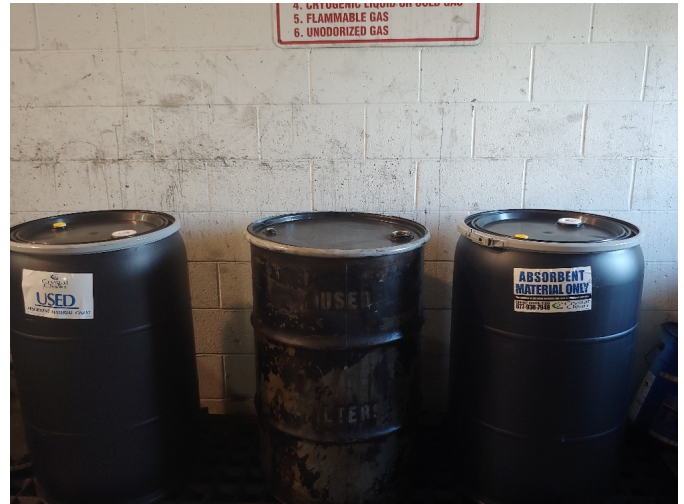
Used oil filters properly closed

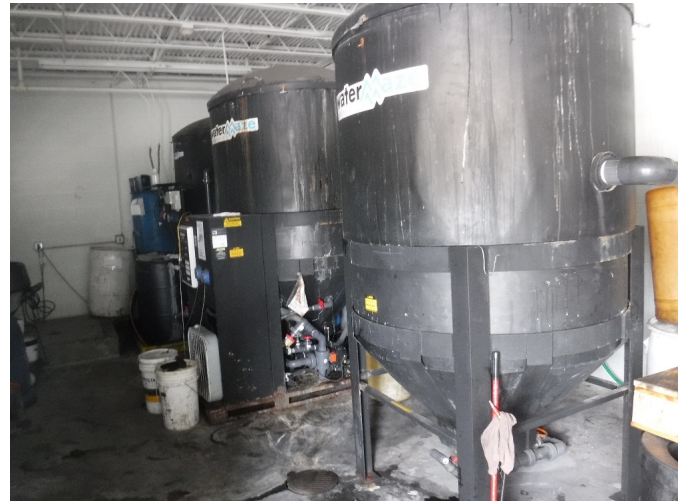
- >Three 500-gallon metal tanks that are part of the oil and water separator system branded "Water Maze". The first tank has an aluminum oxide filtration system, the second tank has a microbe filtration system and the third tank is where the oil is finally separated for pick up.

Water treatment system

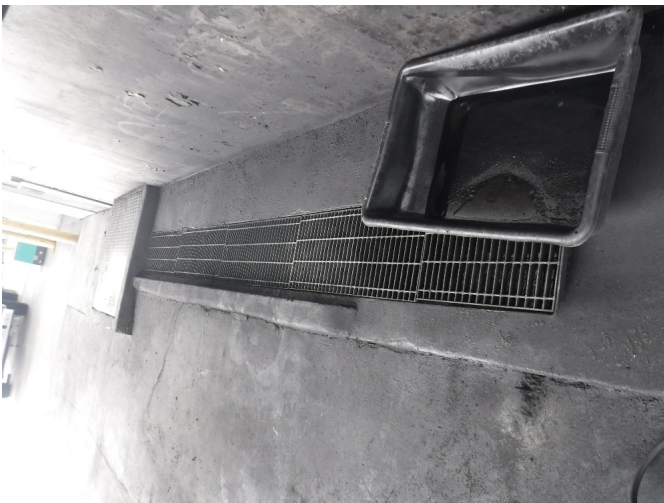
Outside the tanks area there is the pressure washer area, where a drainage system was observed. The oily water is drained and connected the oily water to the separator system.

Drainage system for used oil and water

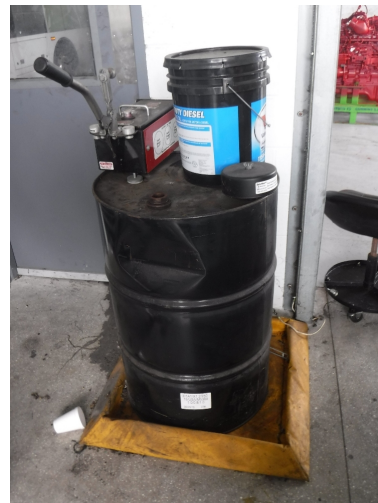
>One 55-gallon metal drum attached to a can puncturer system. This drum collects and stores the spent aerosol can contents, which according to the facility are generated in small quantities and are disposed as hazardous waste.

Aerosol can puncturer system
