Re: Ring Power Corporation – St. Petersburg
Facility ID Number FLR000097444
Pinellas

Hazardous Waste Inspection Report

Facility Name: Ring Power Corporation
On-Site Inspection Start Date: 01/22/2021 **On-Site Inspection End Date:** 01/22/2021
ME ID#: 38304 **EPA ID#:** FLR000097444
Facility Street Address: 2700 Gandy Blvd N, St Petersburg, Florida 33702-2022
Contact Mailing Address: 500 World Commerce Parkway, St Augustine, Florida 32092
County Name: Pinellas **Contact Phone:** (904) 494-7445

Inspection Date: 01/22/2021

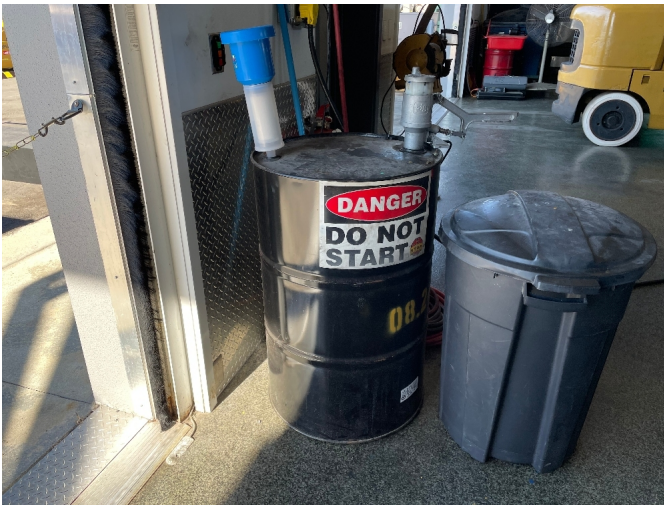
Type:	Violation
Rule:	262.15(a)(5)
Question Number:	3.54
Question:	Has the generator marked satellite containers with the words "Hazardous Waste"? 262.15(a)(5)
Explanation:	All containers storing hazardous waste must be marked with the words "Hazardous Waste". At the time of the inspection, Ring Power did not label the aerosol can puncturing drum with the words "Hazardous Waste".

Aerosol puncturing can drum not properly labeled.

Corrective Action: CORRECTED: Ring Power labeled the aerosol puncturing can drum with the words "Hazardous Waste".

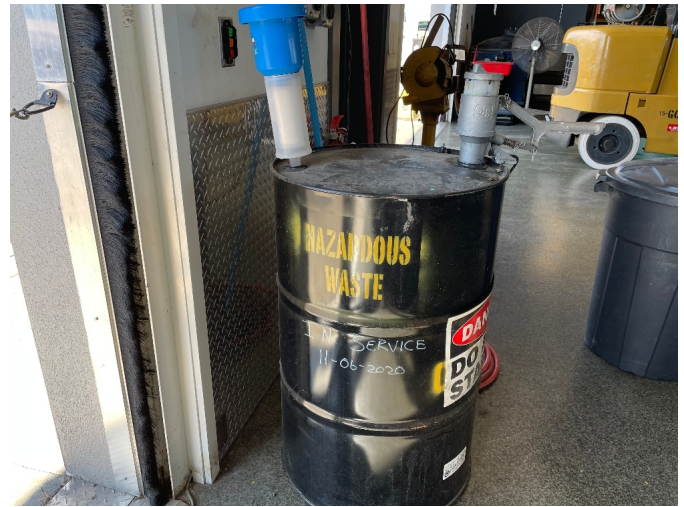
CORRECTED: Properly labeled with the words "Hazardous Waste"

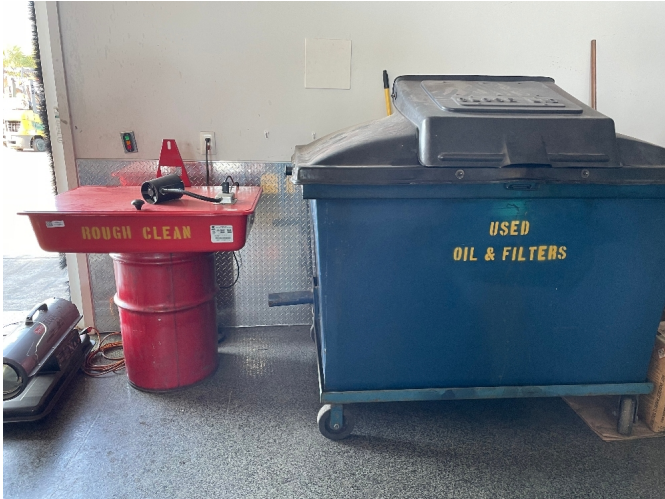
parts washers that were properly closed and managed by Safety Kleen every eight weeks. Adjacent to one of the parts washers was a used oil filter collection container that was being properly managed. South of the used oil filter container and parts washer was a 55-gallon aerosol can puncturing drum. At the time of the inspection, the facility was managing waste liquid from punctured aerosol cans as hazardous waste; however, the drum used for the collection of the waste liquid was not properly labeled with the words "hazardous waste". Mr. Lacey properly labeled the drum during the inspection and the Department verbally discussed the recently adopted rule from October 30, 2020, that aerosol cans can now be managed as universal waste. More information can be found here: <https://floridadep.gov/waste/permitting-compliance-assistance/content/hazardous-waste-rulemaking>.

Used oil filter container and one parts washer

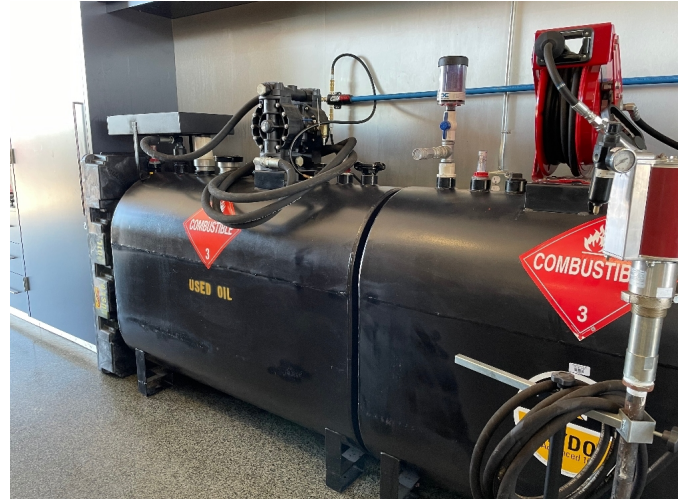
Explanation: Used oil transfer facilities are transportation related facilities including loading docks, parking areas, storage areas, and other areas where shipments of used oil are held for more than 24 hours during the normal course of transportation and not longer than 35 days. Transfer facilities that store used oil for more than 35 days are subject to regulation under subpart F of this part. Ring Power was storing used oil from offsite at the facility for longer than 35 days and was not a registered used oil processor.

Used oil tank

Corrective Action: CORRECTED: Ring Power changed their used oil pickup for offsite disposal from every eight weeks to every four weeks to ensure compliance with the 35 day requirement. This was confirmed via email on February 1, 2021.

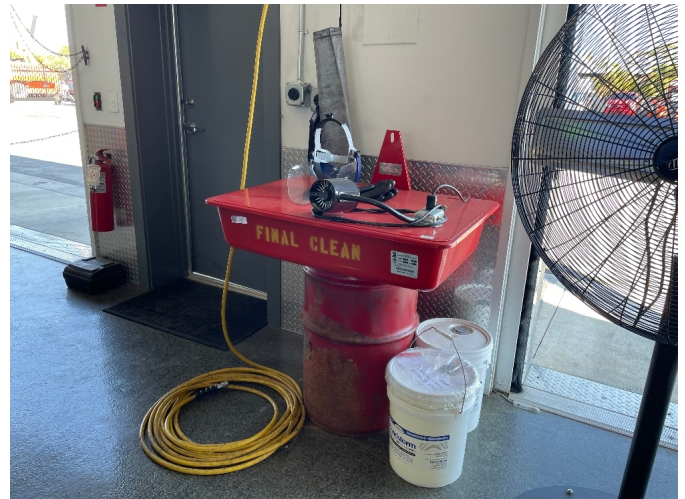
The second parts washer
