Re: Sun Coast Environmental, Inc.
EPA/DEP ID: FLR 000 064 881
Duval County – Hazardous Waste

**Florida Department of
Environmental Protection
Hazardous Waste Inspection Report**

Facility Name: Sun Coast Environmental Inc
On-Site Inspection Start Date: 07/20/2021 **On-Site Inspection End Date:** 07/20/2021
ME ID#: 56934 **EPA ID#:** FLR000064881
Facility Street Address: 405 Mealy Dr, Atlantic Beach, Florida 32233-6945
Contact Mailing Address: 405 Mealy Dr, Atlantic Beach, Florida 32233-6945
County Name: Duval **Contact Phone:** (904) 241-3111

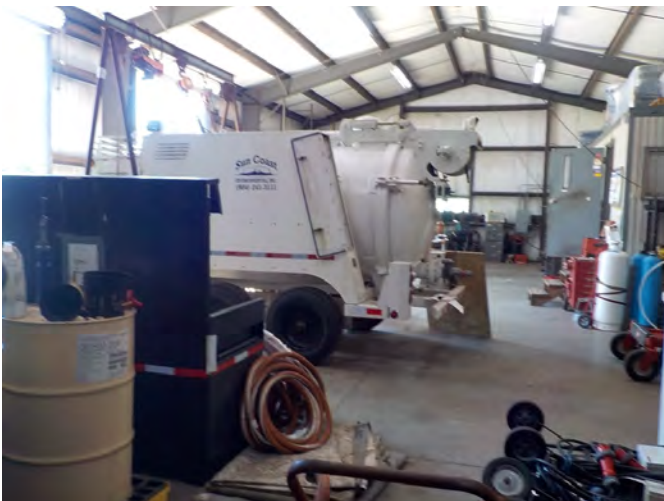
Photo 1

Chemical products, tools and equipment are stored and light maintenance work on company vehicles is performed in the Shop Area (Photo 1). Used oil generated by Sun Coast maintenance activities is drained into a 55-gallon drum (Photo 2). The drum was properly labeled and stored on a spill containment pallet. Used oil filters are collected in a 5-gallon bucket (Photo 3). The drum was properly labeled. Non-hazardous oily rags are collected in a 55-gallon drum. A facility representative stated that solvents/aerosols are not used on rags. The facility does not have a parts washer.

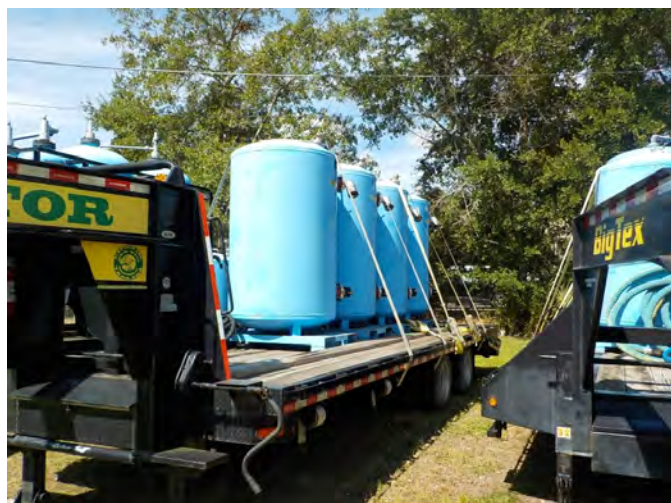
Photo 5

The facility offers a water purifying service to US Navy vessels. Sun Coast takes the vessel demineralizers (Photo 5) to Mayport to purify the water. To regenerate the demineralizers, Sun Coast returns the vessels to its facility and flushes the cation bed with hydrochloric acid and the anion bed with sodium hydroxide. The two solutions are discharged to a 4,000-gallon poly tank (background of Photo 6) where the wastewater is mixed and neutralized to a pH of between 5-9. The pH is then adjusted to 7.3, allowed to rest for a period of time and then discharged into the city sewer system via flexible hoses. This process is conducted with the permission of the

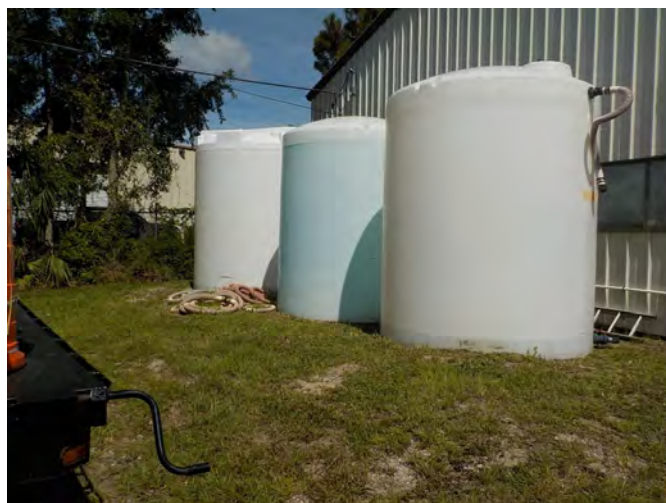
Photo 6

City of Atlantic Beach. The facility also stores deionized water onsite in two 3,000-gallon poly tanks (other two tanks in Photo 6).
